**FEMA Levee Certification
Ventura County, California**

**Santa Clara River Levee (SCR-1)
Highway 101 to Saticoy**

**Evaluation Report
February 13, 2009**

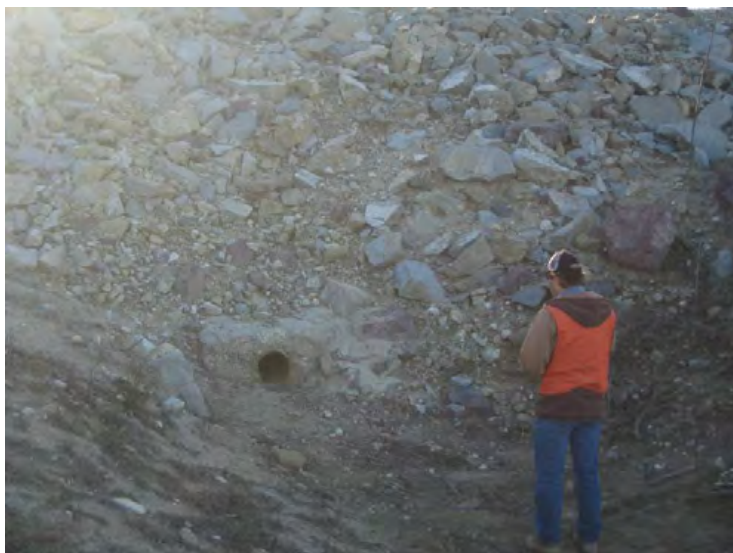
Santa Clara River Levee, From Hwy 101 to Saticoy. (Photo No. P5) – 12” metal pipe, commercial drain from process plant (riverward side)

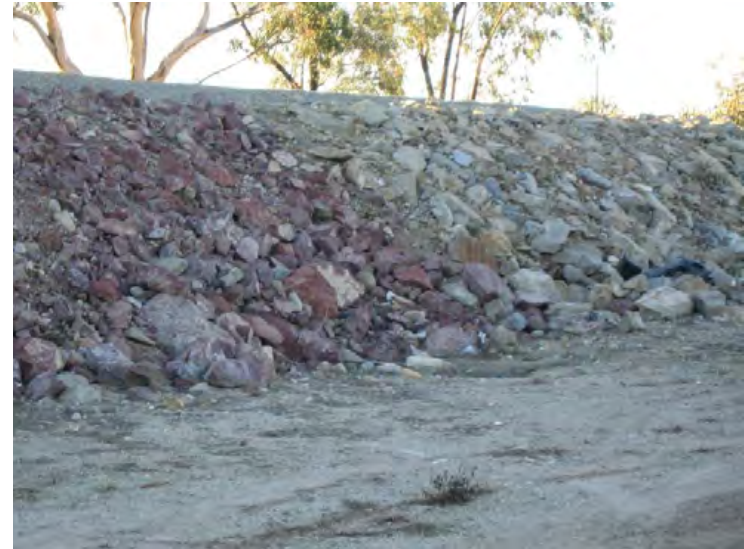
Santa Clara River Levee, From Hwy 101 to Saticoy. (Photo No. F5) – Levee bank stone protection, two different types of stone (riverward side)

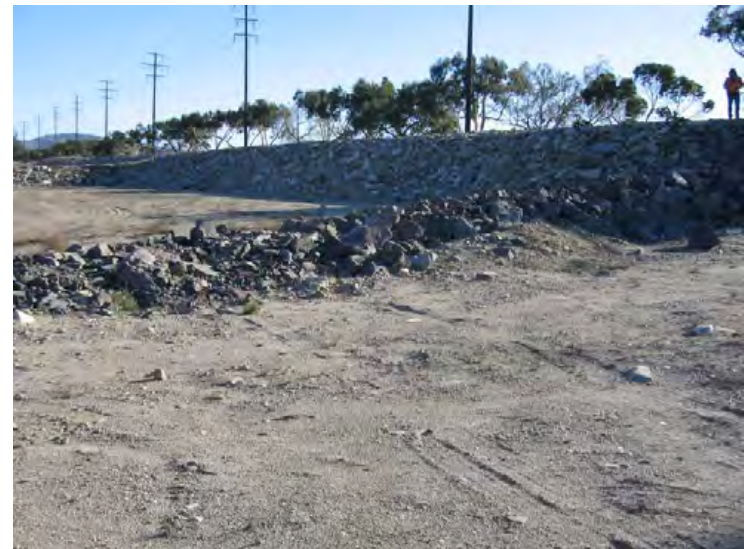
Santa Clara River Levee, From Hwy 101 to Saticoy. (Photo No. F6) – Groin and levee embankment, looking downstream (riverward side)

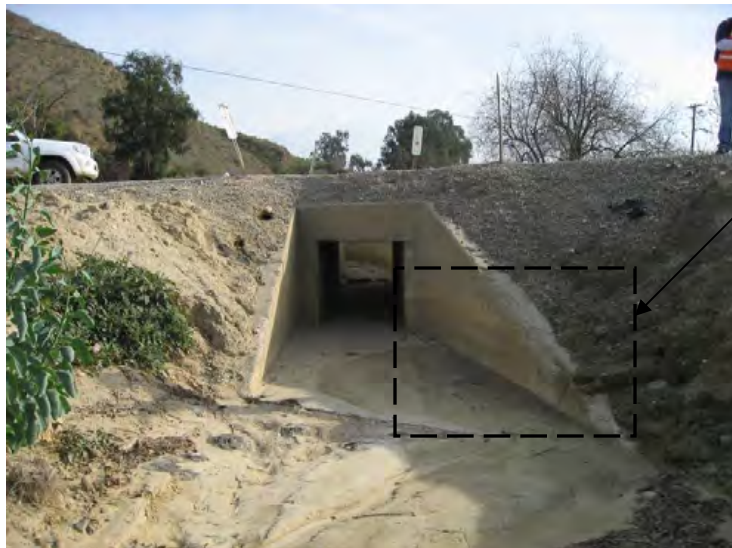
Santa Clara River Levee, From Hwy 101 to Saticoy. (Photo No. M1) –
Damaged concrete on Side Drain 1A headwall with rebar exposed

GPS		*Photo No.	Description	Action Required
Lat	Long			
<u>Santa Clara River Levee (SCR-1)</u>				
N34.28292	W119.12323	M1, M2	Damaged concrete on Side Drain 1A headwall with rebar exposed (riverward side)	Repair the concrete headwall of outlet structure
N34.28300	W119.12337	M3	Sediment spoils (riverward side)	Remove spoils from levee
N34.28128	W119.12649	M4, M5	Sediment deposition in Side Drain No. 1, 42” RCP inlet and outlet. Flap gate is stuck open by debris and sediment	Remove sediment and debris and establish a clear passage from pipe to channel (riverward & landward sides)
N34.27899	W119.13102	M6, M7	Wood debris (riverward side)	Remove debris from the levee
N34.27848	W119.13181	M8, M9	Broken stone revetment (riverward side)	Stone revetment may need to be repaired, additional engineering analysis is recommended
N34.27828	W119.13232	M10	Animal burrows at levee toe (riverward side)	Fill voids with impervious material and firmly compact

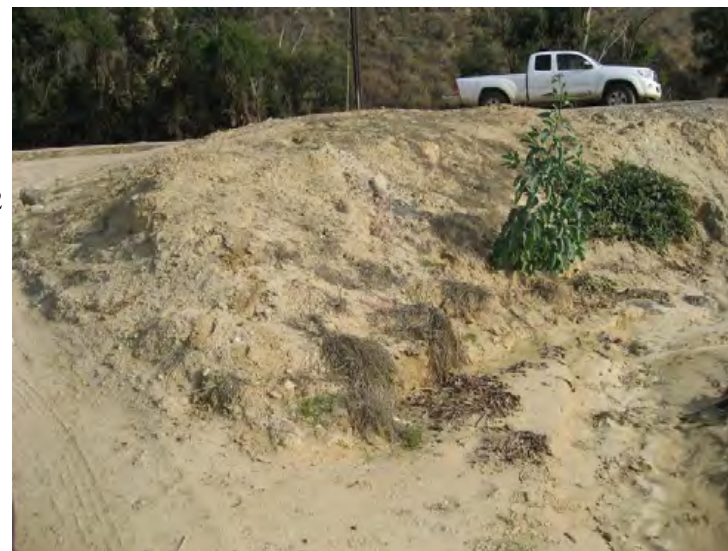
Santa Clara River Levee, From Hwy 101 to Saticoy. (Photo No. M3) –
Sediment spoils, upstream end of levee (riverward side)

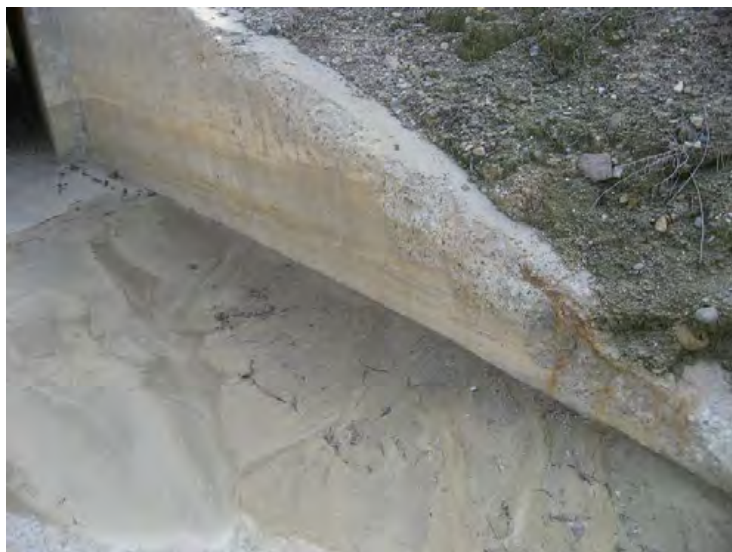
Santa Clara River Levee, From Hwy 101 to Saticoy. (Photo No. M2) –
Detail of damaged concrete headwall & exposed rebar (riverward side)

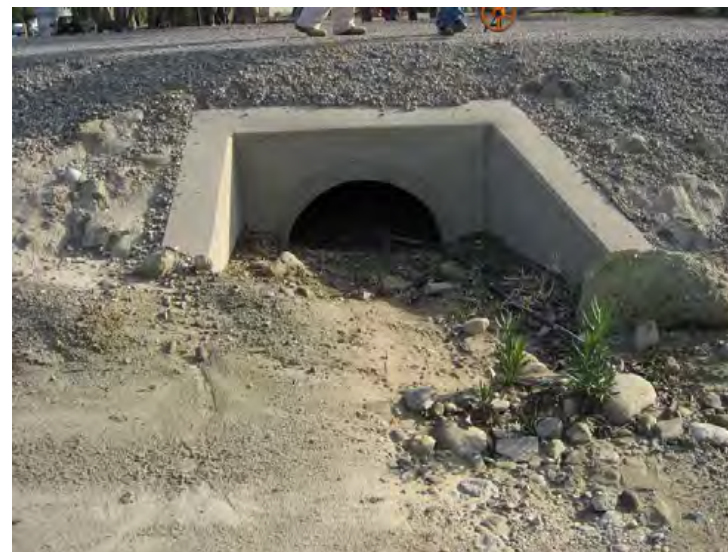
Santa Clara River Levee, From Hwy 101 to Saticoy. (Photo No. M4) –
Sediment deposition in Side Drain No. 1, 42" RCP outlet (riverward side)

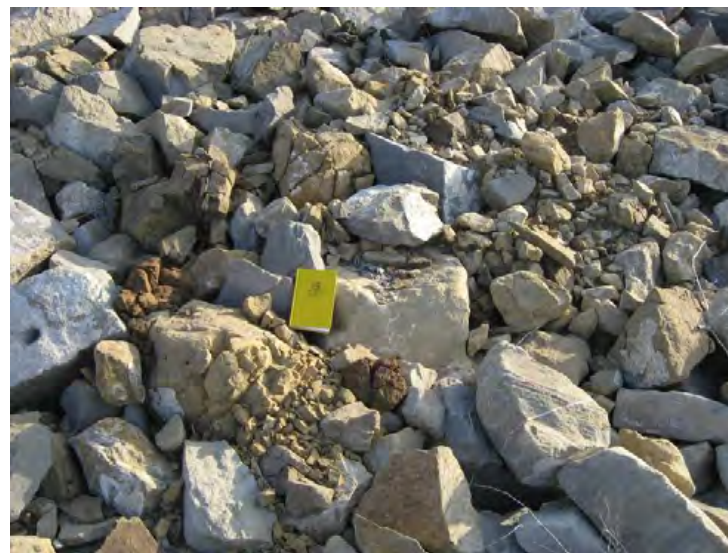
Santa Clara River Levee, From Hwy 101 to Saticoy. (Photo No. M8) – Broken stone revetment (riverward side)

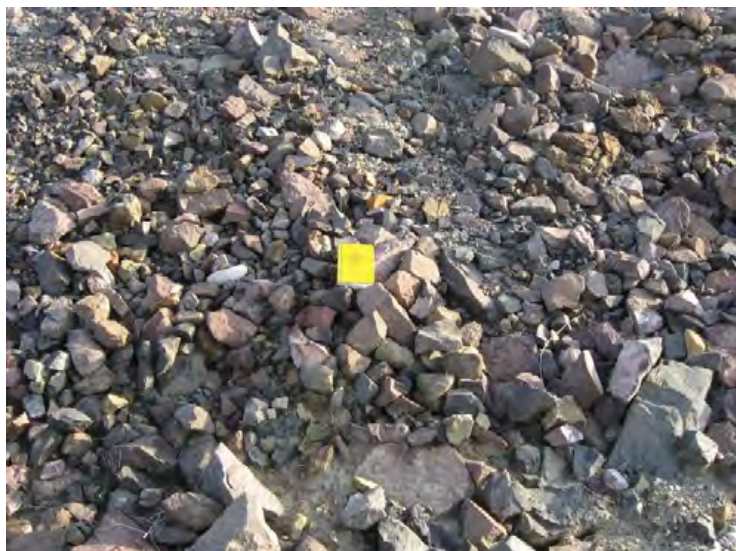
Santa Clara River Levee, From Hwy 101 to Saticoy. (Photo No. M9) –
Broken stone revetment (riverward side)

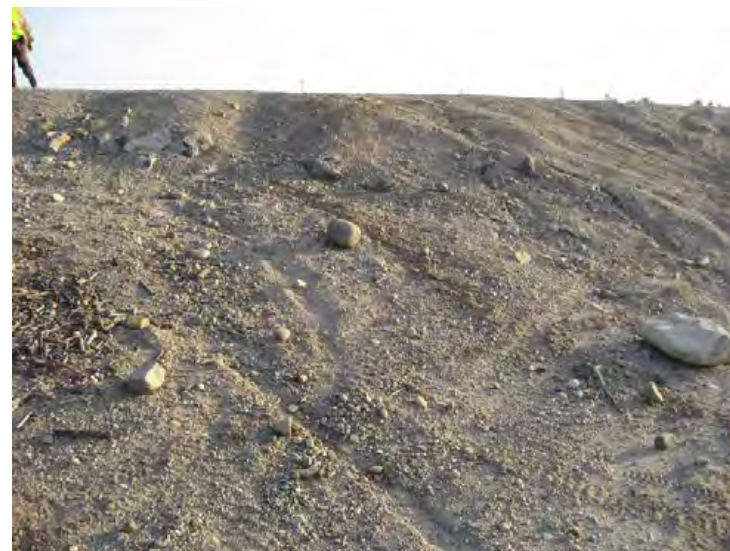
Santa Clara River Levee, From Hwy 101 to Saticoy. (Photo No. M11) –
Erosion of levee embankment (riverward side)

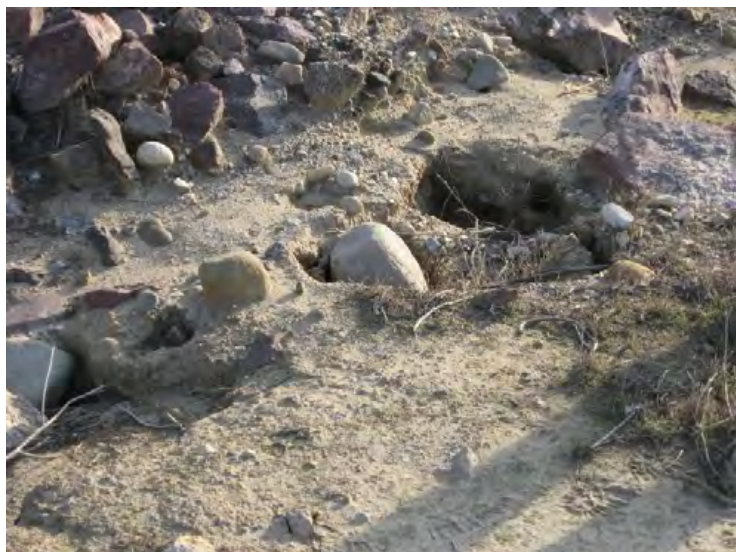
Santa Clara River Levee, From Hwy 101 to Saticoy. (Photo No. M10) –
Animal burrows at levee toe (riverward side)

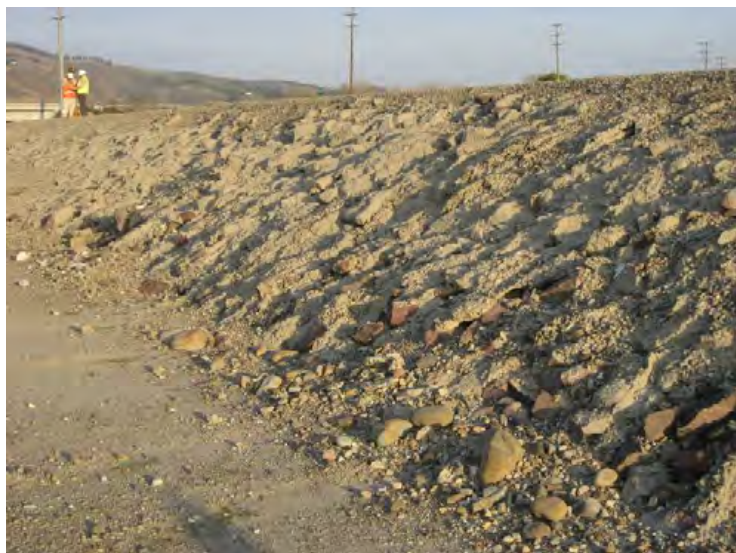
Santa Clara River Levee, From Hwy 101 to Saticoy. (Photo No. M13) –
Concrete spread over levee embankment, looking d/s (riverward side)

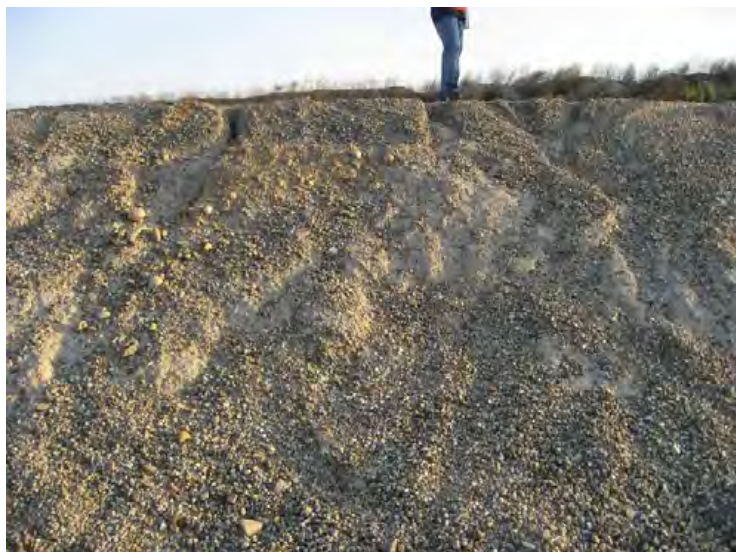
Santa Clara River Levee, From Hwy 101 to Saticoy. (Photo No. M14) –
Erosion on levee embankment, looking d/s (riverward side)

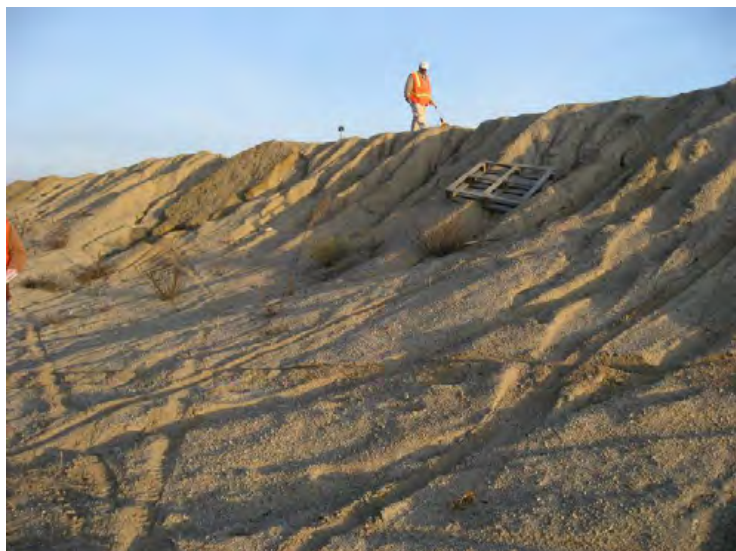
Santa Clara River Levee, From Hwy 101 to Saticoy. (Photo No. M17) – Erosion of levee embankment, adjacent to asphalt plant (riverward side)

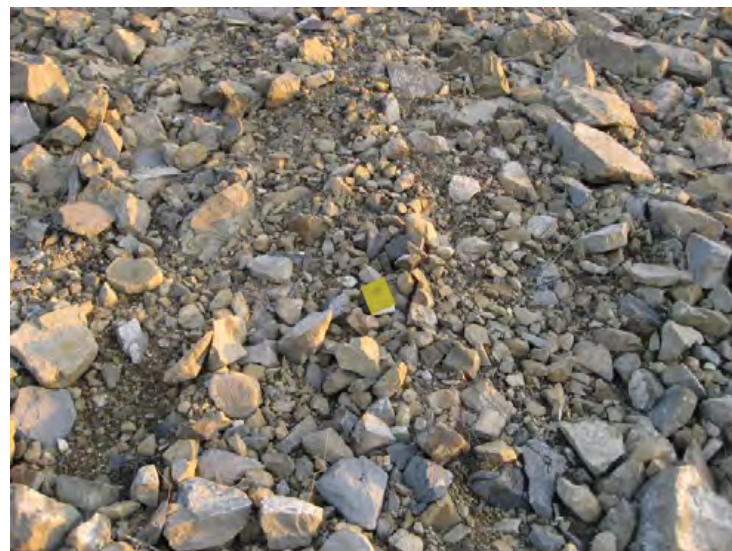
Santa Clara River Levee, From Hwy 101 to Saticoy. (Photo No. M19) – Broken stone revetment (riverward side)

N34.27188	W119.14478	M19	Broken stone revetment (riverward side)	Stone revetment may need to be repaired, additional engineering analysis is recommended
N34.27117	W119.14602	M20	Sediment deposition in Side Drain No. 3, 48” RCP outlet (riverward side)	Remove sediment and establish a clear passage from pipe to channel

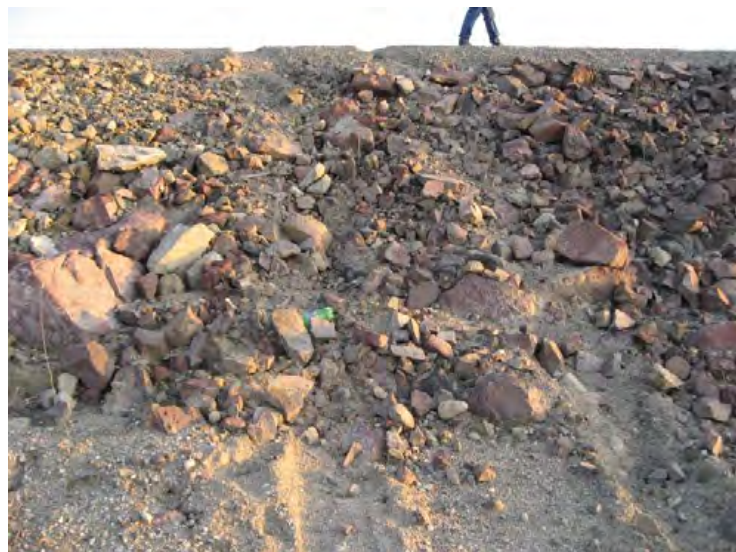
Santa Clara River Levee, From Hwy 101 to Saticoy. (Photo No. M18) – Levee embankment erosion caused by vehicles (riverward side)

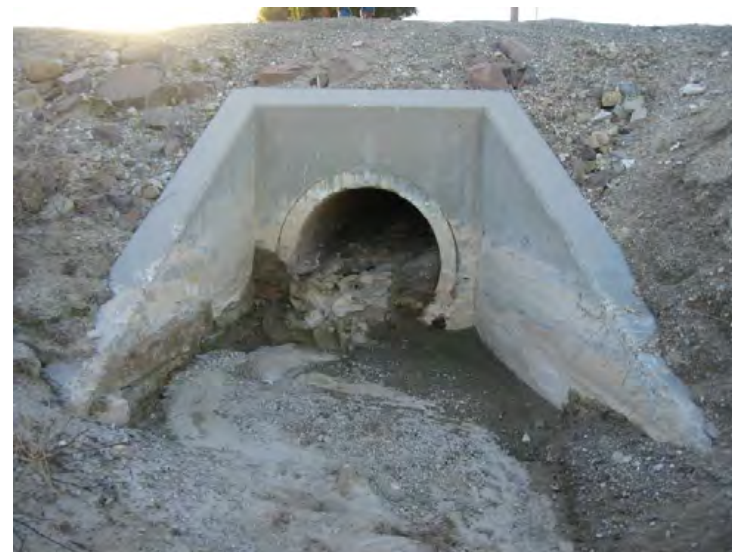
Santa Clara River Levee, From Hwy 101 to Saticoy. (Photo No. M20) – Sediment deposition in Side Drain No. 3, 48" RCP outlet (riverward side)

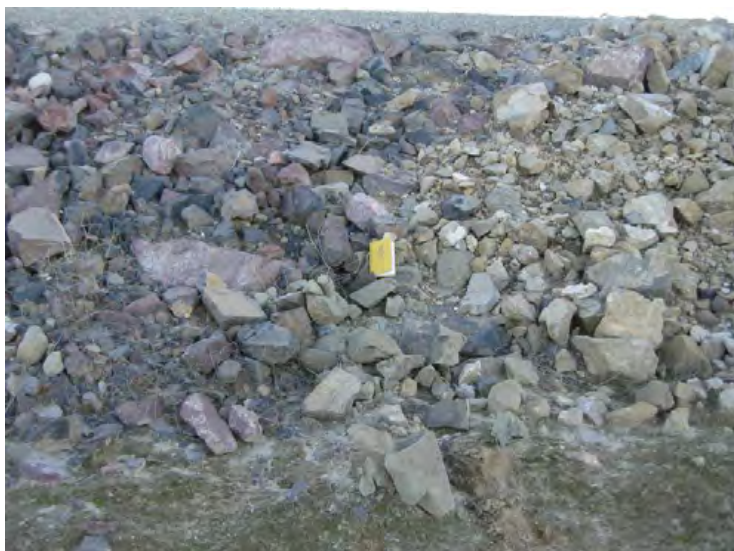
Santa Clara River Levee, From Hwy 101 to Saticoy. (Photo No. M21) –
Broken stone revetment (riverward side)

GPS		*Photo No.	Description	Action Required
Lat	Long			
<i>Santa Clara River Levee (SCR-1)</i>				
N34.27086	W119.14668	M21	Broken stone revetment (riverward side)	Additional engineering analysis is recommended
N34.26952	W119.14963	M22, M23	Erosion on top of levee caused by vehicular traffic (landward side)	Reestablish top of levee to meet design elevations
N34.26663	W119.15408	M24	Levee embankment erosion caused by vehicular traffic (riverward side)	Reestablish levee revetment with design specifications. Fill voids with impervious material and firmly compact
N34.26585	W119.15552	M25	Broken stone revetment (riverward side)	Additional engineering analysis is recommended
N34.26352	W119.15907	M26	Broken concrete pipe debris along levee toe (riverward side)	Remove unauthorized concrete pipe debris from levee embankment
N34.25950	W119.16435	M27	Unauthorized ramp on levee (riverward side)	Remove unauthorized earthen ramp

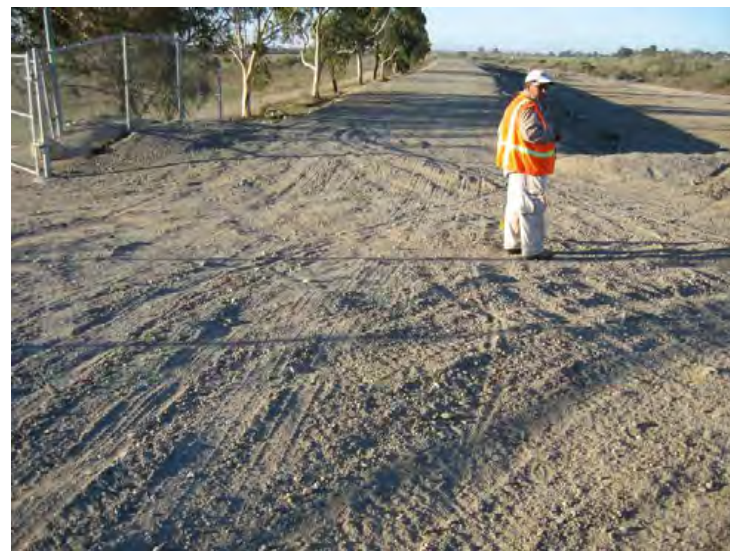
Santa Clara River Levee, From Hwy 101 to Saticoy. (Photo No. M23) –
Erosion on top of levee caused by vehicles, looking d/s (riverward side)

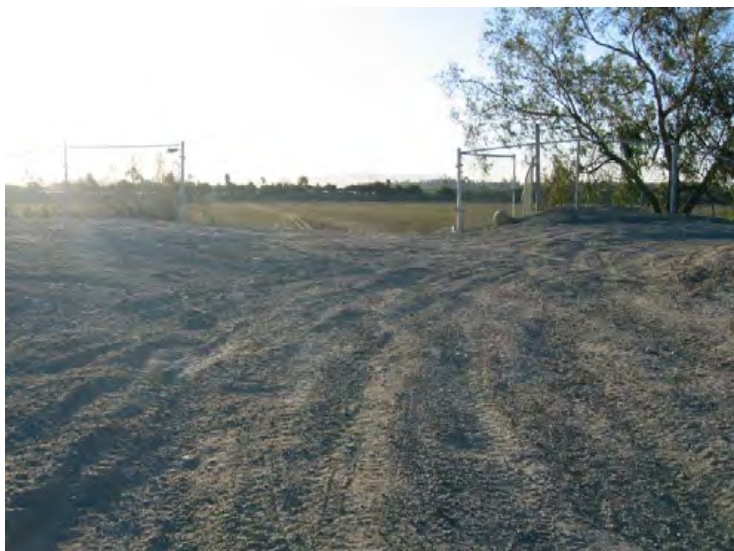
Santa Clara River Levee, From Hwy 101 to Saticoy. (Photo No. M22) –
Erosion on top of levee caused by vehicles (riverward side)

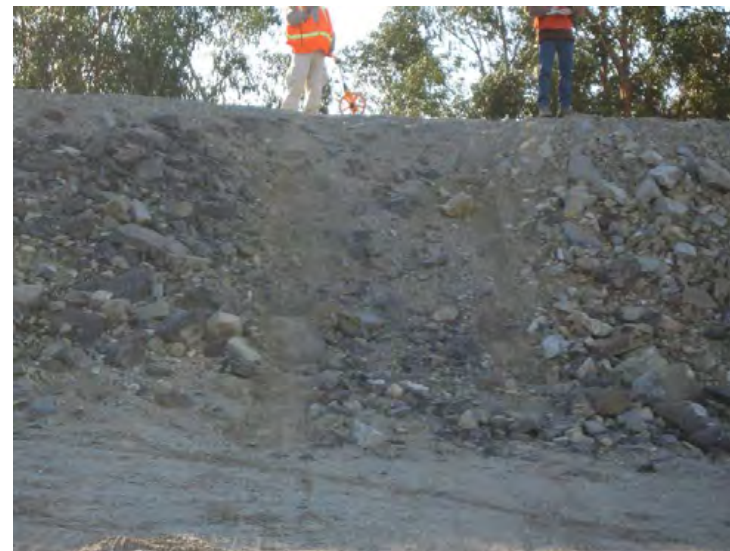
Santa Clara River Levee, From Hwy 101 to Saticoy. (Photo No. M24) –
Levee embankment erosion caused by vehicles (riverward side)

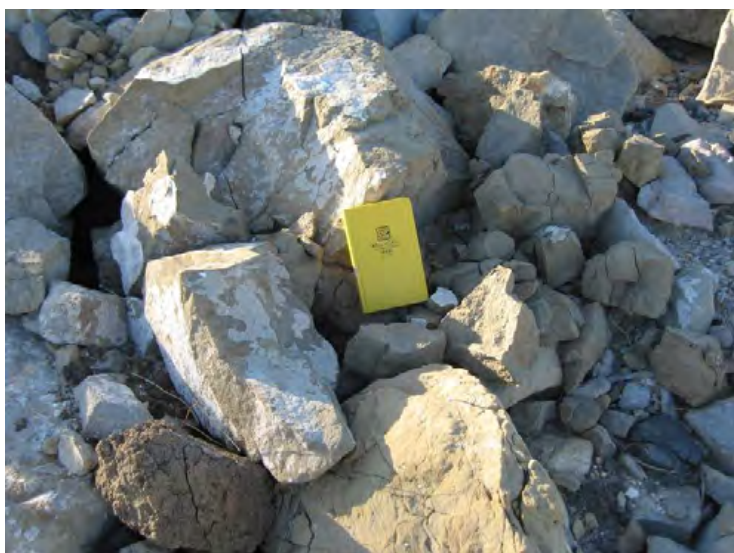
Santa Clara River Levee, From Hwy 101 to Saticoy. (Photo No. M25) –
Broken stone revetment (riverward side)

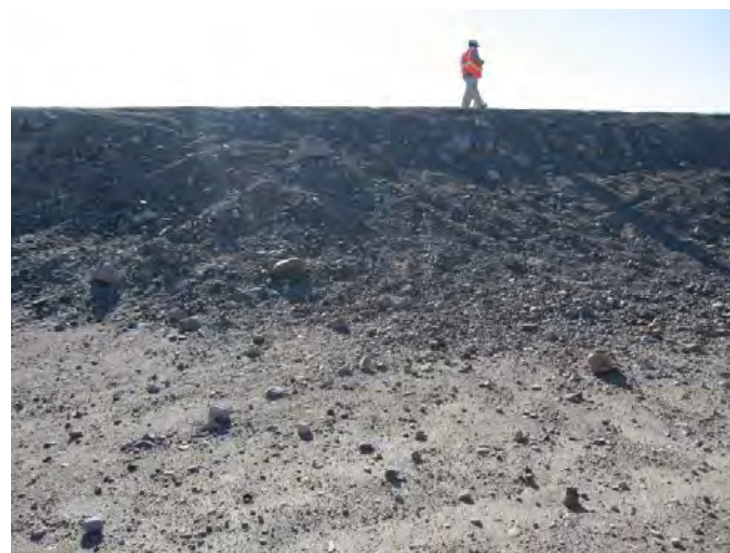
Santa Clara River Levee, From Hwy 101 to Saticoy. (Photo No. M27) –
Unauthorized ramp on levee (riverward side)

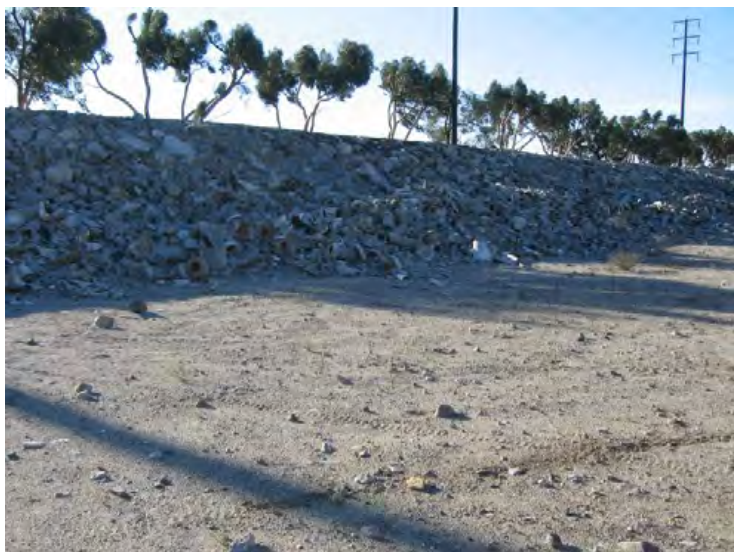
Santa Clara River Levee, From Hwy 101 to Saticoy. (Photo No. M26) –
Concrete pipe debris along levee toe, looking d/s (riverward side)

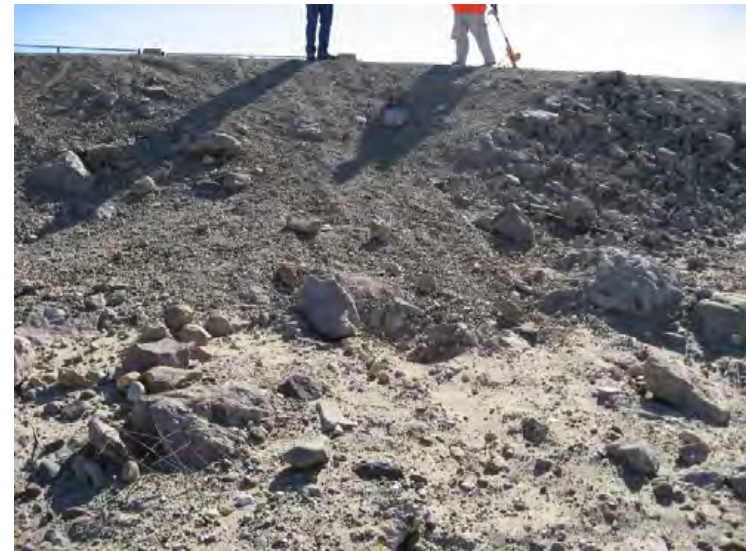
Santa Clara River Levee, From Hwy 101 to Saticoy. (Photo No. M31) –
Sloughing levee embankment protection (riverward side)

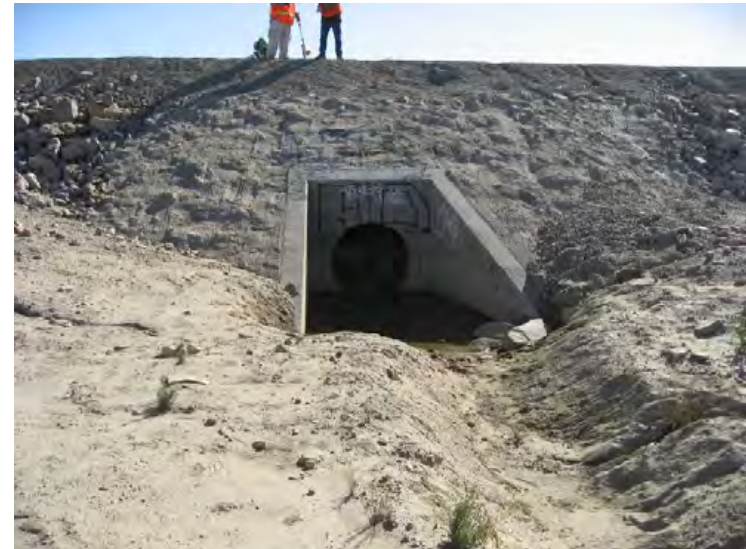
Santa Clara River Levee, From Hwy 101 to Saticoy. (Photo No. M32) –
Sediment deposition in Side Drain No. 4, 48" RCP outlet (riverward side)

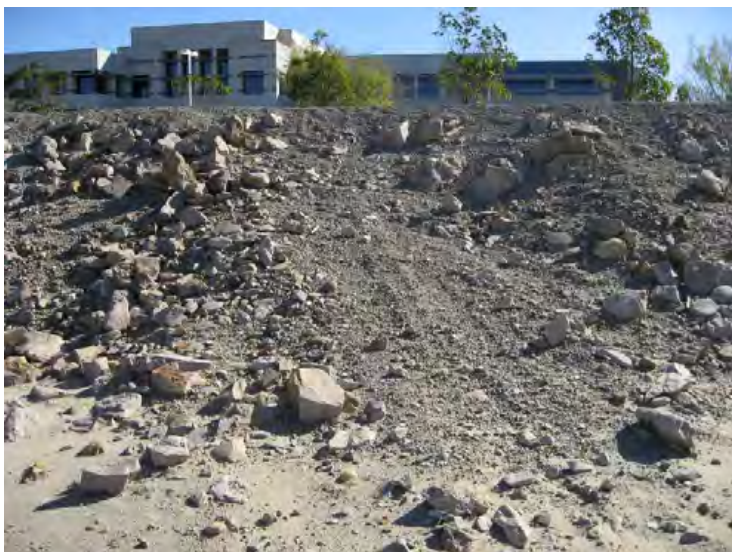
Santa Clara River Levee, From Hwy 101 to Saticoy. (Photo No. M38) – Unauthorized ramp with missing levee embankment protection (riverward)

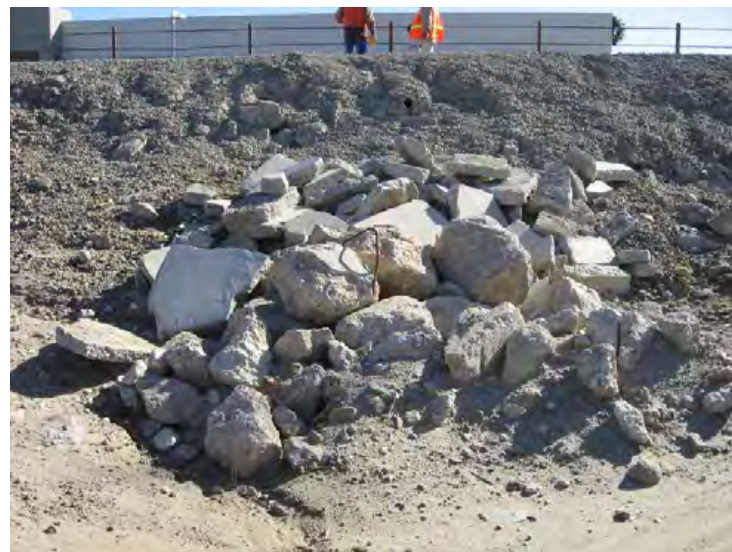
Santa Clara River Levee, From Hwy 101 to Saticoy. (Photo No. M40) – Dumped concrete debris at levee toe (riverward side)

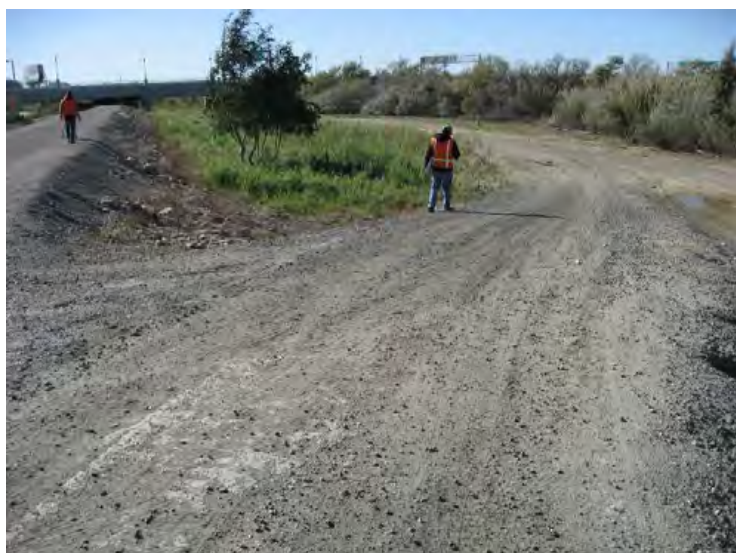
Santa Clara River Levee, From Hwy 101 to Saticoy. (Photo No. M41) –
Vegetation within 15' levee toe, looking d/s (riverward side)

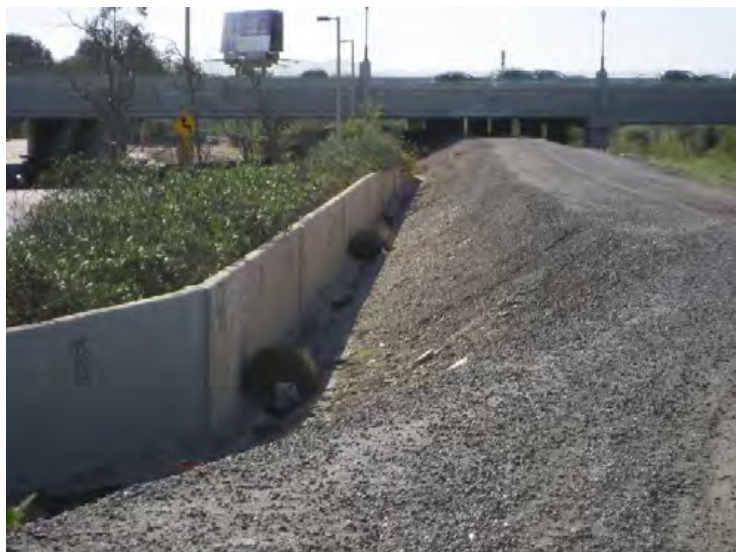
Santa Clara River Levee, From Hwy 101 to Saticoy. (Photo No. M42) –
Vegetation within 15-feet of levee toe looking d/s (landward side)

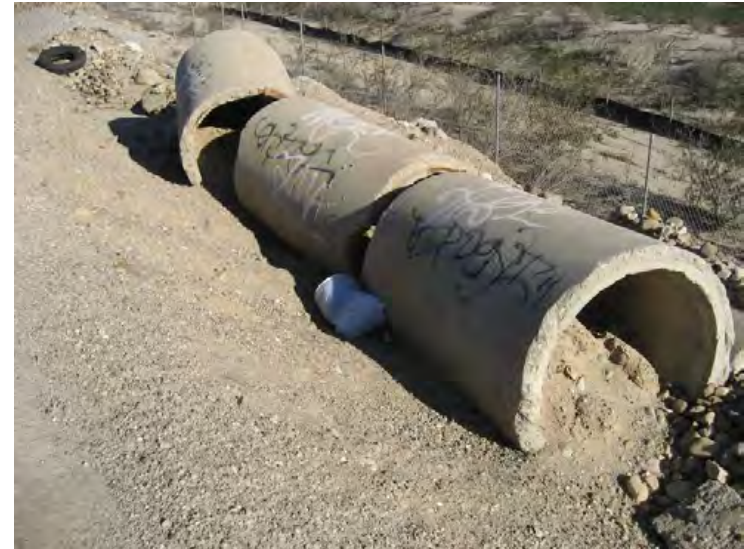
Santa Clara River Levee, From Hwy 101 to Saticoy, (Photo No. M47) –
Debris approx. 100' along levee, looking u/s (riverward side)

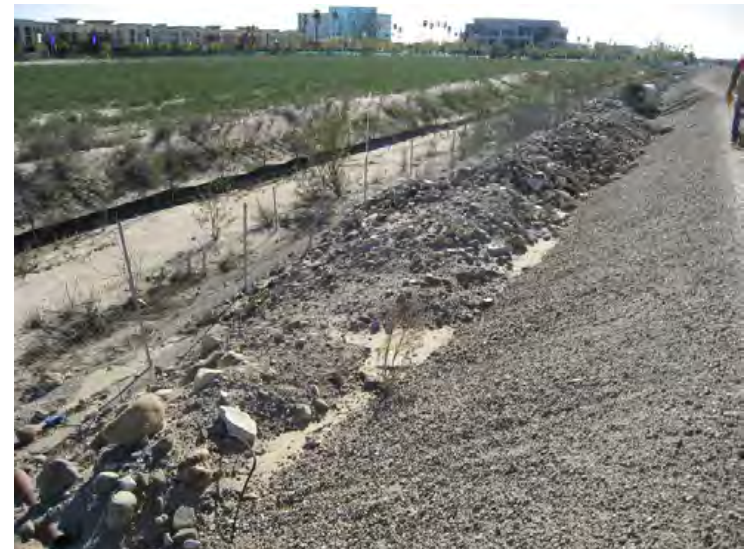
Santa Clara River Levee, From Hwy 101 to Saticoy, (Photo No. M48) –
Debris approx. 100' along levee, looking u/s (riverward side)

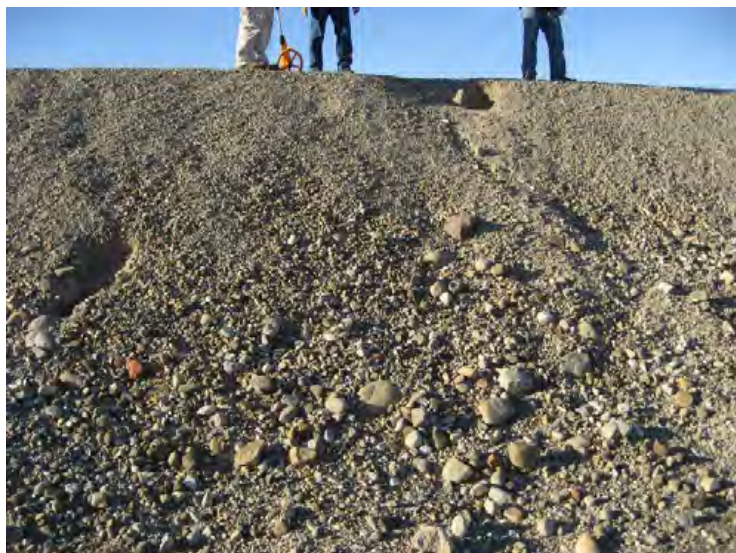
Santa Clara River Levee, From Hwy 101 to Saticoy, (Photo No. M53) –
Animal burrows at top of levee (landward side)

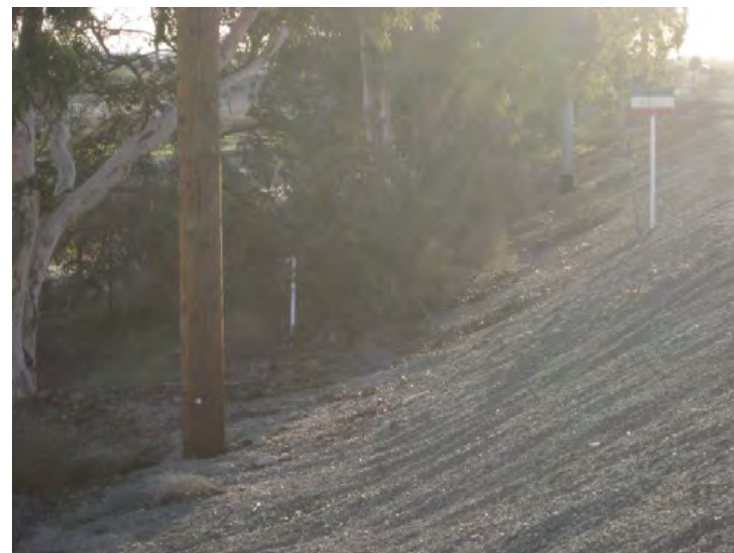
Santa Clara River Levee, From Hwy 101 to Saticoy, (Photo No. M55) –
Trees within 15' of levee toe, looking downstream (landward side)

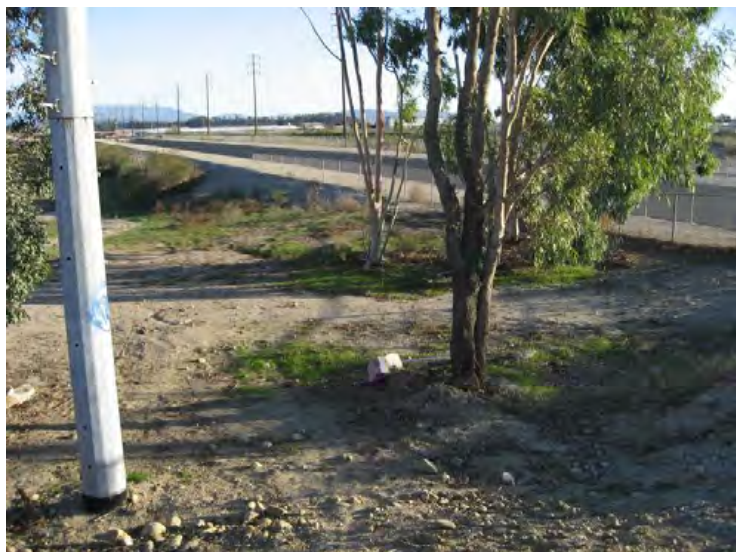
Santa Clara River Levee, From Hwy 101 to Saticoy, (Photo No. M54) –
Tree within 15' of levee toe, looking downstream (landward side)

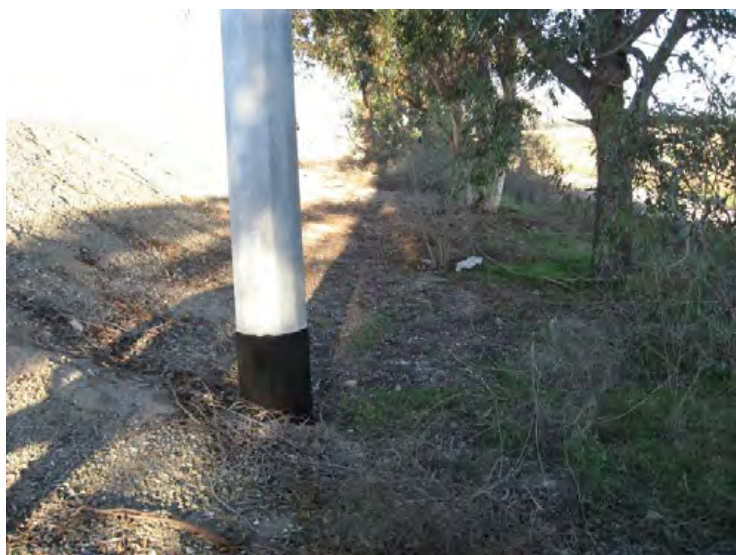
Santa Clara River Levee, From Hwy 101 to Saticoy, (Photo No. M57) –
Power poles within 15' of levee toe, looking upstream (landward side)

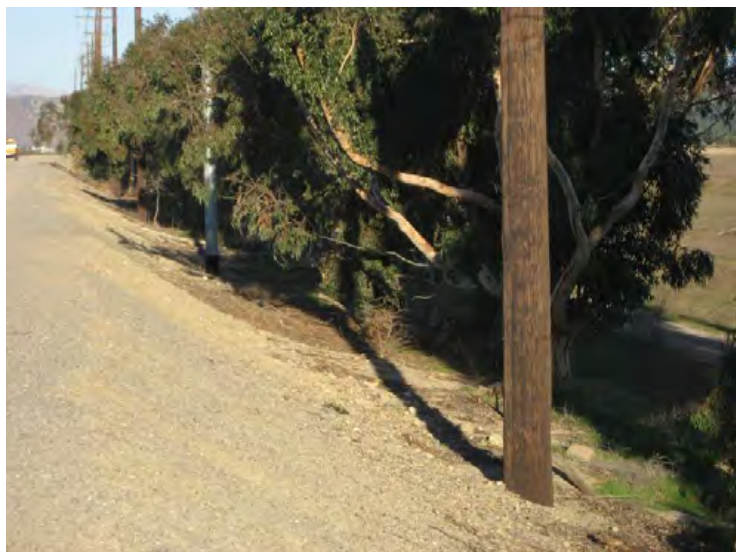
Santa Clara River Levee, From Hwy 101 to Saticoy, (Photo No. M58) –
Power poles within 15' of levee toe, looking upstream (landward side)

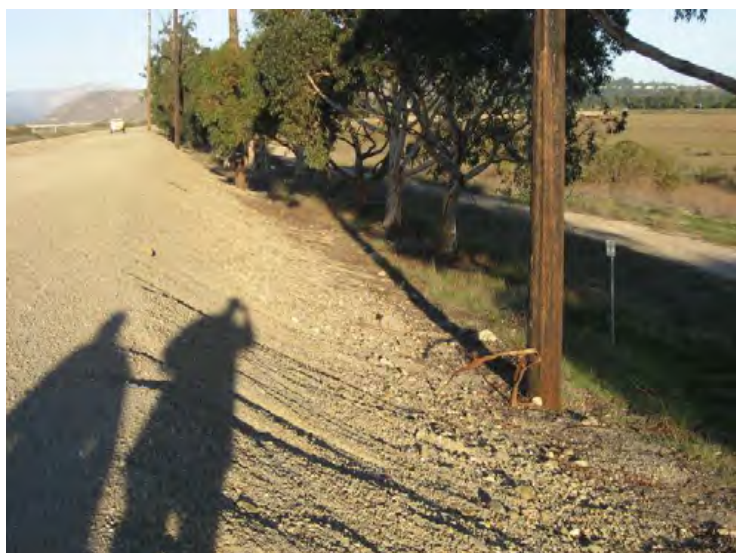
Santa Clara River Levee, From Hwy 101 to Saticoy, (Photo No. M61) –
Power poles on levee embankment, looking upstream (landward side)

N34.26498	W119.15623	M61, M63, M64	Fallen trees on levee embankment (landward side)	Remove vegetation and root ball, fill voids with impervious material and firmly compact.
N34.26918	W119.14969	M65	Trees and fallen trees within 15’ along levee toe (landward side)	Remove vegetation and root ball, fill voids with impervious material and firmly compact.
N34.26929	W119.14954	M66	Erosion on top of levee caused by vehicles (landward side)	Reestablish top of levee and fill voids with impervious material and firmly compact
N34.26933	W119.14939	M67	Vegetation within 15-feet of levee toe (landward side)	Remove vegetation and root ball, fill voids with impervious material and firmly compact.
N34.27027 to N34.27071	W119.14750 to W119.14673	M68	Vegetation within 15-feet of levee toe approximately 150-feet along levee (landward side)	Remove vegetation and root ball, fill voids with impervious material and firmly compact.

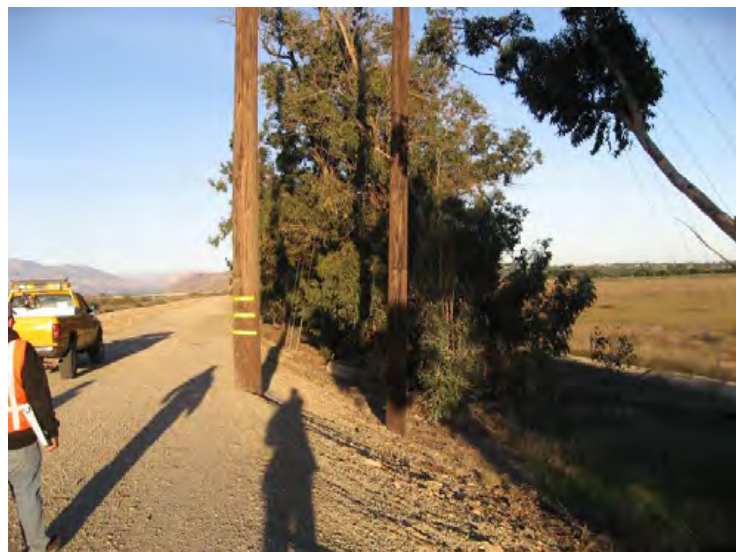
Santa Clara River Levee, From Hwy 101 to Saticoy, (Photo No. M62) –
Power poles on levee embankment, looking upstream (landward side)

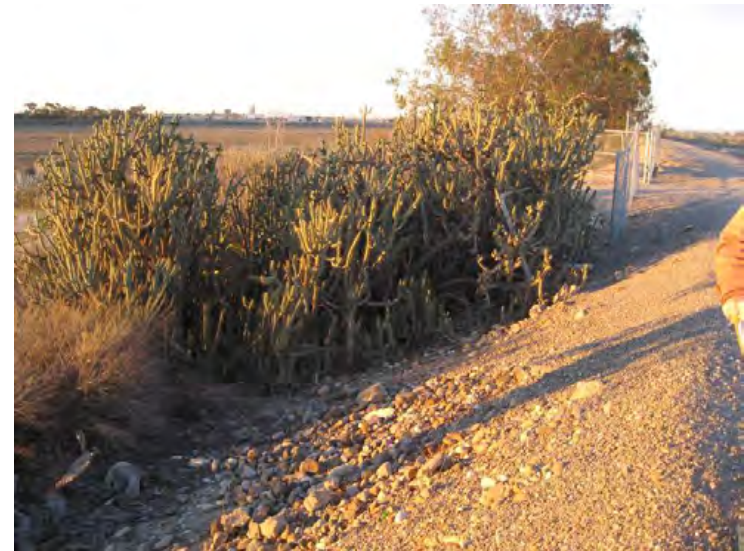
Santa Clara River Levee, From Hwy 101 to Saticoy, (Photo No. M67) –
Vegetation within 15-feet of levee toe, looking downstream (landward side)

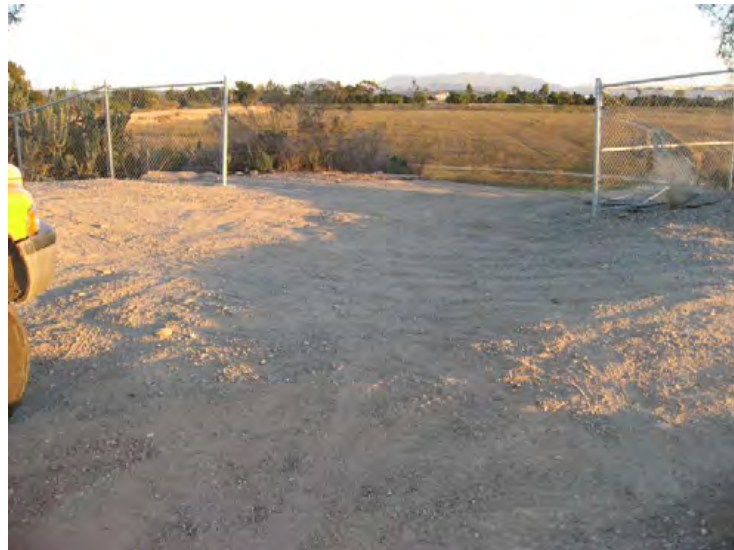
Santa Clara River Levee, From Hwy 101 to Saticoy, (Photo No. M66) –
Erosion on top of levee caused by vehicles, looking S/E (landward side)

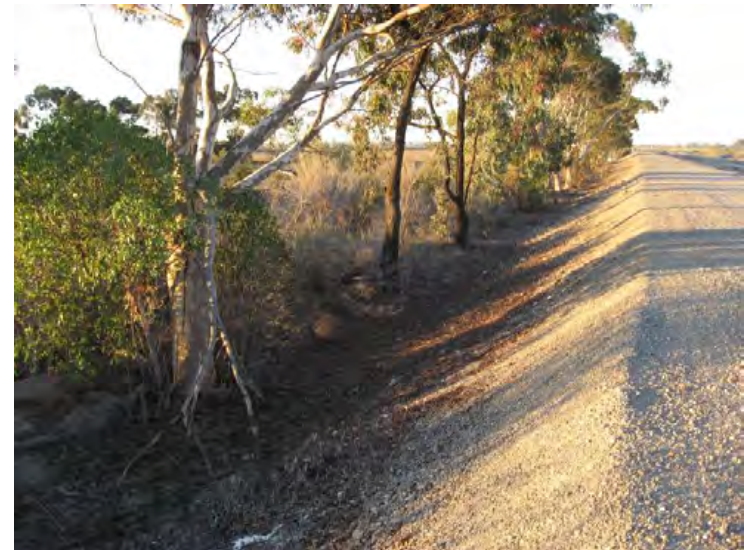
Santa Clara River Levee, From Hwy 101 to Saticoy, (Photo No. M68) –
Vegetation within 15-feet of levee toe, looking d/s (landward side)

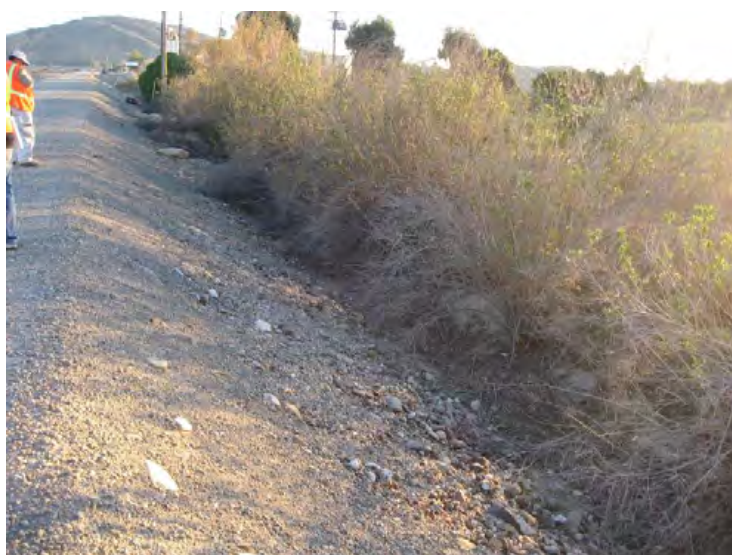
Santa Clara River Levee, From Hwy 101 to Saticoy, (Photo No. M69) –
Vegetation within 15-feet of levee toe, looking u/s (landward side)

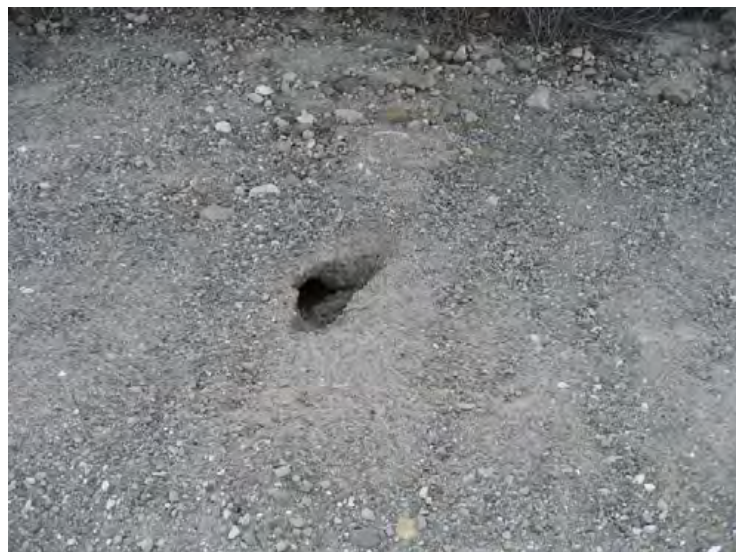
Santa Clara River Levee, From Hwy 101 to Saticoy, (Photo No. M70) –
Animal burrow on top of levee (landward side)

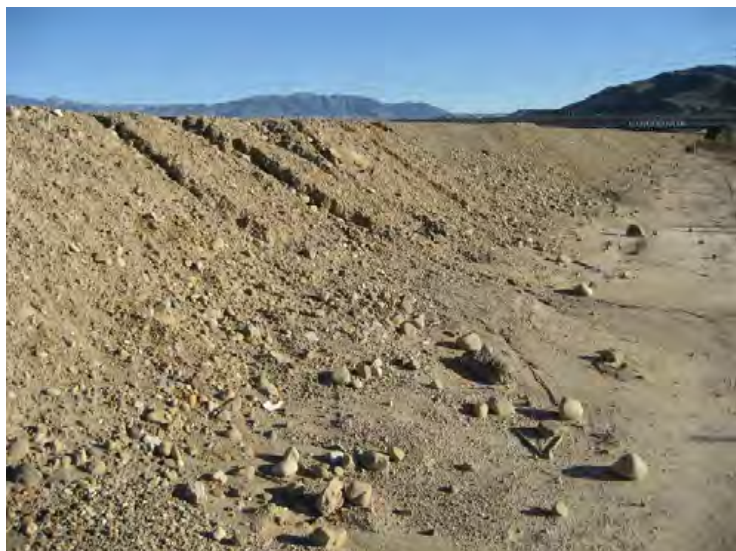
Santa Clara River Levee, From Hwy 101 to Saticoy, (Photo No. M73) –
Erosion on levee embankment, looking upstream (landward side)

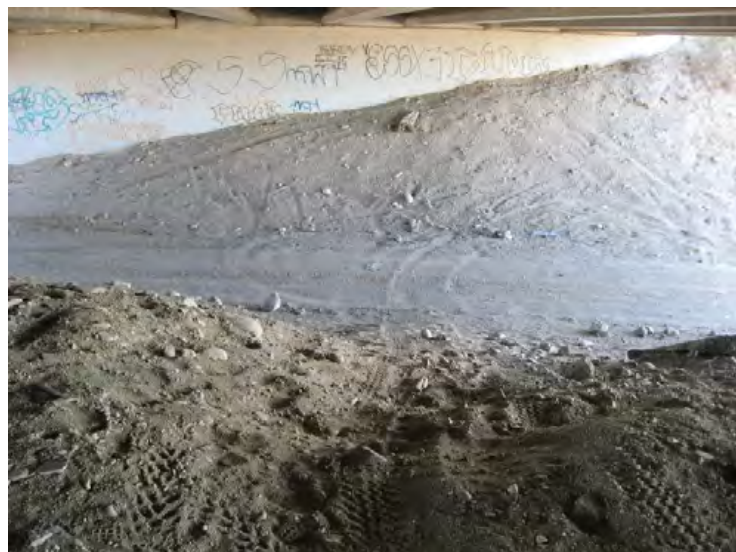
Santa Clara River Levee, From Hwy 101 to Saticoy, (Photo No. M74) –
Erosion caused by vehicles under L.A. Ave. Bridge (landward side)

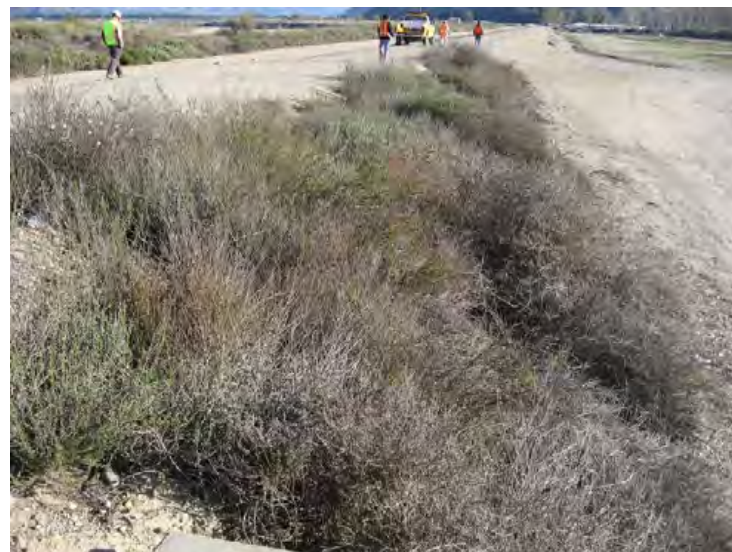
Santa Clara River Levee, From Hwy 101 to Saticoy, (Photo No. M76) –
Vegetation within 15-feet of levee toe, looking downstream (landward side)

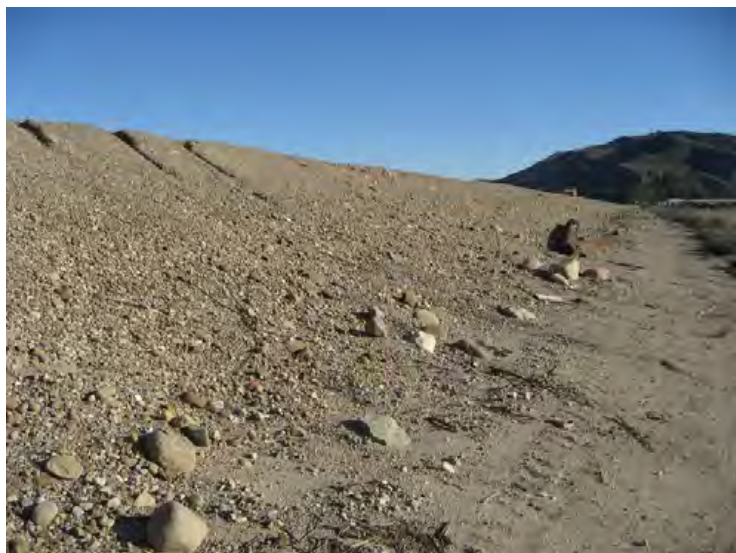
Santa Clara River Levee, From Hwy 101 to Saticoy, (Photo No. M77) –
Erosion at top of levee with debris at toe, looking d/s (landward side)

N34.27638	W119.13571	M77	Erosion at top of levee with miscellaneous debris at toe (landward side)	Repair erosion and remove miscellaneous debris
N34.27671	W119.13503	M78	Animal burrows at top of levee (landward side)	Remove animal burrows, fill voids with impervious material and firmly compact
N34.27997 to N34.28052	W119.12884 to W119.12786	M79	Trees within 15-feet of levee toe, approximately 200-feet along levee (landward side)	Remove vegetation and root ball, fill voids with impervious material and firmly compact.
N34.28123	W119.12643	M80	Sediment deposition and debris in Side Drain No. 1, 42” RCP inlet invert (landward side)	Remove sediment and debris and establish a clear passage from pipe to channel (riverward & landward sides)
N34.28123 to N34.28155	W119.12643 to W119.12585	M81	Vegetation within 15-feet of toe, approximately 1,200-feet along levee toe (landward side)	Remove vegetation and root ball, fill voids with impervious material and firmly compact.
