**FEMA Levee Certification
Ventura County, California**

**Santa Clara River Levee (SCR-1)
Highway 101 to Saticoy**

**Evaluation Report
February 13, 2009**

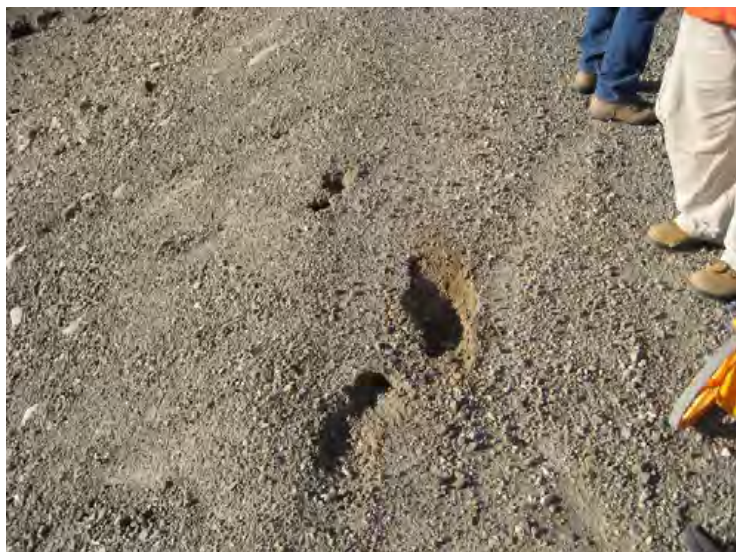
Santa Clara River Levee, From Hwy 101 to Saticoy, (Photo No. M78) –
Animal burrows at top of levee (landward side)

N34.27638	W119.13571	M77	Erosion at top of levee with miscellaneous debris at toe (landward side)	Repair erosion and remove miscellaneous debris
N34.27671	W119.13503	M78	Animal burrows at top of levee (landward side)	Remove animal burrows, fill voids with impervious material and firmly compact
N34.27997 to N34.28052	W119.12884 to W119.12786	M79	Trees within 15-feet of levee toe, approximately 200-feet along levee (landward side)	Remove vegetation and root ball, fill voids with impervious material and firmly compact.
N34.28123	W119.12643	M80	Sediment deposition and debris in Side Drain No. 1, 42” RCP inlet invert (landward side)	Remove sediment and debris and establish a clear passage from pipe to channel (riverward & landward sides)
N34.28123 to N34.28155	W119.12643 to W119.12585	M81	Vegetation within 15-feet of toe, approximately 1,200-feet along levee toe (landward side)	Remove vegetation and root ball, fill voids with impervious material and firmly compact.

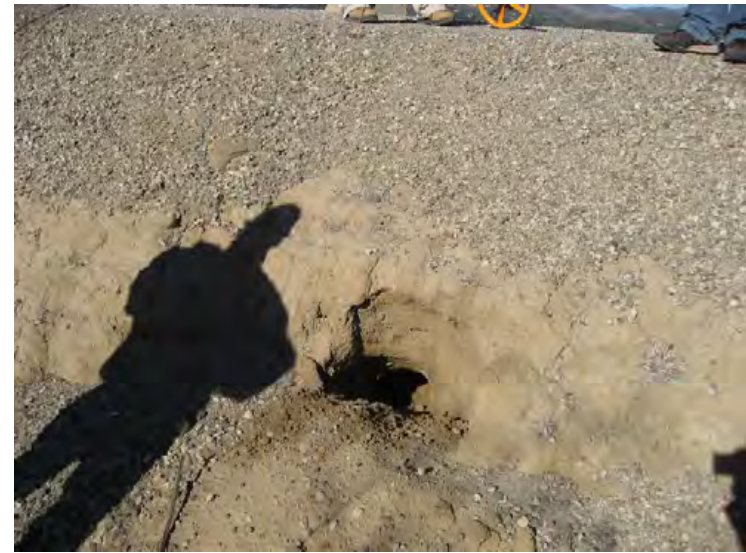
Santa Clara River Levee, From Hwy 101 to Saticoy, (Photo No. M83) –
Animal burrows at levee toe (landward side)
