# DOCUMENTATION OF DESIGN DEFICIENCIES SANTA CLARA RIVER LEVEE SYSTEM (SCR-1)

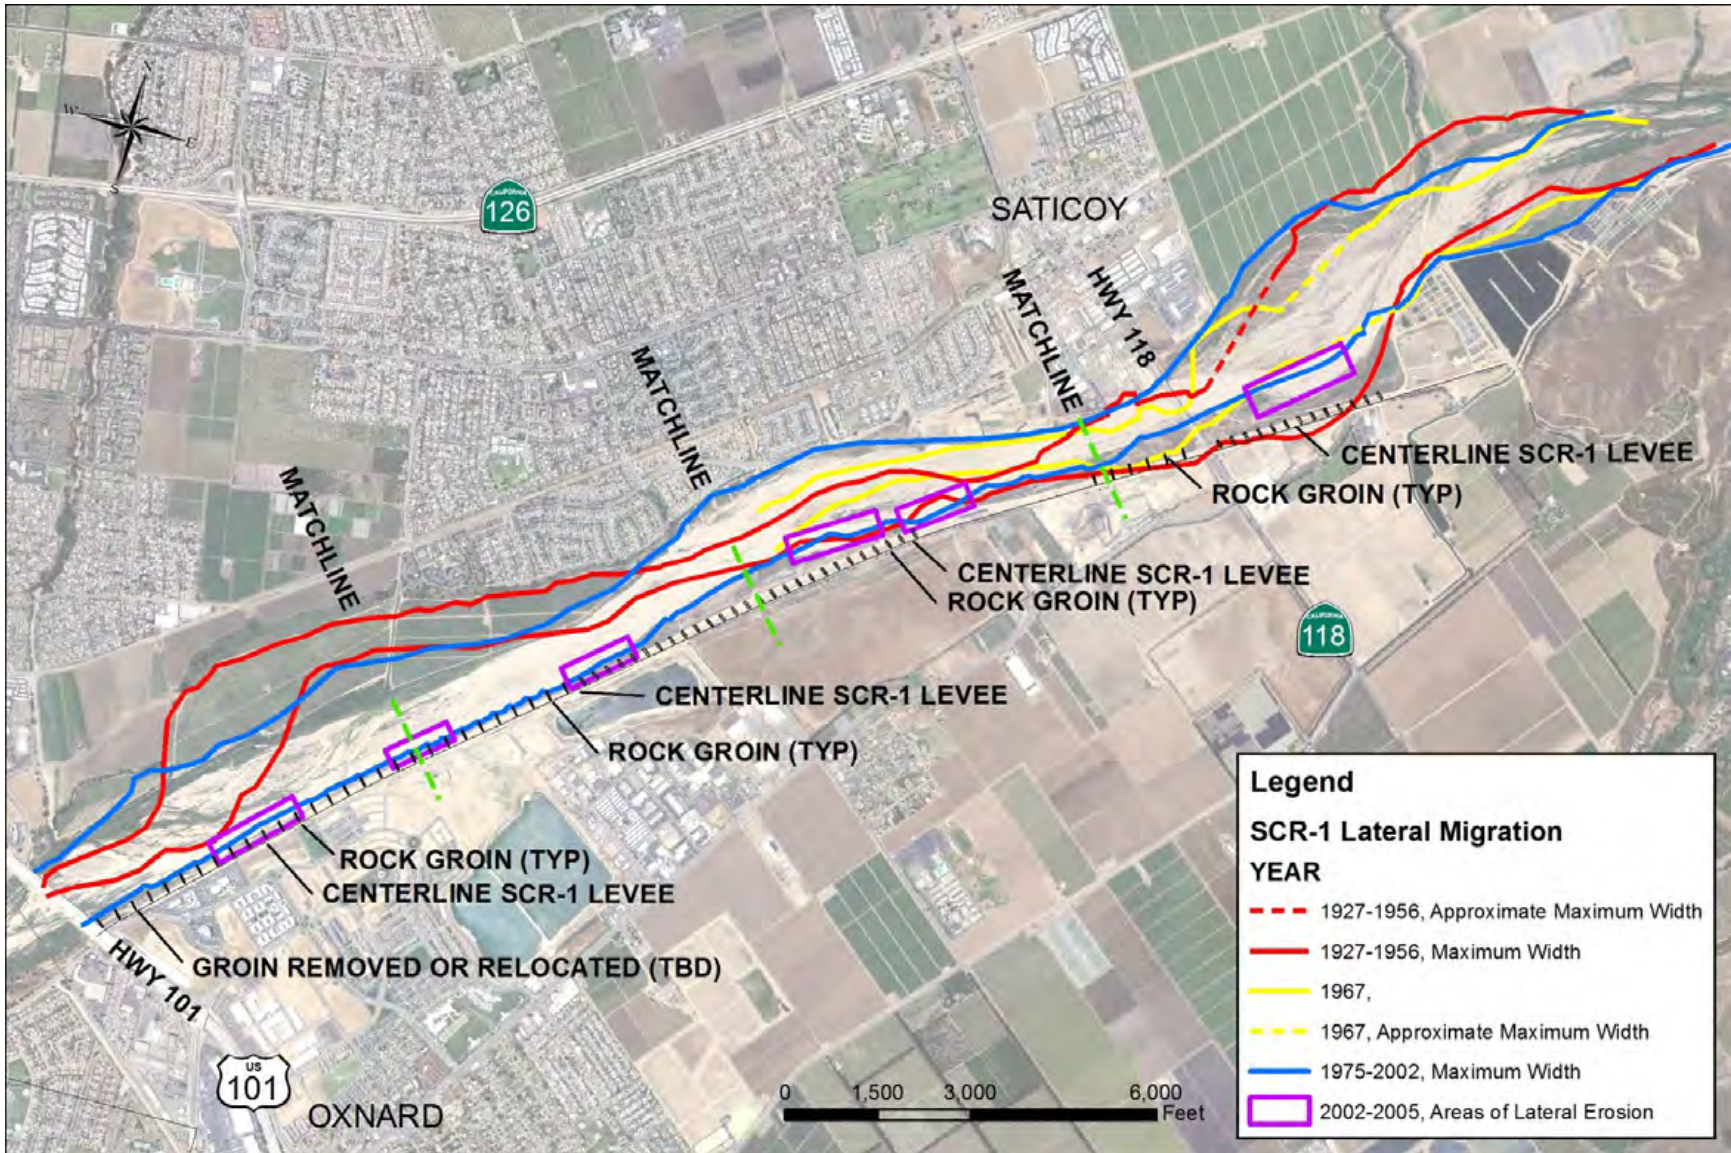
Construction of the SCR-1 project was completed in 1961. The levee was constructed adjacent to the active channel of the Santa Clara River. A review of historical aerial photography, dating as far back as 1927, indicates that before construction of the SCR-1, there were numerous locations along the project reach where the primary braid of the Santa Clara River impinged directly on the east and west banks of the river at rather abrupt flow angles. Aerial photographs of the SCR-1 project reach taken between 2002 and 2005 show no less than four separate locations along SCR-1 where the primary braid impinged directly on the east bank of the river at abrupt flow angles, resulting in lateral bank erosion (see Figure 2).

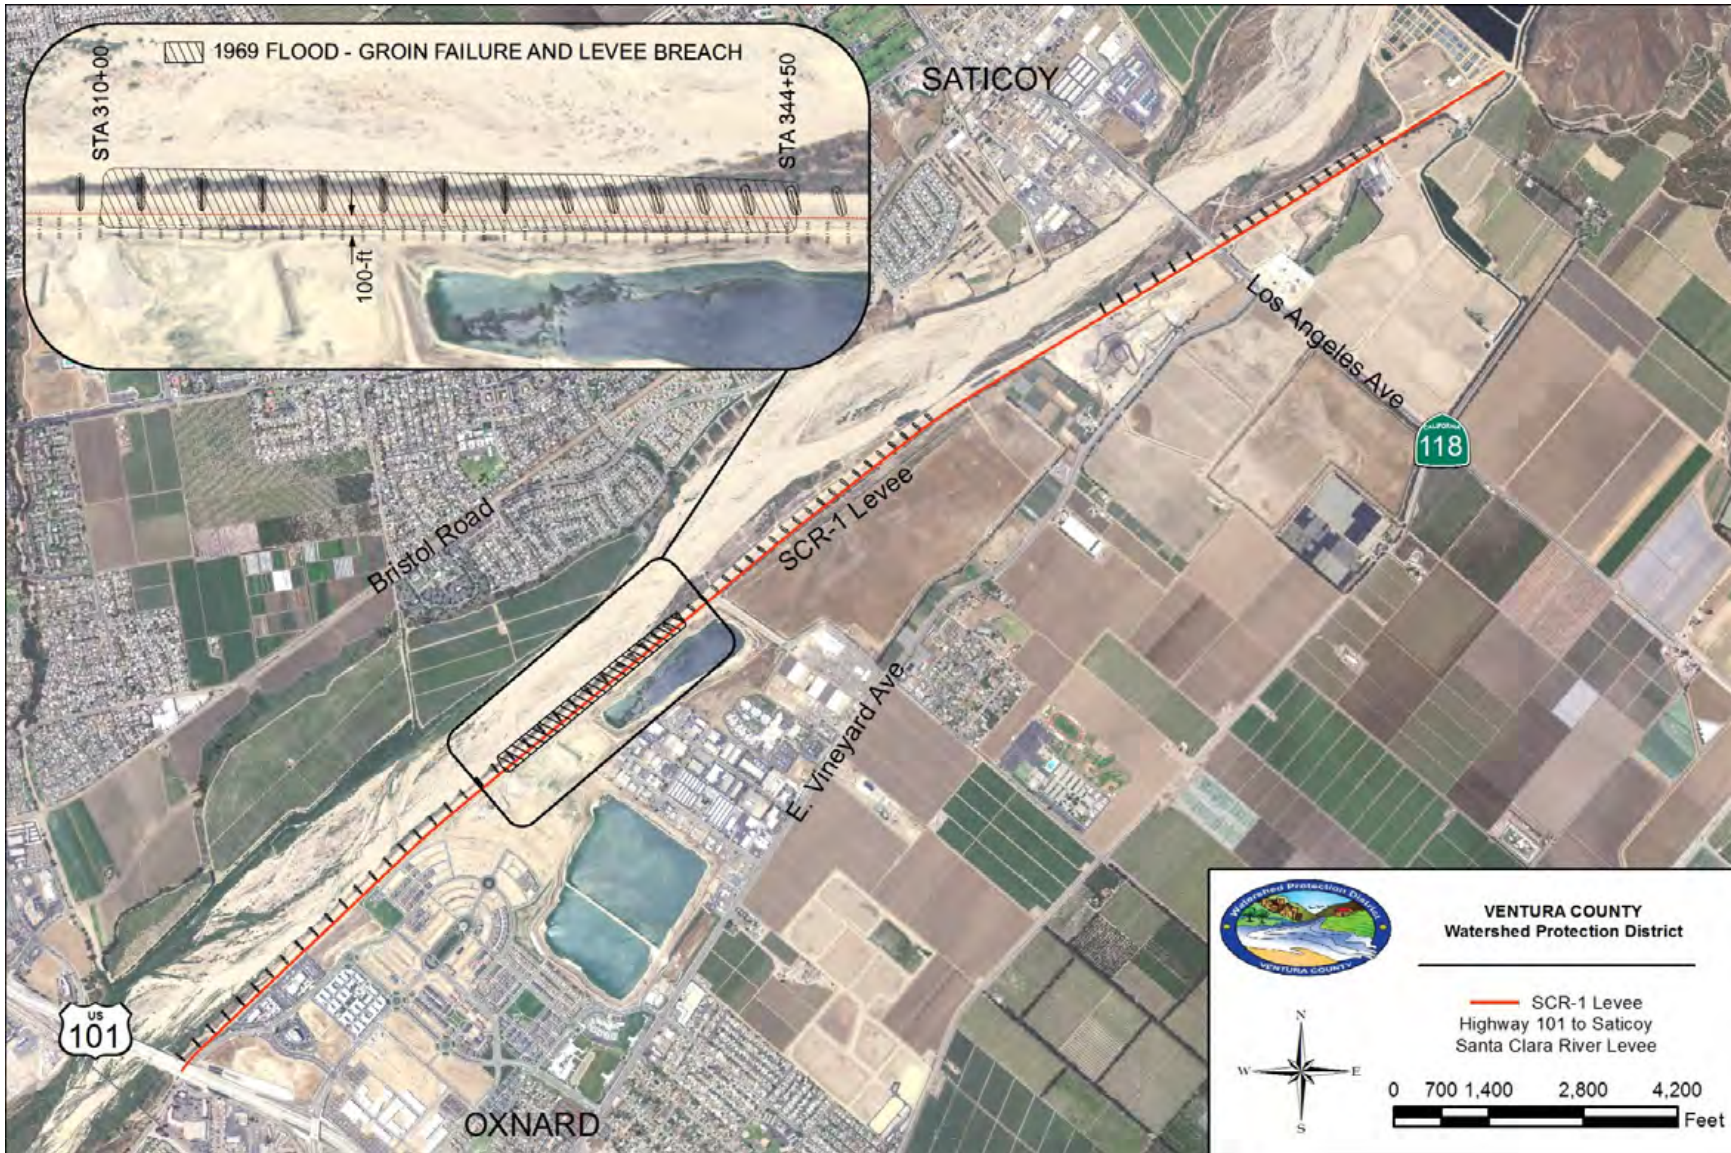
*The only significant damage that occurred in this reach during the January flood was damage to the revetment of an existing levee constructed by the Corps of Engineers. February floodflows washed out about 500 feet of State Route 118 bridge, damaged agricultural property and utilities, and severely damaged flood-control improvements constructed by the Corps of Engineers. ...The flood eroded the south bank near the existing Corps levee, damaging some groins; then deflected, ricocheted from the State Route 118 bridge, and returned to the south bank – where the floodflows cut in close to the Corps levee, bounced off to the north bank, and carved a long arch. The floodflows then deflected to the south bank where they undercut the toe protection on the Corps levee, causing the failure of about 2,000 feet of levee and eroding the ground behind the levee for a distance of about 100 feet.*

The location of the 1969 levee failure is shown on Figure 3. From 2002 through 2005, SCR-1 continued to experience episodes of streambank erosion/lateral migration that threatened the integrity of the levee system.

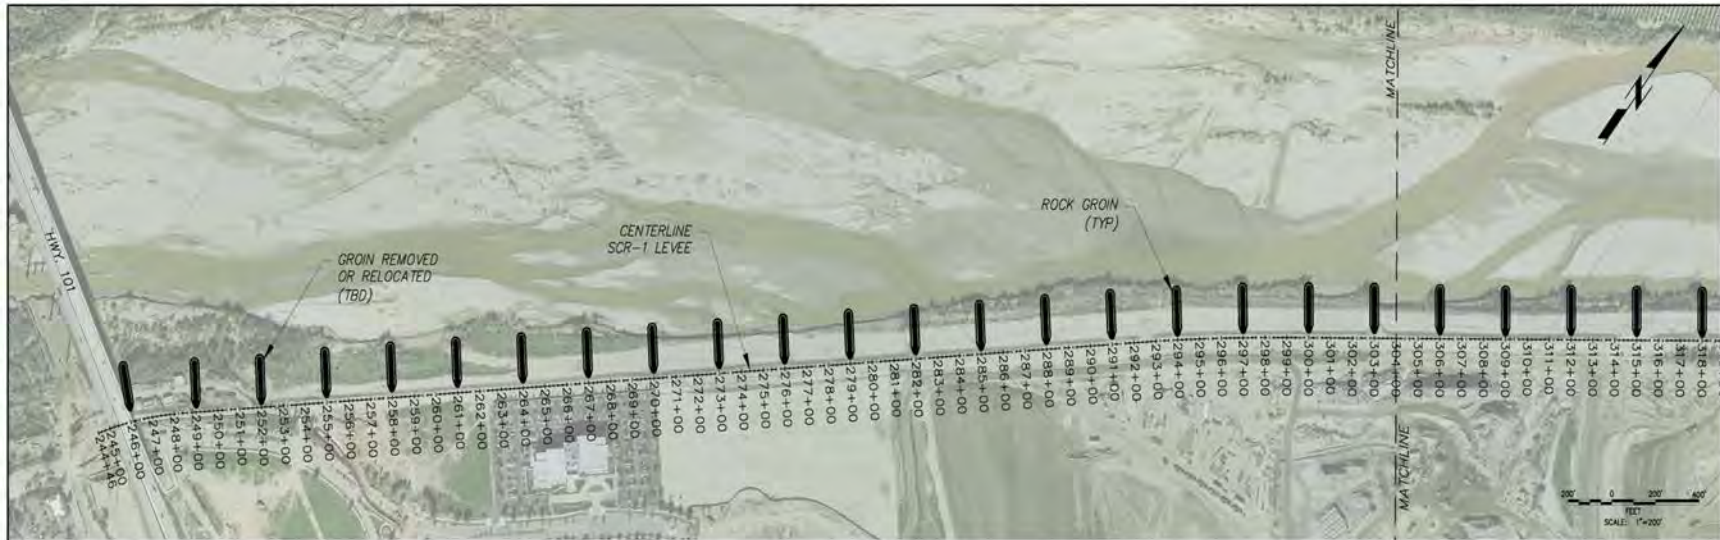
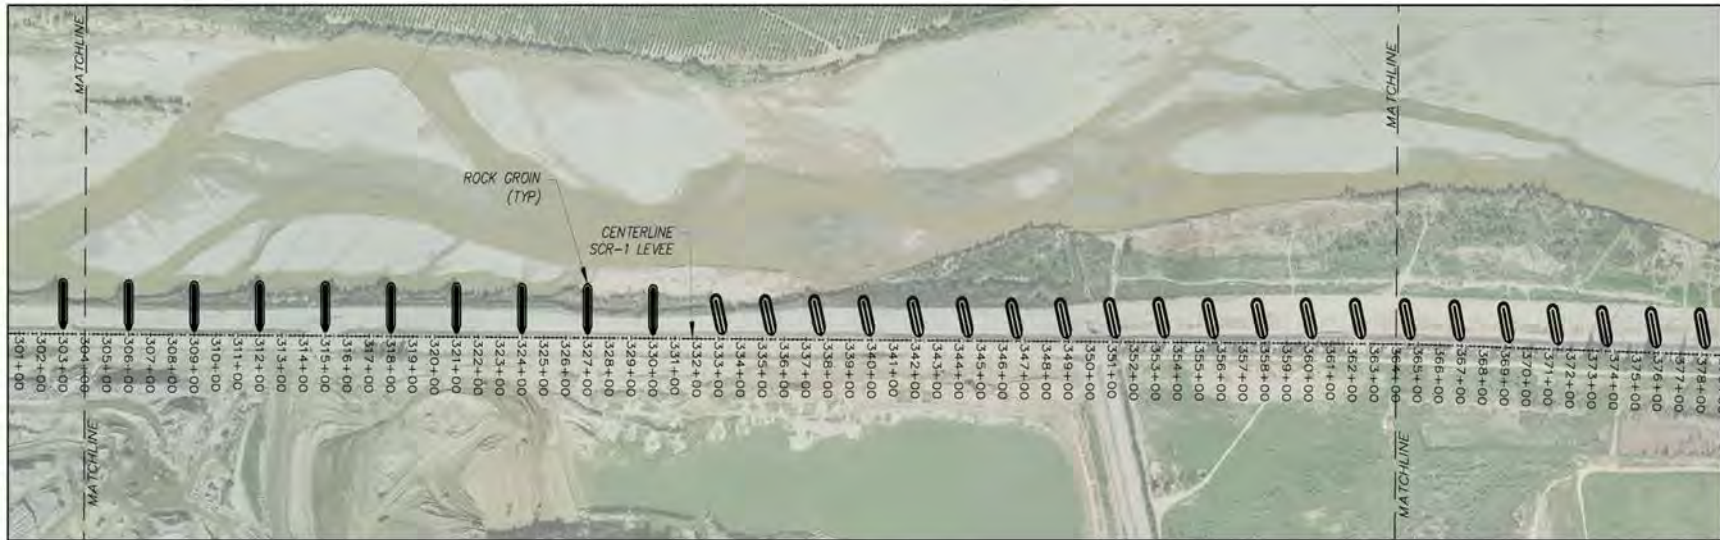
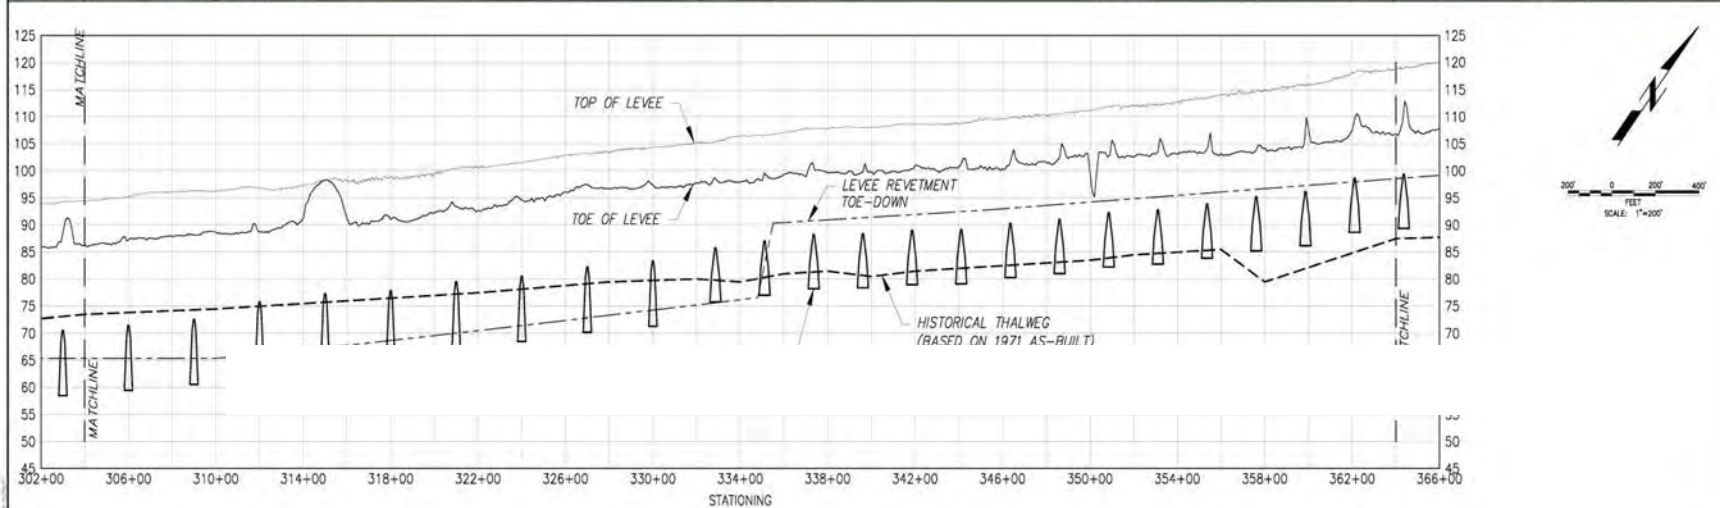
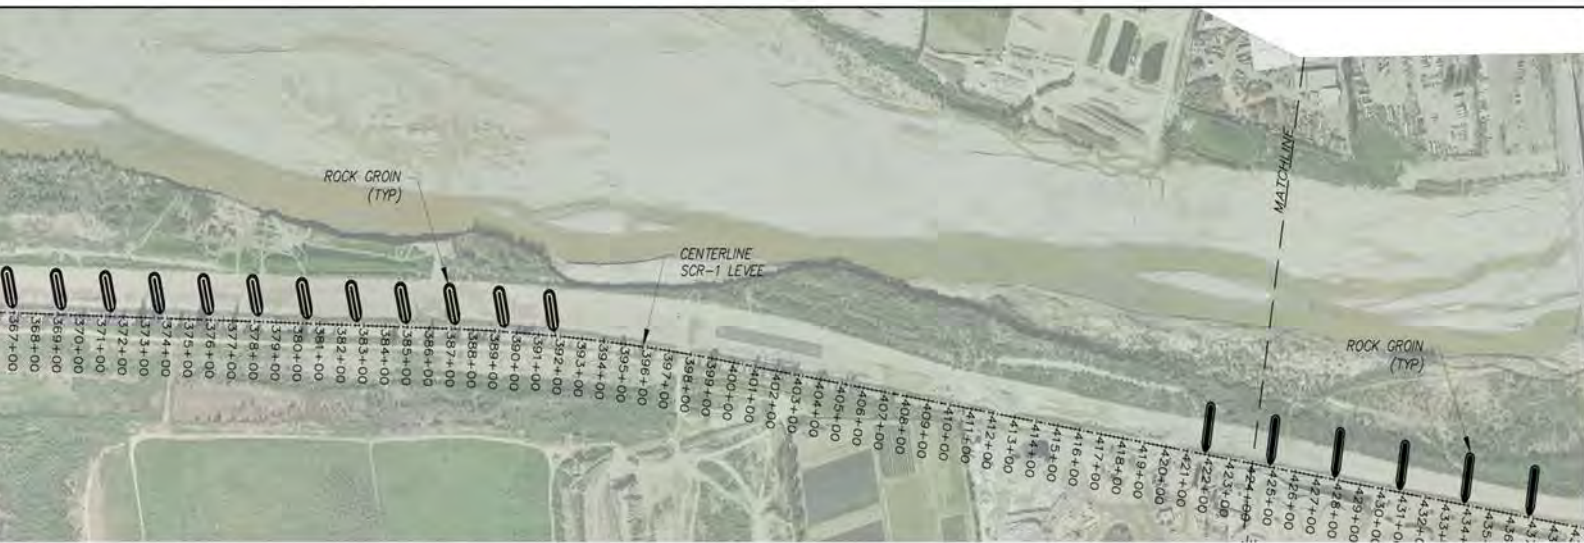
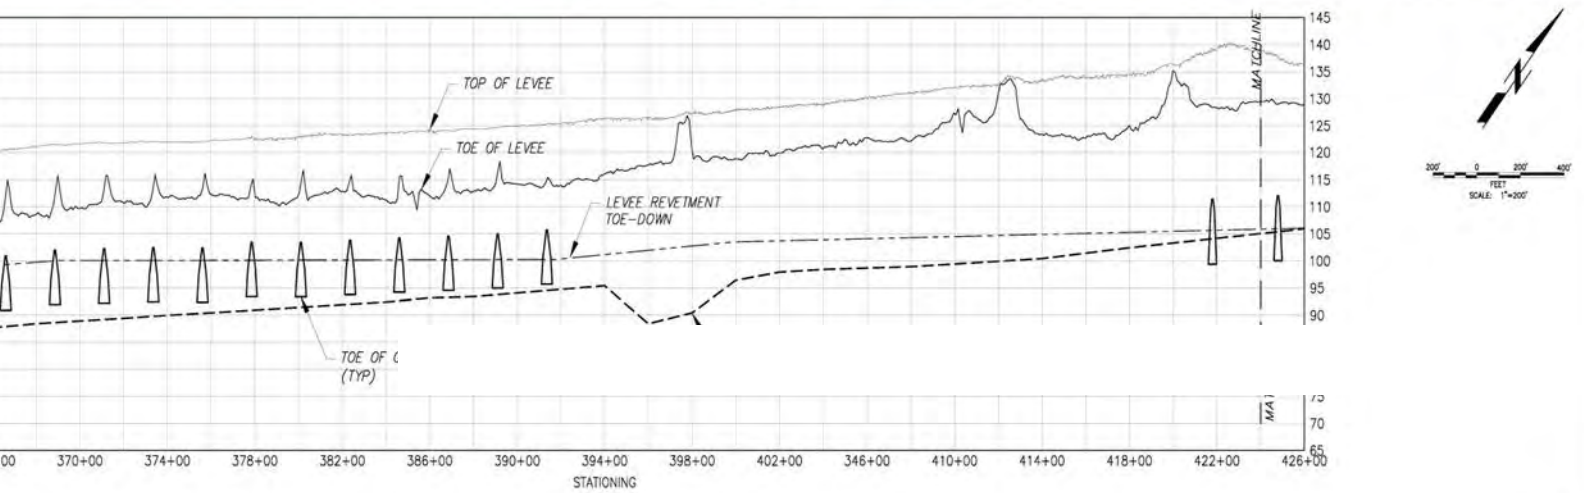
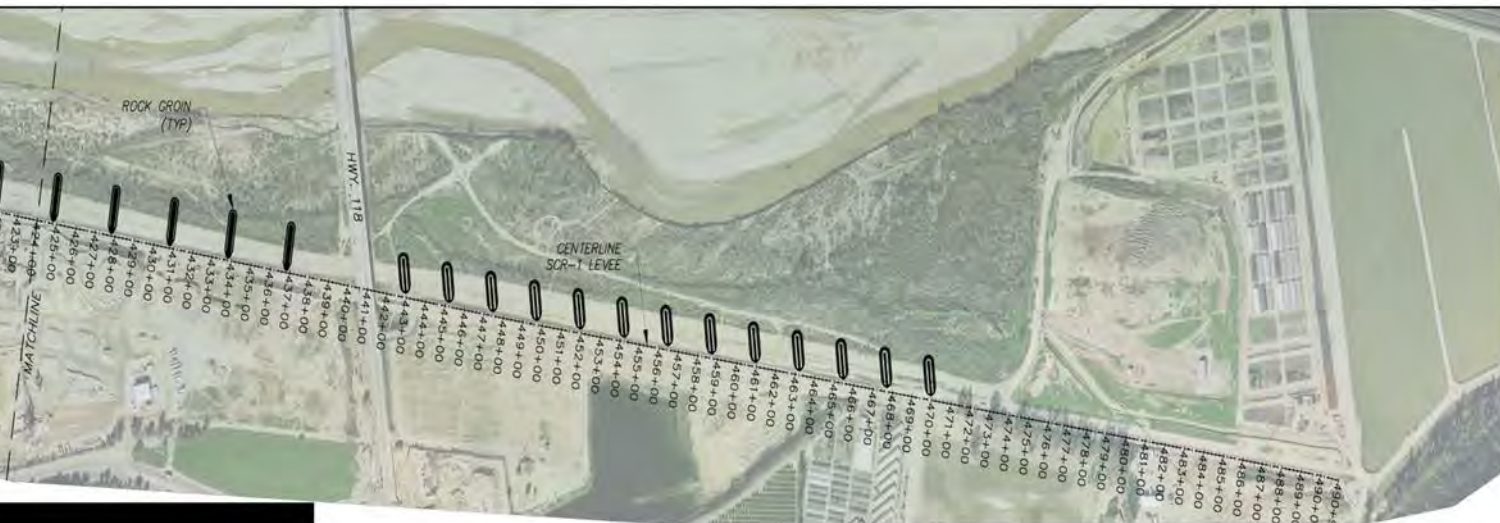
EXHIBIT 1  
 SANTA CLARA RIVER LEVEE (SCR-1)  
 PLAN AND PROFILE - STA. 424+00 TO STA. 486+00

- At the time of the design, the elevation of the river streambed was below the elevation of the rock revetment along the levee where it extends from location of the 1969 levee failure (near as-built Station 330+00) to the upstream end of the levee system (at Station 490+90).

- At the time of the design, the elevation of the river streambed was lower than the elevations of the rock-groin toedown that extends from Station 360+00 to Station 392+00.

- Analysis indicates that from as-built Station 335+50 to Station 391+75, the volume of the as-built weighted stone toe is insufficient, by a factor of 3.0, to protect against the currently predicted scour depth, particularly if the channel thalweg were to migrate toward the levee (Tetra Tech 2009).
