Preliminary Geotechnical Report
Matilija Canyon Road Storm Damage,
Approximate Mile Post 0.3 to 0.7, Ojai (Ventura County), California

Yeh Project No.: 223-274

September 25, 2024

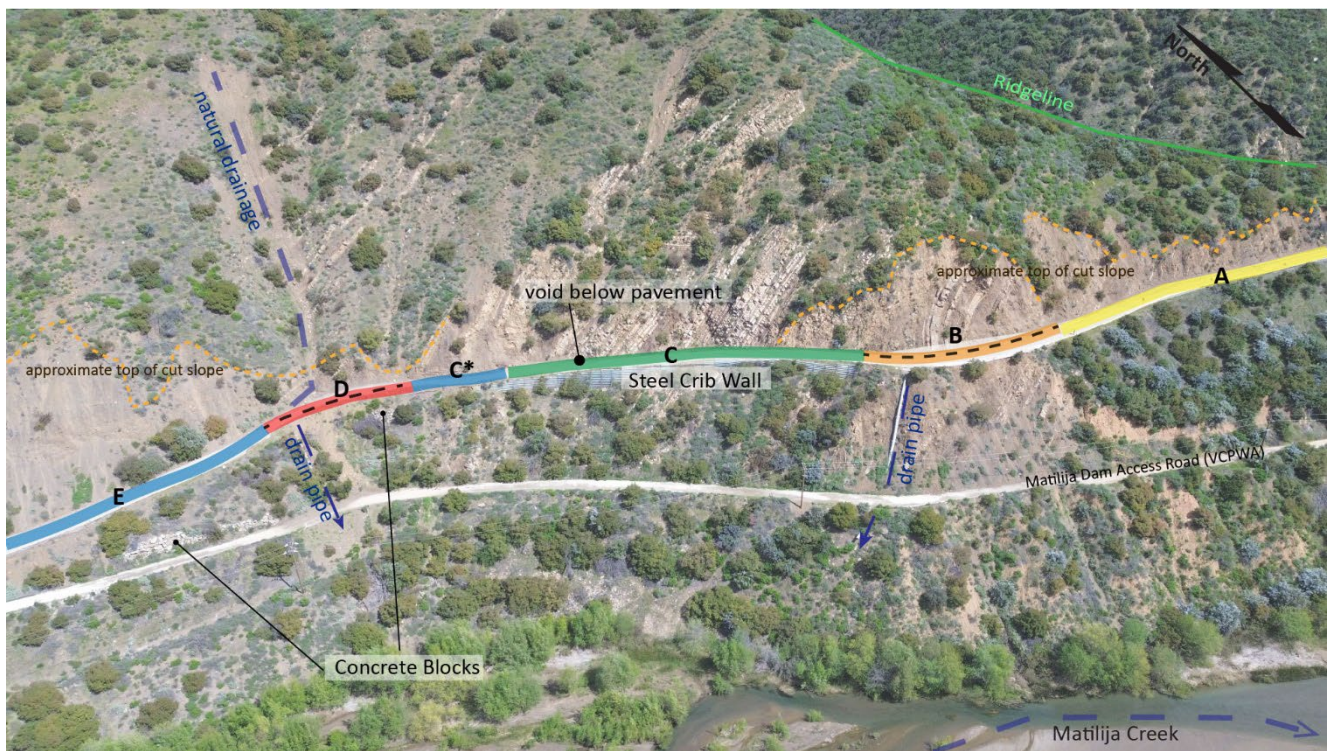
Figure 2: Project Segments

Condition ID	Approx. County MP	Description of Existing Erosion/Unstable Condition
A	0.36 to 0.45	Several feet of outer shoulder/lane are undermined. Existing Fill slope. Roadway cracks show distress throughout the eastbound lane.
B	0.45 to 0.49	Several feet of outer lane are undermined. Existing Cut Slope. Roadway cracks show distress throughout the eastbound lane. Travelable lane width reduced .
C	0.49 to 0.55	Supported by steel crib wall on downslope side, construction date unknown. Less erosion than other segments, large void below the roadway (see Appendix A Photos)
C*	0.55 to 0.57	Supported by steel crib wall on downslope side, construction date unknown. Erosion above the road is depositing material on inside shoulder and lane.
D	0.57 to 0.60	Across natural drainage. Slope failure upslope and downslope of road. Area of concrete blocks visible below road and likely used for emergency fill repair.

E	0.60 to 0.68	Erosion of upslope cut depositing material onto road. Area of concrete blocks visible below road and likely used for emergency fill repair. Undermining of road in areas.

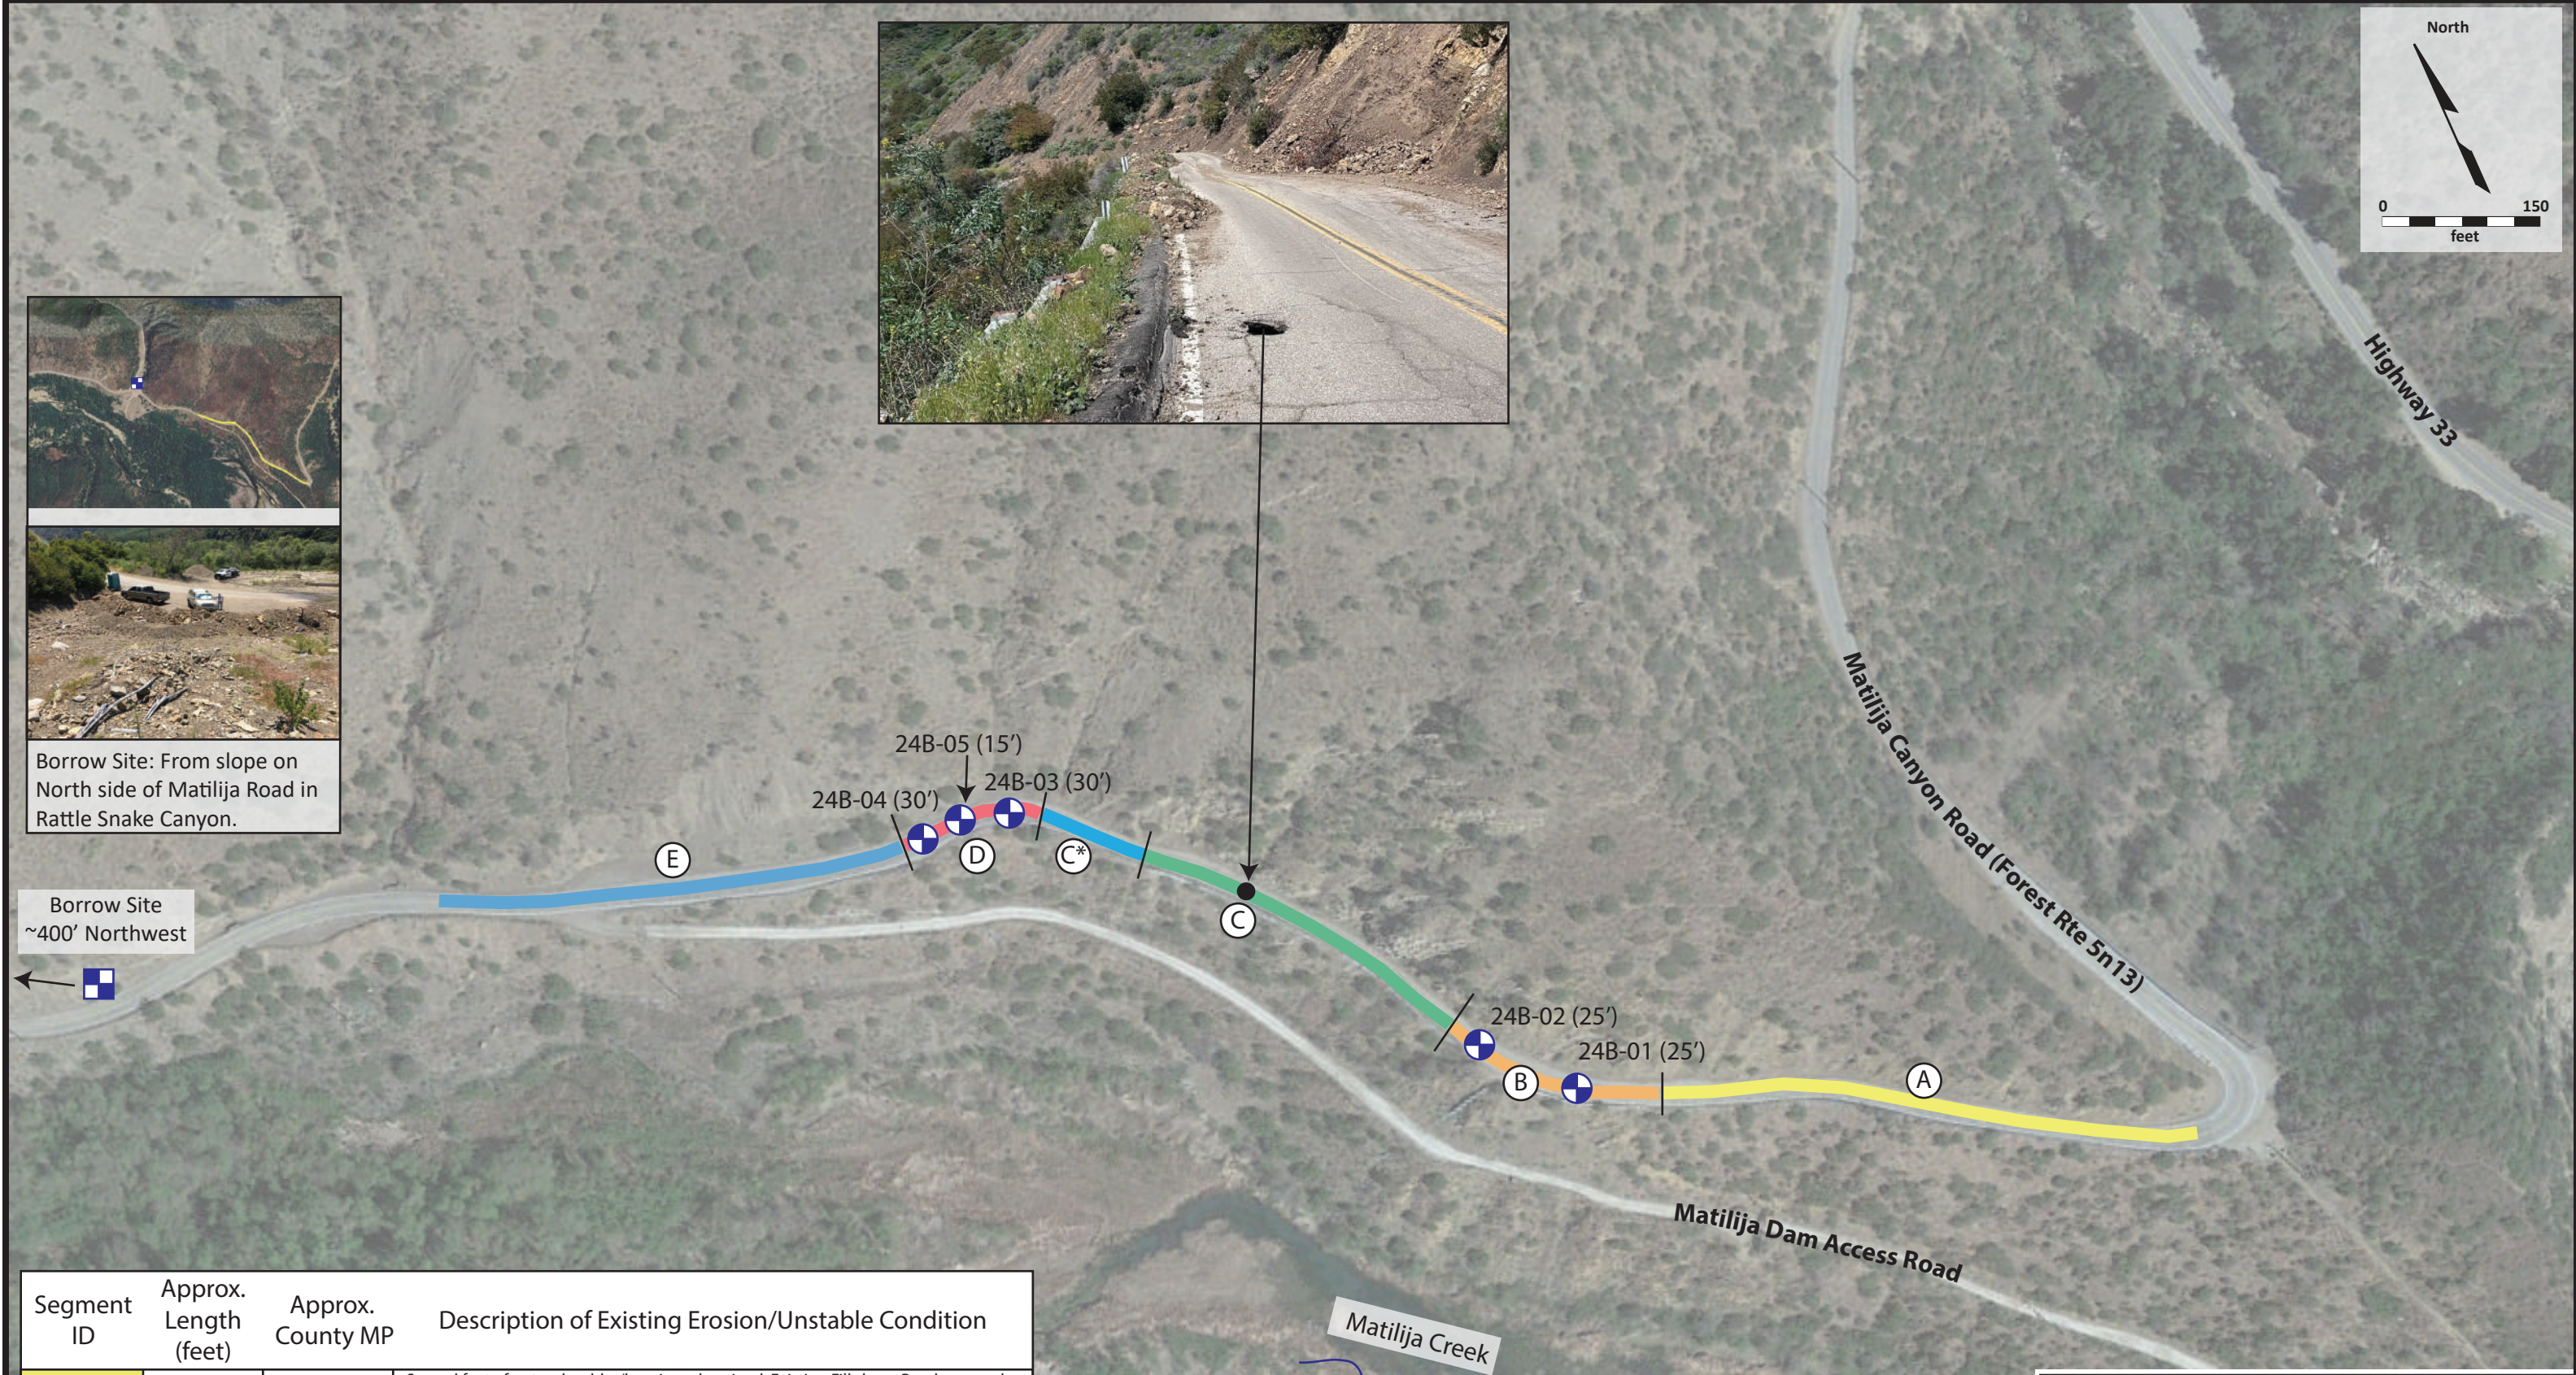
PROJECT NAME: MATILIJIA CANYON STORM DAMAGE Ojai, CA		PLATE 1
PROJECT NUMBER: 223-274	REVISION DATE: 9.18.2024

Segment ID	Approx. Length (feet)	Approx. County MP	Description of Existing Erosion/Unstable Condition
A	460	0.36 - 0.45	Several feet of outer shoulder/lane is undermined. Existing Fill slope. Roadway cracks show distress throughout the eastbound lane.
B	160	0.45 - 0.49	Several feet of outer lane is undermined. Existing Cut Slope. Roadway cracks show distress throughout the eastbound lane. Lane width compromised.
C	355	0.49 - 0.55	Supported by steel crib wall on downslope side, construction date unknown. Less erosion than other segments, large void below the roadway (see Appendix A Photos)
C*	105	0.55 - 0.57	Supported by steel crib wall on downslope side, construction date unknown. Material from slope above the road is depositing material on inside shoulder and lane.
D	150	0.57 - 0.60	Across natural drainage. Slope failure on upslope and downslope of road. Area of concrete blocks visible below road and likely used for emergency fill repair.

E	330	0.60 - 0.68	Upslope cut slope eroding onto road. Area of concrete blocks visible below road and likely used for emergency fill repair. Undermining of road in areas.

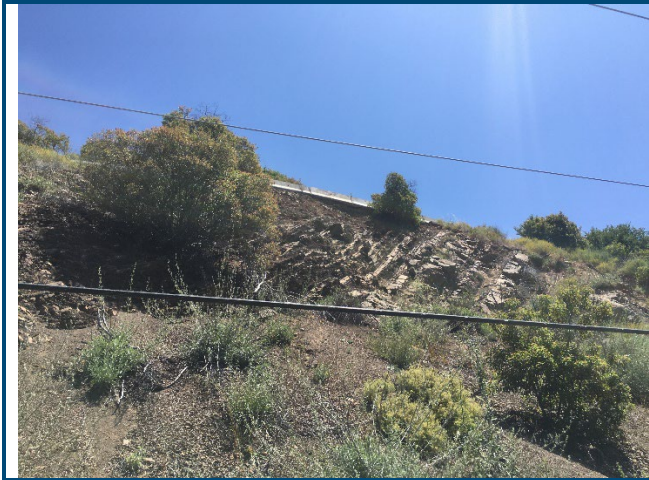
Undermined Matilija Canyon Road ~MP 0.42

A geosynthetic reinforced embankment (GRE) is recommended along the eastbound side of the existing roadway for Segments A and E to restore the fill slope supporting the road and shoulder. Figure 4 presents a concept for a geosynthetic reinforced embankment relative to the existing slope cross section through Segment A. Construction of the GRE would include removal of the existing embankment material that is susceptible to creep-type movement and underlying soil susceptible to erosion and slope instability associated with landsliding.

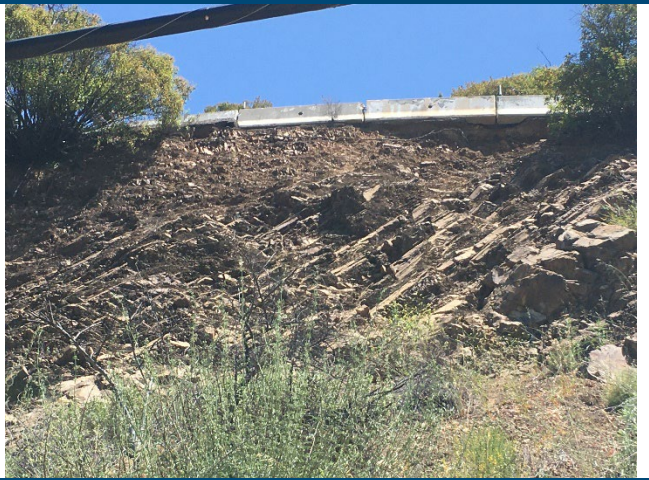
Undermined Matilija Canyon Road ~MP 0.42

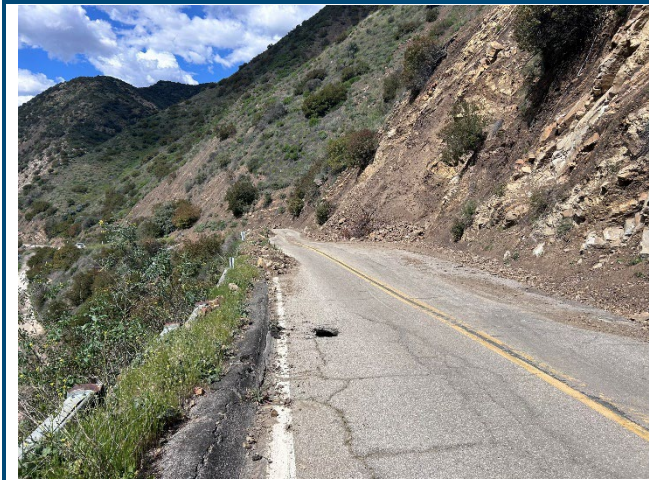
Existing Void, Matilija Canyon Road ~MP 0.53

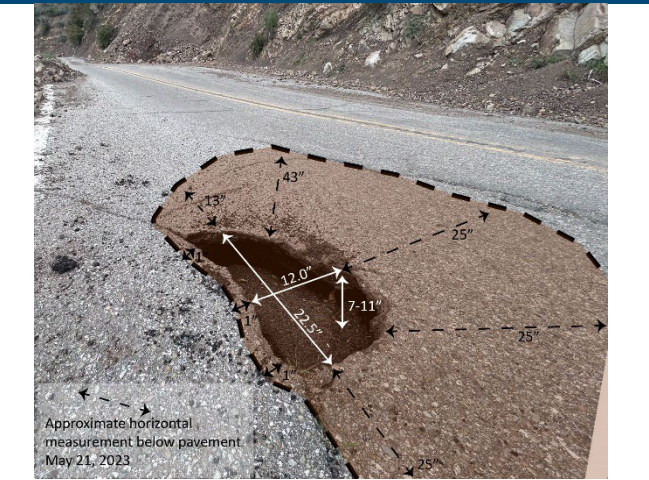
Existing Void with 5/21/24 Measurements , Matilija Canyon Road ~MP 0.53

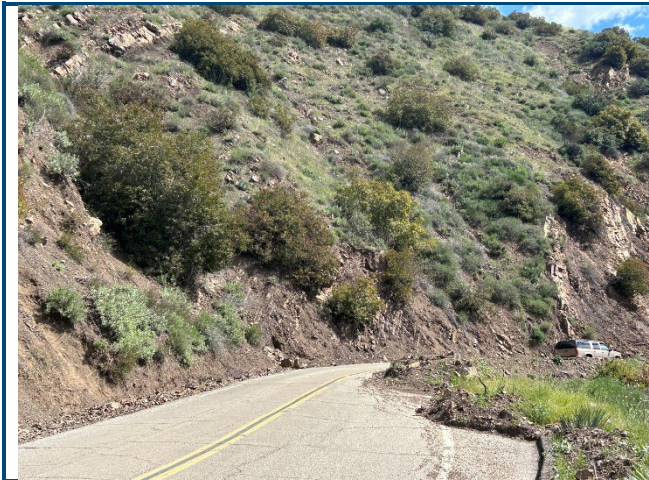
Undermined Matilija Canyon Road and Erosion and Rockfall from above, ~MP 0.58

Rockfall fencing is recommended along the westbound shoulder of the project alignment to reduce the potential for rockfall to impact the roadway and facilitate the County's management program, which would likely consist of periodic removal of debris that will accumulate behind the barrier, particularly following relatively intense storm events.

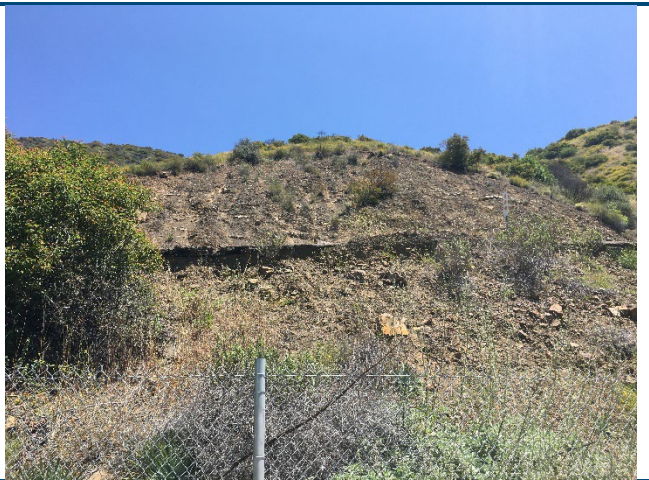
Undermined Matilija Canyon Road ~MP 0.63, looking up from lower access road

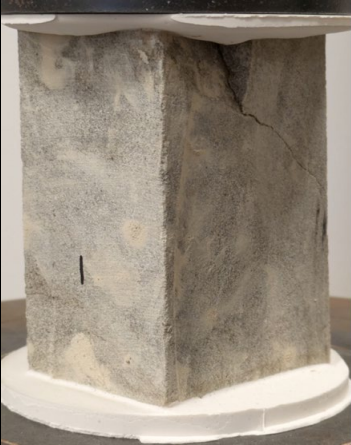
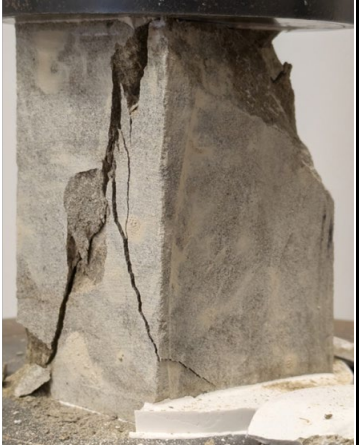
Note: crack and missing piece near top on right face prior to testing
