**ASSESSMENT OF STEELHEAD HABITAT  
IN UPPER MATILIJA CREEK BASIN**

*Stage One: Qualitative Stream Survey*

9 June 2003

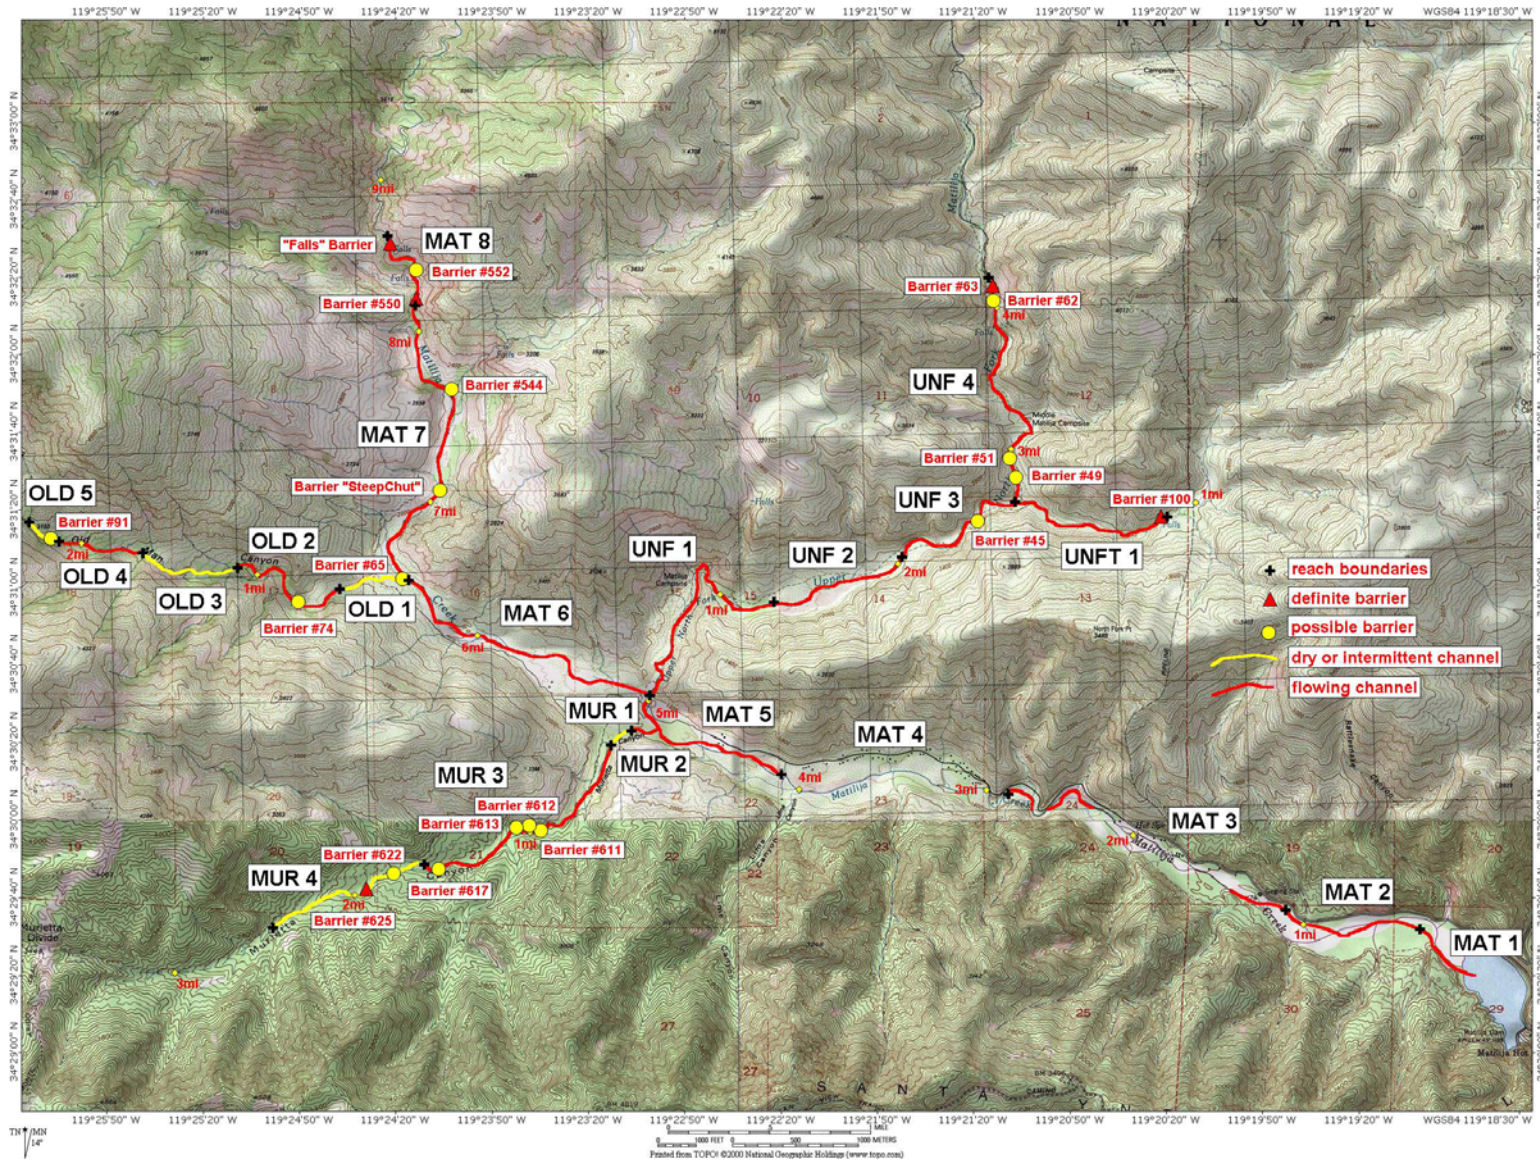
Figure 3. Map of the upper Matilija Basin showing reach boundaries, dominant streamflow characteristics (colored lines), and barrier locations. Channels not outlined were not mapped.

throughout this reach, the cementing of some gravel was still evident. Access was good with one possible barrier (barrier #46, Table 2, Figure 3, Appendix C). One unidentified fish was observed in this reach. Overall, the habitat rating for this reach was good.

Most of this reach was completely dry making access to the rest of the stream impossible at the current flow (Table 1). Access at higher flows would probably be difficult, due to some steep cascades and falls (barrier #65, Table 2, Figure 3, Appendix C). Less than 300 ft of this reach contained intermittent flow (<0.5 cfs), and no fish observed in this portion of the stream. No spawning gravel was observed in this reach, and the overall habitat rating for this reach was poor.

be provided, with an additional two to three miles of habitat if the definite barrier at the Wheeler Campground was removed. Of the 21.6 miles, 6.7 miles occur above “possible” barriers to upstream migration (Table 2), and thus such areas may not be accessible to steelhead. Also, 1.5 miles of the potentially accessible habitat were either dry or intermittent during the March survey, and thus such areas would be unlikely to provide summer rearing habitat except during wetter years (Table 1, Figure 3).

“complete” that are relatively close to the barriers we classified as “definite” in the upper mainstem Matilija and the Upper North Fork (Figure 3, Table 2). However, the Chubb Report also shows complete barriers in the Lower North Fork that we did not encounter (or, that we judged differently). Also, we identified a number of “possible” barriers in Old Man Creek and in Murietta Creek that were not identified in the Chubb Report. Given the lack of detail in how barriers were assessed for the Chubb Report, it is difficult to give a cause for these differences. Even with the semi-quantitative methodology that we employed, a significant amount of “professional opinion” is ultimately involved in most evaluations, and the streamflow conditions that exist during the survey can also have a large effect on the final assessment. Despite the ambiguities inherent to barrier assessment, the results can clearly have significant effects on the overall estimation of potential steelhead habitat. As previously discussed, a thorough barrier analysis is best performed under flow conditions typical during upstream migration and, ideally, in the presence of migratory steelhead. Neither option was feasible during this short-term study.

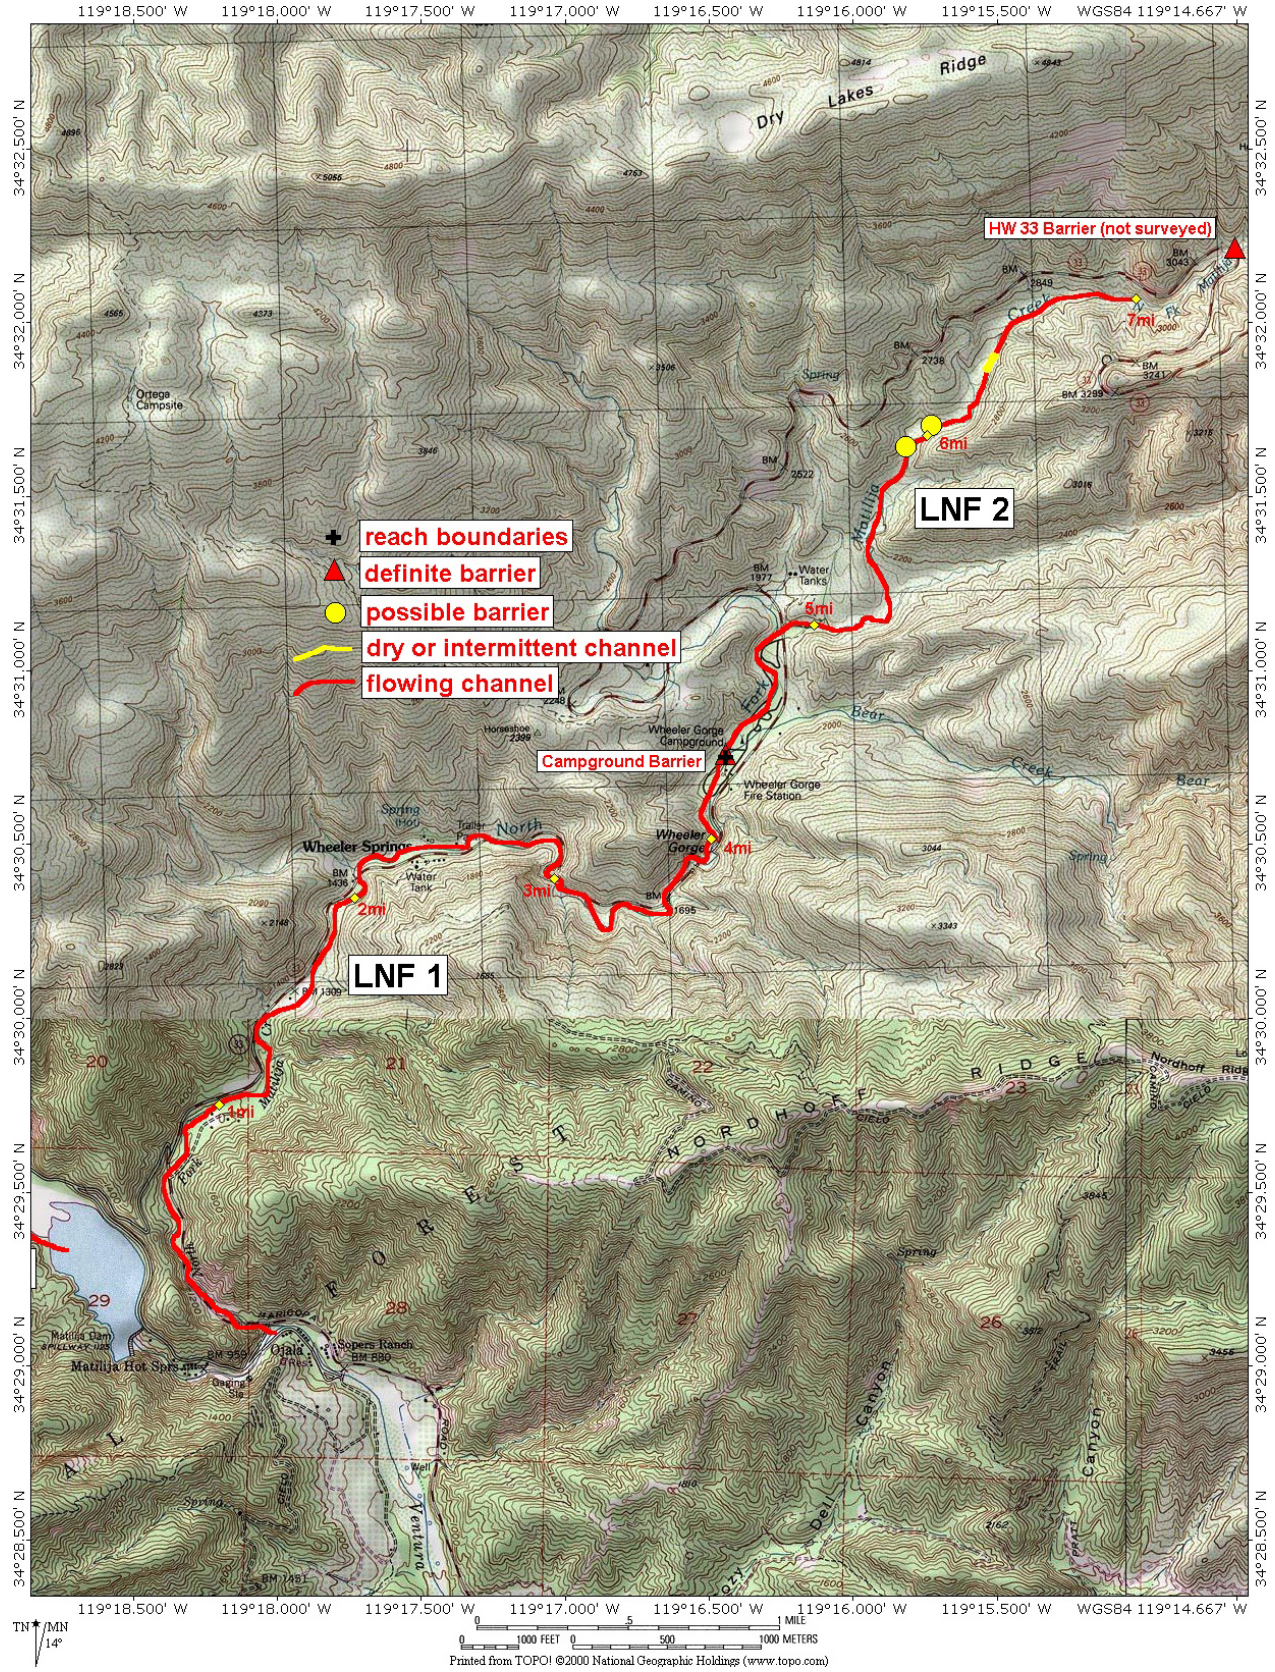
Figure 6. Map of Lower North Fork Matilija Creek showing reach boundaries and barrier locations. Most of the channel was B-type with surface flow and riparian forest. Channels not outlined were not mapped.

The Lower North Fork of the Matilija appeared to contain some of the best habitat for steelhead spawning and rearing within the upper basin. The majority of the channel was type B and was enclosed by riparian forest or, in Wheeler Gorge, by canyon walls (Table 1, Figure 6). Spawning gravels were very abundant and in good condition, although there was some mineral cementation in areas. Rainbow trout were frequently observed, and several redds and spawning adults were also seen during the March survey. Potential access for steelhead was good throughout most of this reach, despite some steep cascades and falls in the lower end that were expected to be passable at higher flows. There was, however, a definite man-made barrier at a road crossing in the Wheeler Gorge Campground (barrier #710, Table 2, Figure 6, Appendix C).

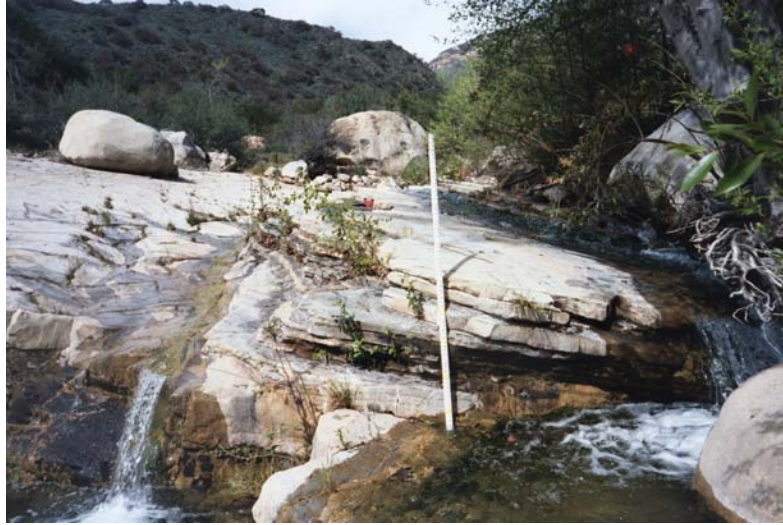
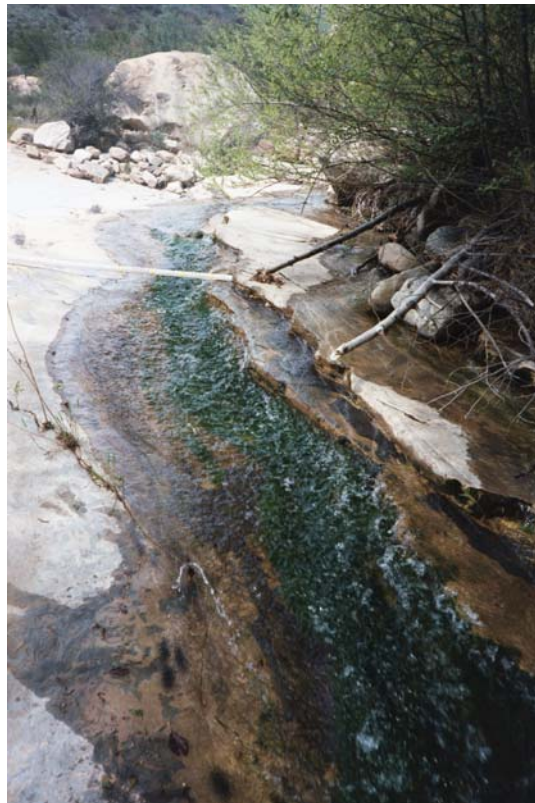
Barrier "steepchut" in mainstem Matilija Creek. Visible portion of stadia rod is approximately 8 ft long. See Figure 3 for location and Table 2 for barrier details.

Barrier "steepchut" in mainstem Matilija Creek. See Figure 3 for location and Table 2 for barrier details.

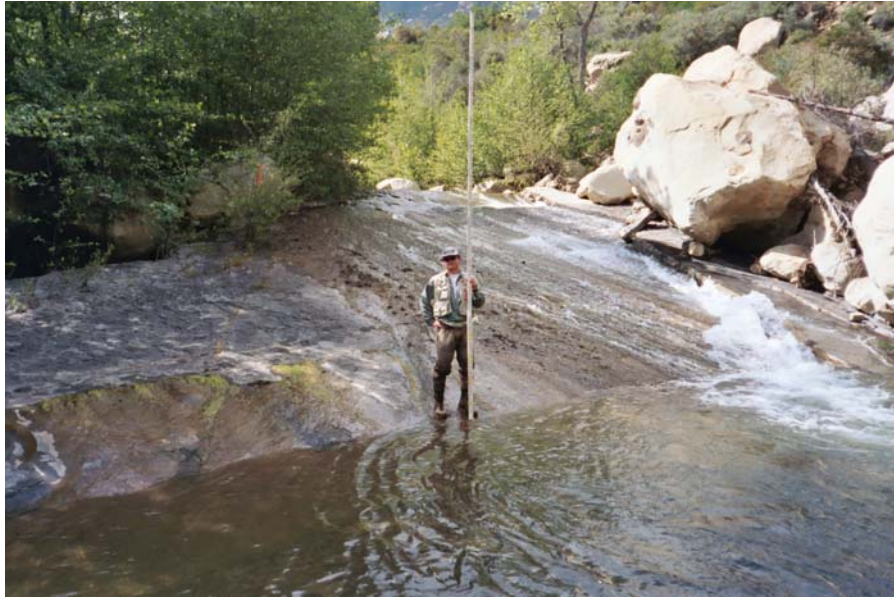
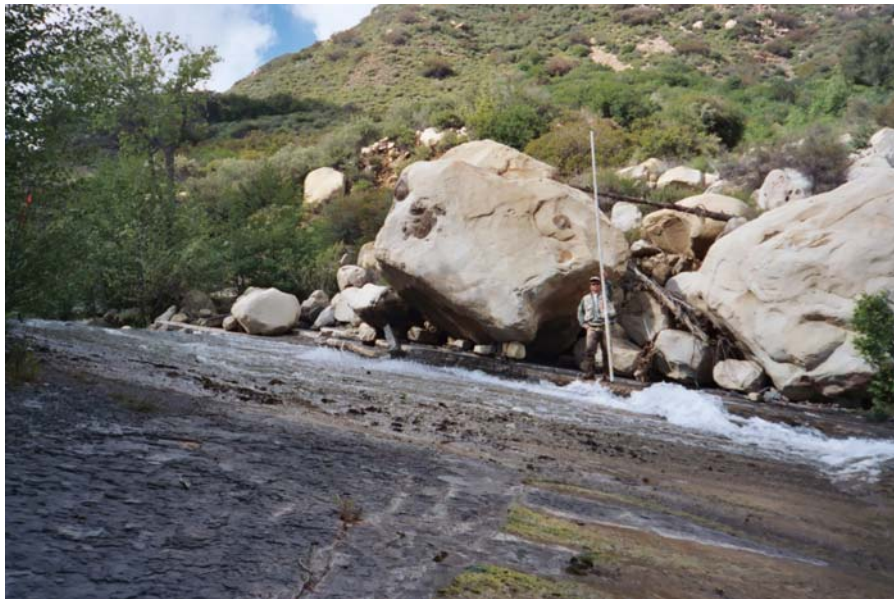
Barrier #544 in mainstem Matilija Creek, April survey. Visible portion of stadia rod is approximately 14 ft long. See Figure 3 for location and Table 2 for barrier details.

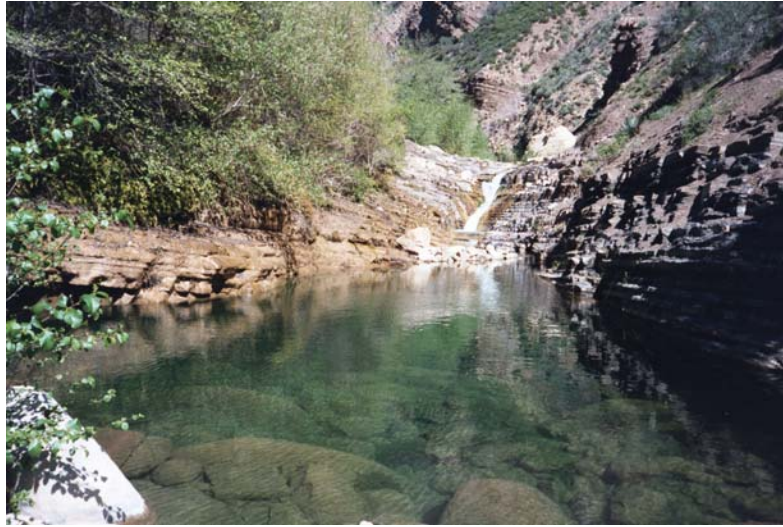
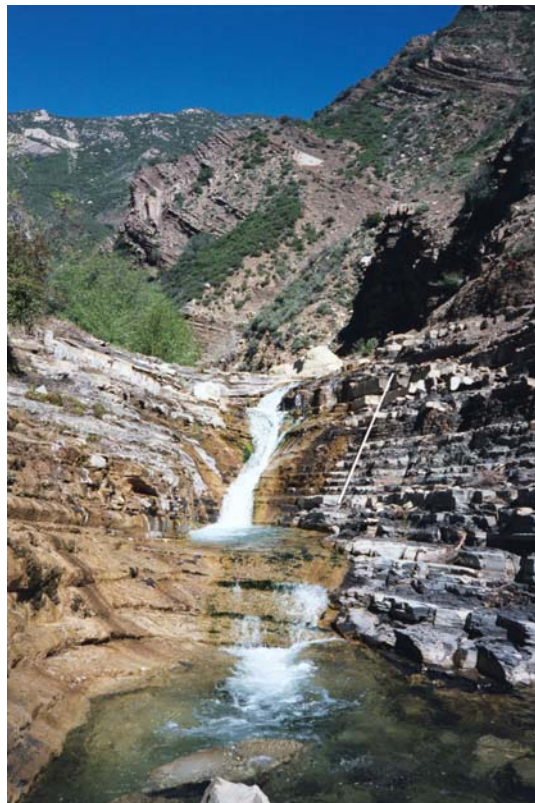
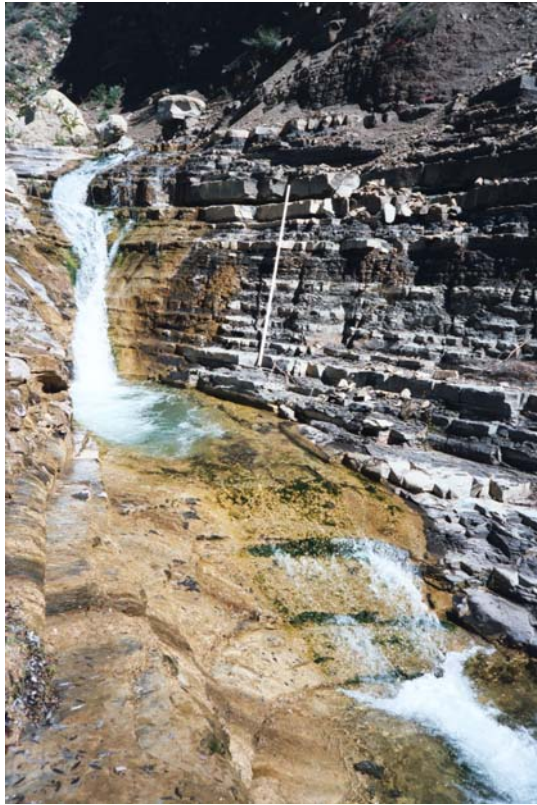
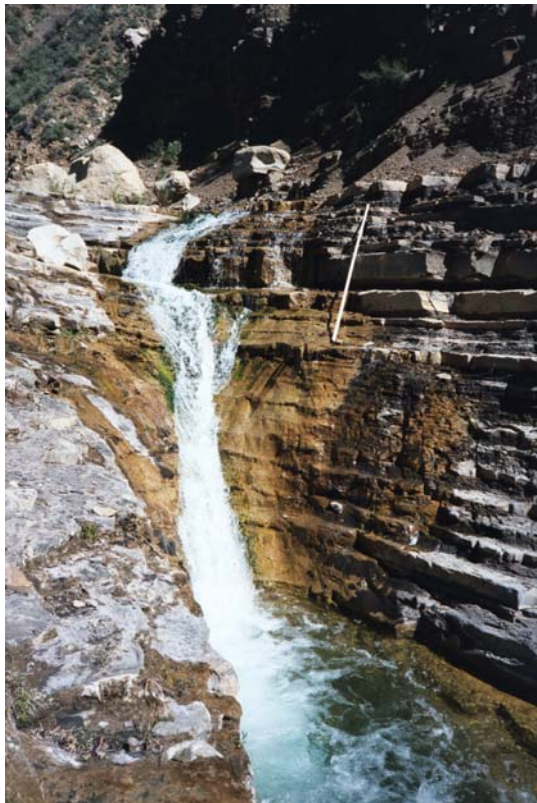
Barrier #550 in mainstem Matilija Creek. See Figure 3 for location and Table 2 for barrier details.

Barrier #550 in mainstem Matilija Creek. Visible portion of stadia rod is approximately 14 ft long. See Figure 3 for location and Table 2 for barrier details.

Barrier #550 in mainstem Matilija Creek. Visible portion of stadia rod is approximately 11 ft long. See Figure 3 for location and Table 2 for barrier details.

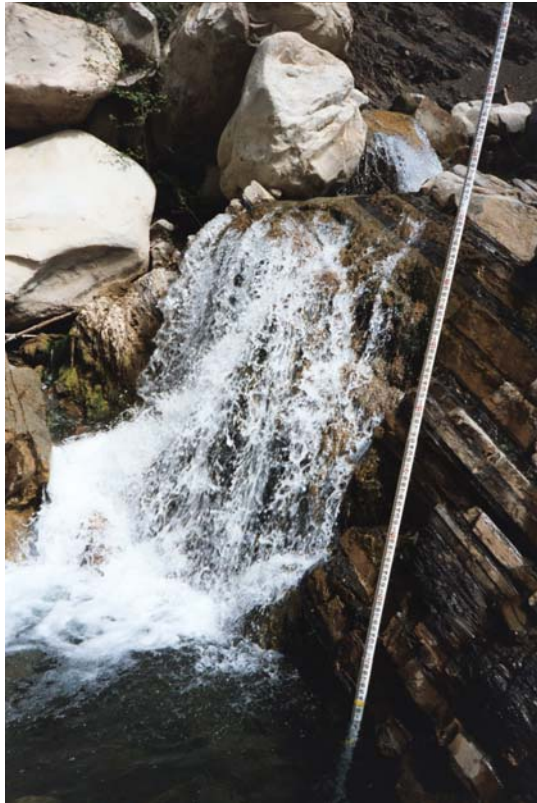
Barrier #552 in mainstem Matilija Creek. Visible portion of stadia rod is approximately 14 ft long. See Figure 3 for location and Table 2 for barrier details.

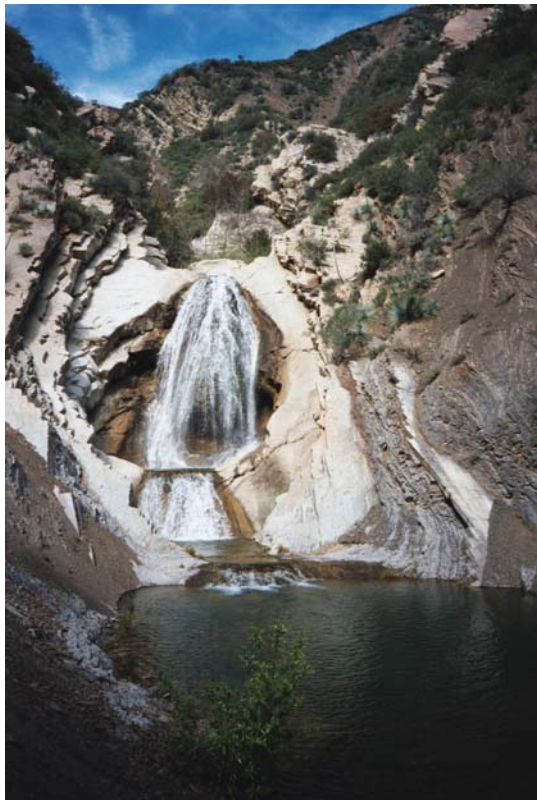
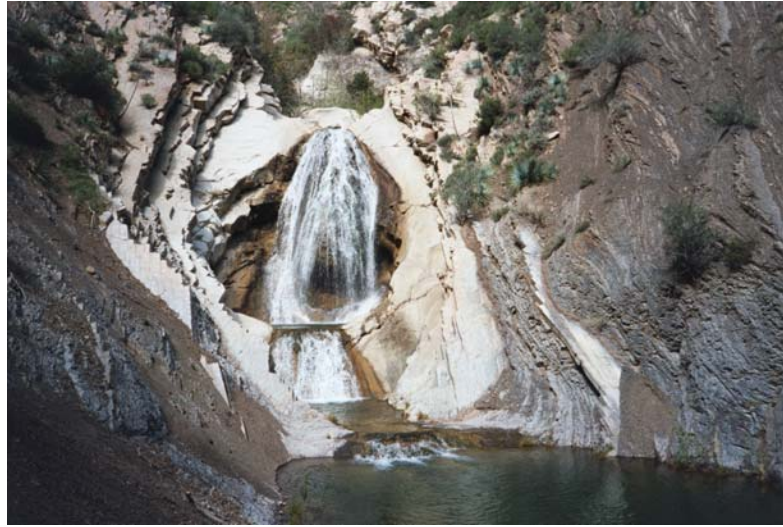
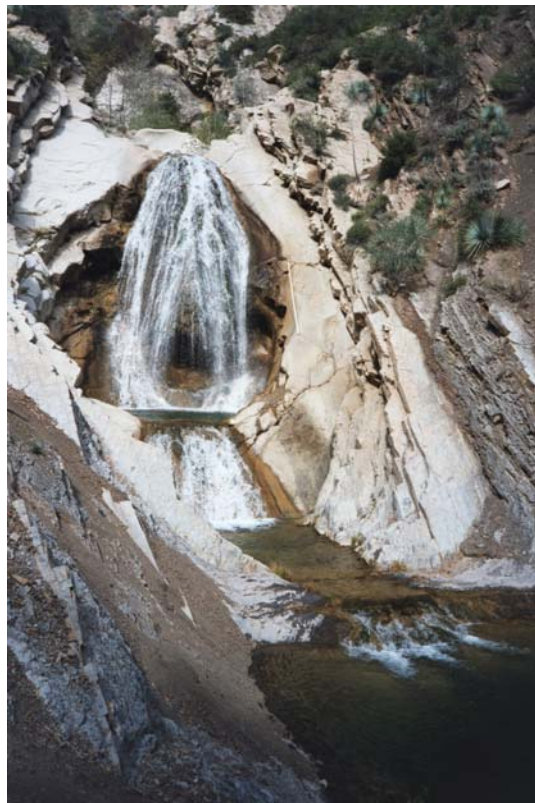
“Falls” barrier in mainstem Matilija Creek. See Figure 3 for location and Table 2 for barrier details.

“Falls” barrier in mainstem Matilija Creek. Visible portion of stadia rod (1/2 way up right edge of second falls) is approximately 14 ft long. See Figure 3 for location and Table 2 for barrier details.

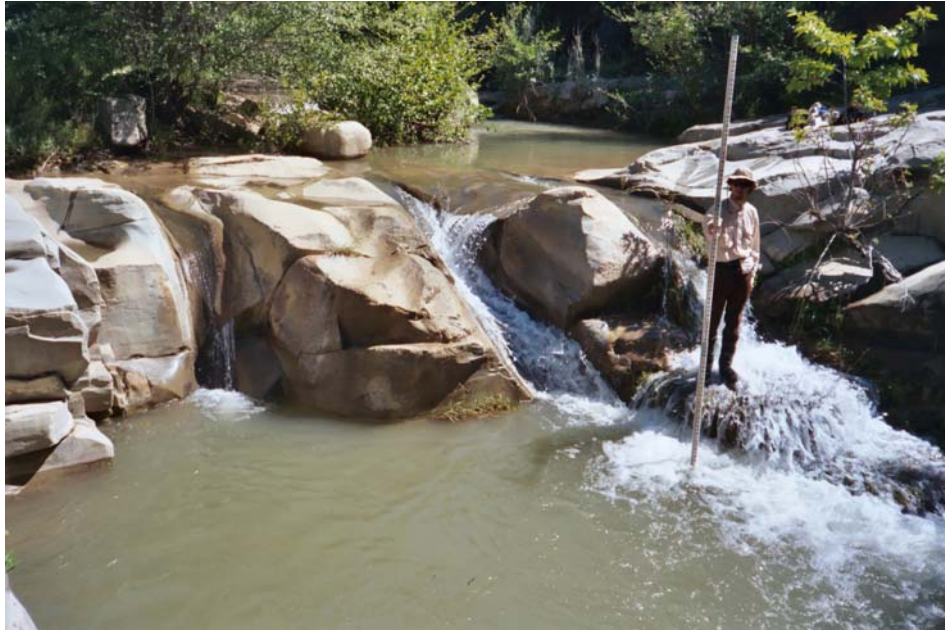
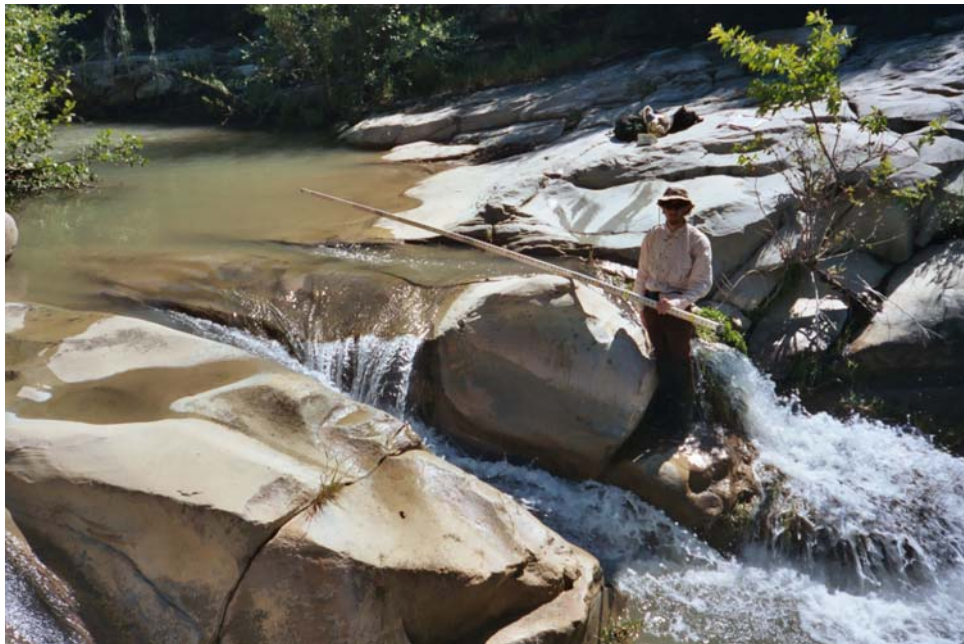
Barrier #45 in Upper North Fork Matilija Creek, April survey. Visible portion of stadia rod is approximately 10 ft long. See Figure 3 for location and Table 2 for barrier details.

Barrier #45 in Upper North Fork Matilija Creek, April survey. Visible portion of stadia rod is approximately 14 ft long. See Figure 3 for location and Table 2 for barrier details.

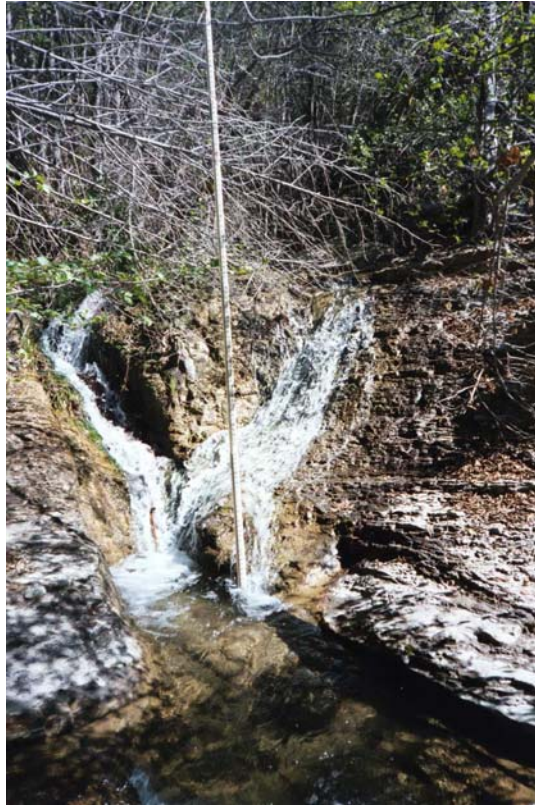
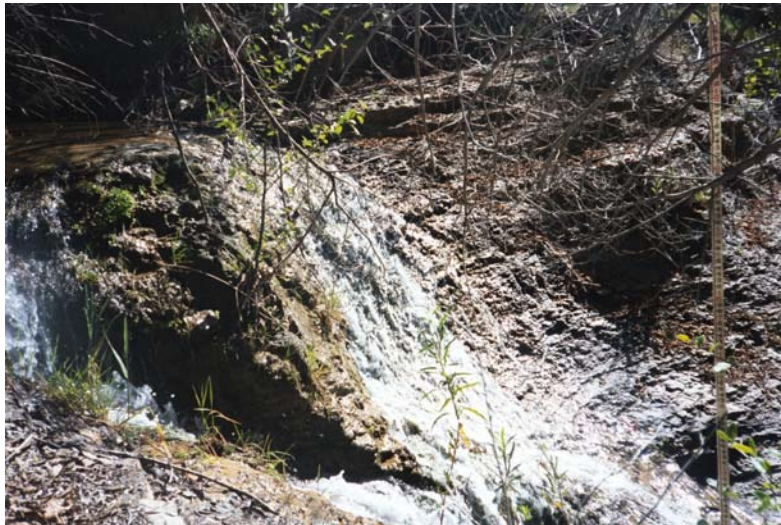
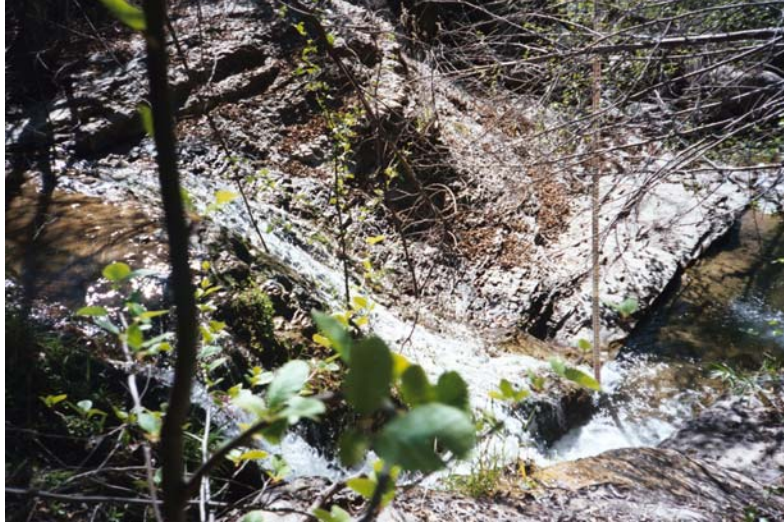
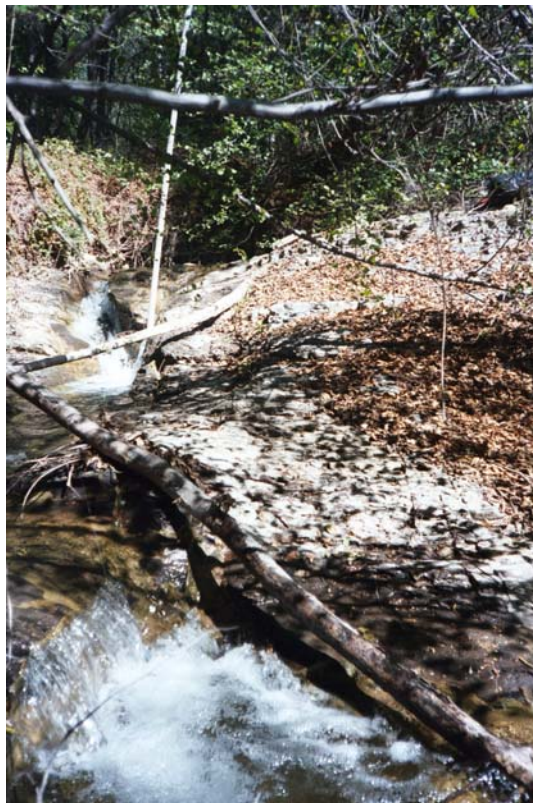
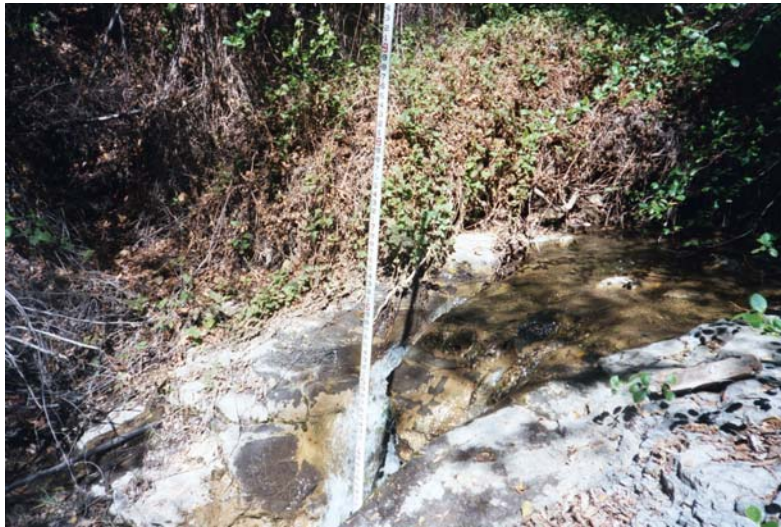
Barrier #49 (right side) in Upper North Fork Matilija Creek. Visible portion of stadia rod is approximately 12 ft long. See Figure 3 for location and Table 2 for barrier details.

Barrier #49 (right side) in Upper North Fork Matilija Creek. Visible portion of stadia rod is approximately 7 ft long. See Figure 3 for location and Table 2 for barrier details.

Barrier #49 (right side) in Upper North Fork Matilija Creek. Visible portion of stadia rod is approximately 10 ft long. See Figure 3 for location and Table 2 for barrier details.

Barrier #49 (left side) in Upper North Fork Matilija Creek. Visible portion of stadia rod is approximately 13 ft long. See Figure 3 for location and Table 2 for barrier details.

Barrier #49 (left side) in Upper North Fork Matilija Creek. Visible portion of stadia rod is approximately 7 ft long. See Figure 3 for location and Table 2 for barrier details.

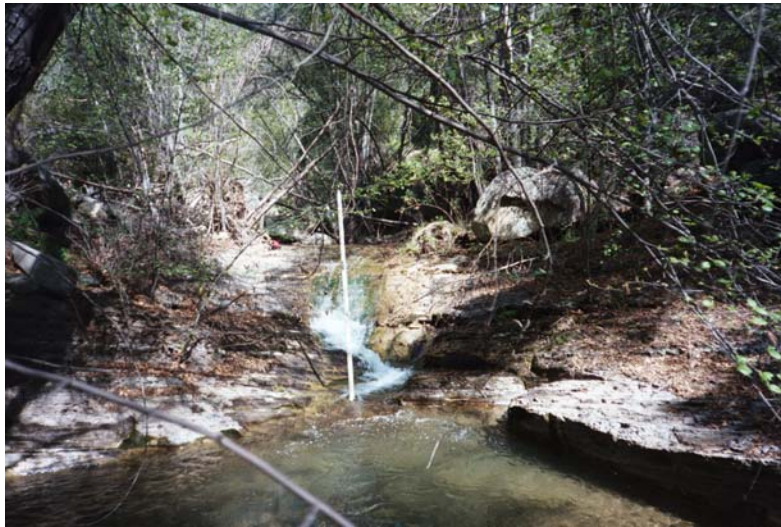
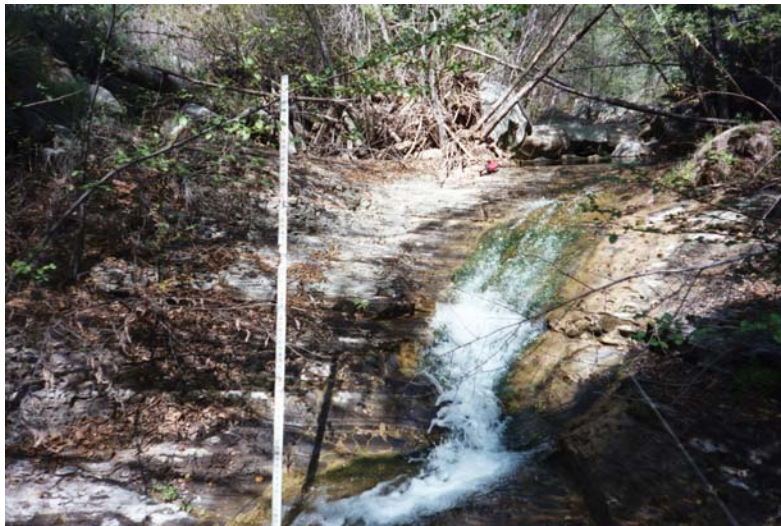
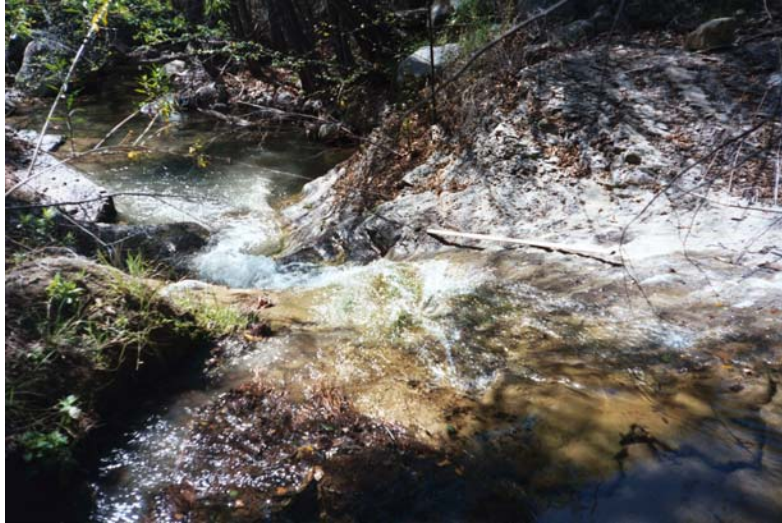
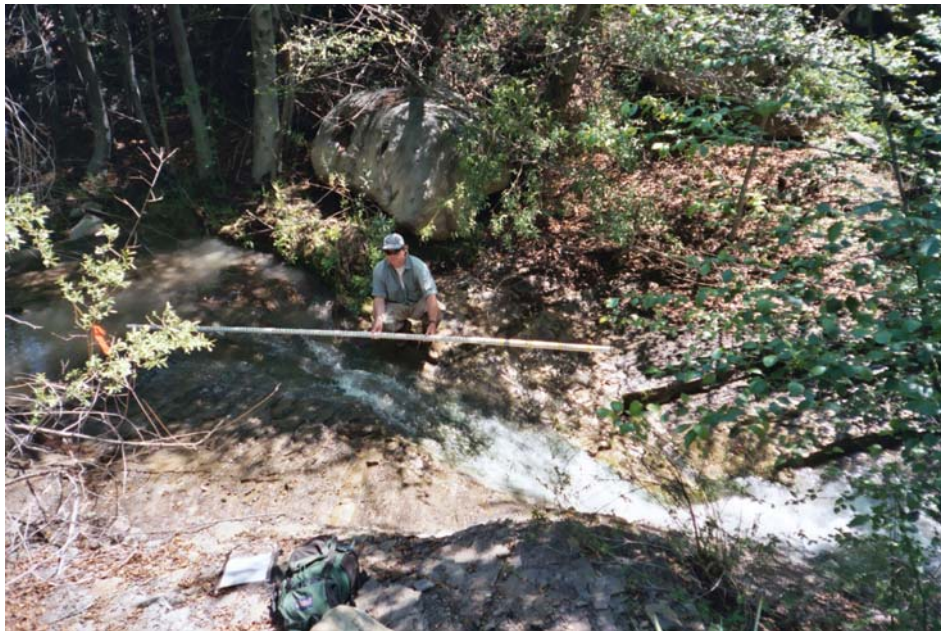
Barrier #51 in Upper North Fork Matilija Creek. Visible portion of stadia rod is approximately 8 ft long. See Figure 3 for location and Table 2 for barrier details.

Barrier #51 in Upper North Fork Matilija Creek. Visible portion of stadia rod is approximately 11 ft long. See Figure 3 for location and Table 2 for barrier details.

Barrier #51 in Upper North Fork Matilija Creek, April survey. Visible portion of stadia rod is approximately 14 ft long. See Figure 3 for location and Table 2 for barrier details.

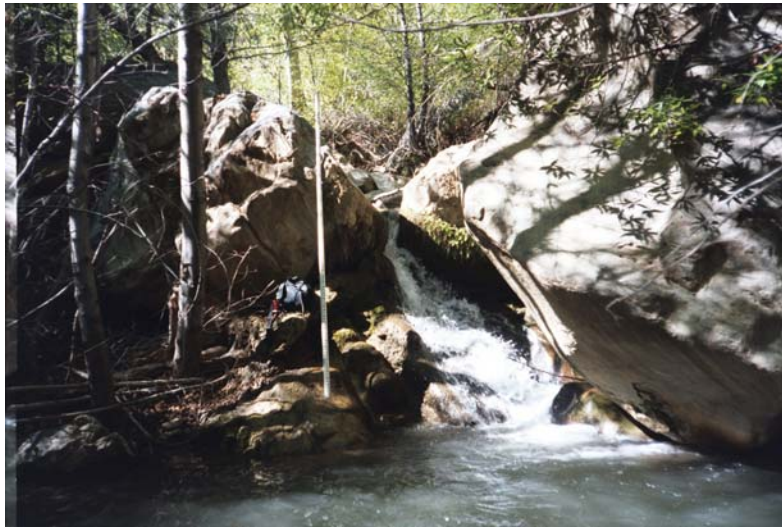
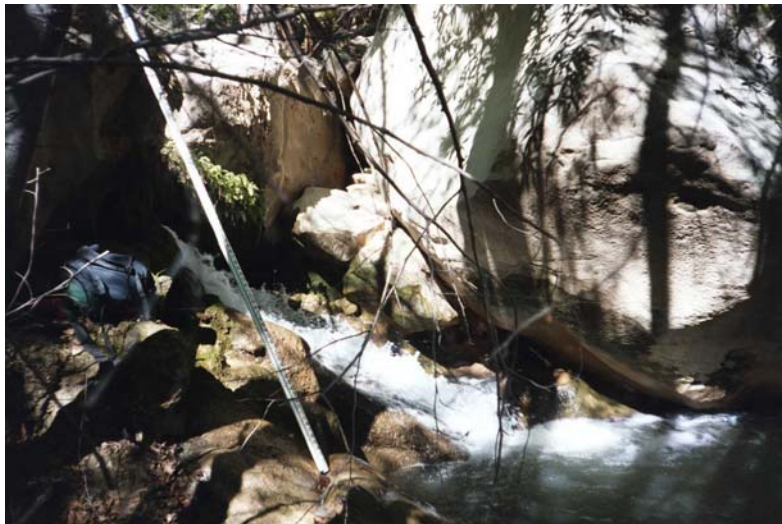
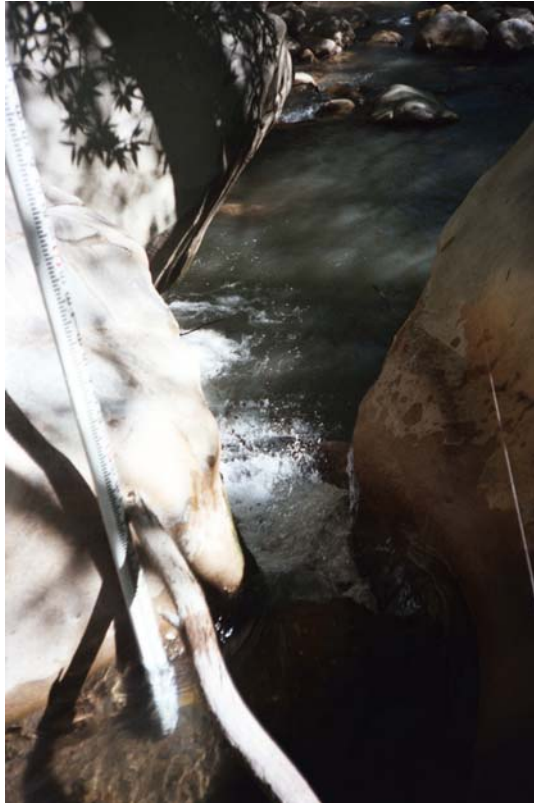
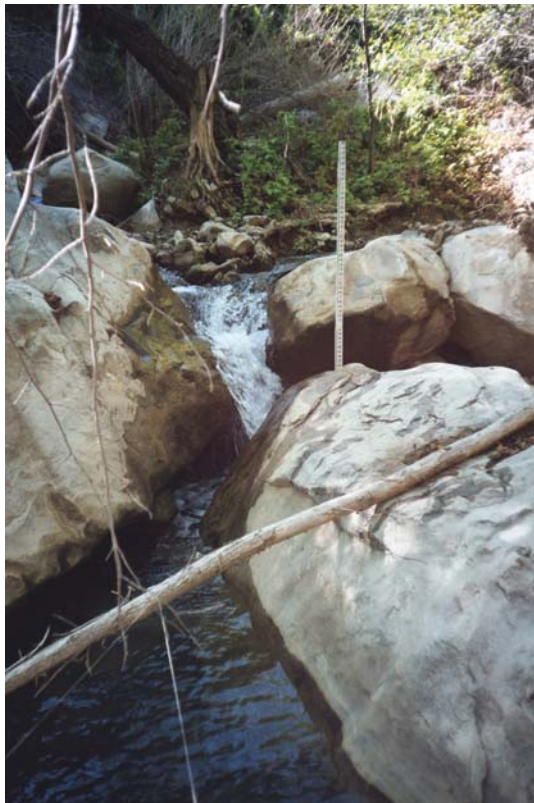
Barrier #62 in Upper North Fork Matilija Creek. Visible portion of stadia rod is approximately 11 ft long. See Figure 3 for location and Table 2 for barrier details.

Barrier #62 in Upper North Fork Matilija Creek. Visible portion of stadia rod is approximately 7 ft long. See Figure 3 for location and Table 2 for barrier details.

Barrier #62 in Upper North Fork Matilija Creek. Visible portion of stadia rod is approximately 3.5 ft long. See Figure 3 for location and Table 2 for barrier details.

Cascade immediately above barrier #62 in Upper North Fork Matilija Creek. Visible portion of stadia rod is approximately 5 ft long. See Figure 3 for location and Table 2 for barrier details.

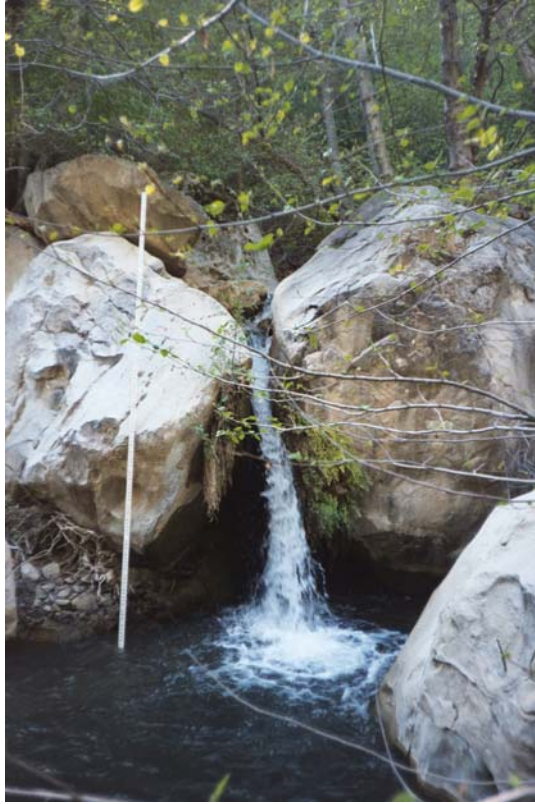
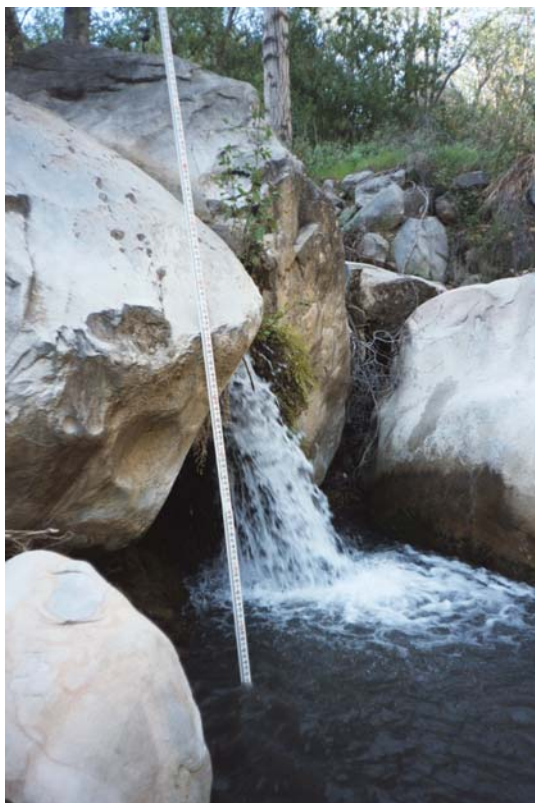
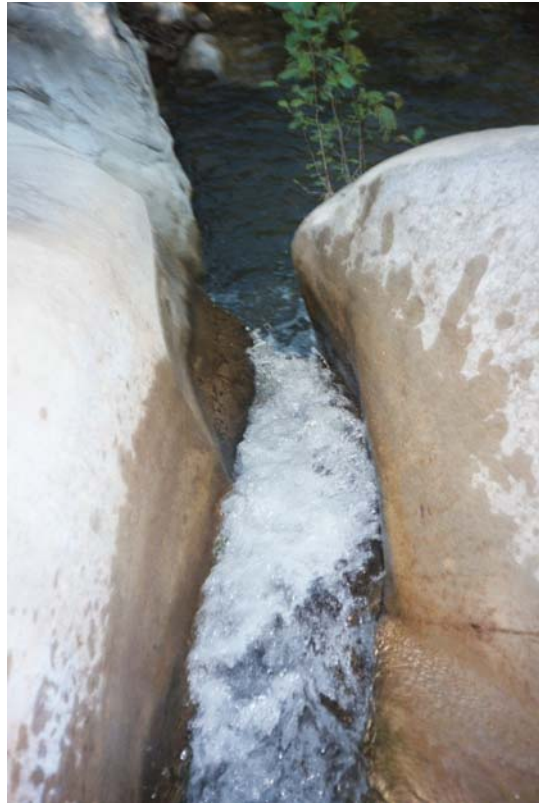
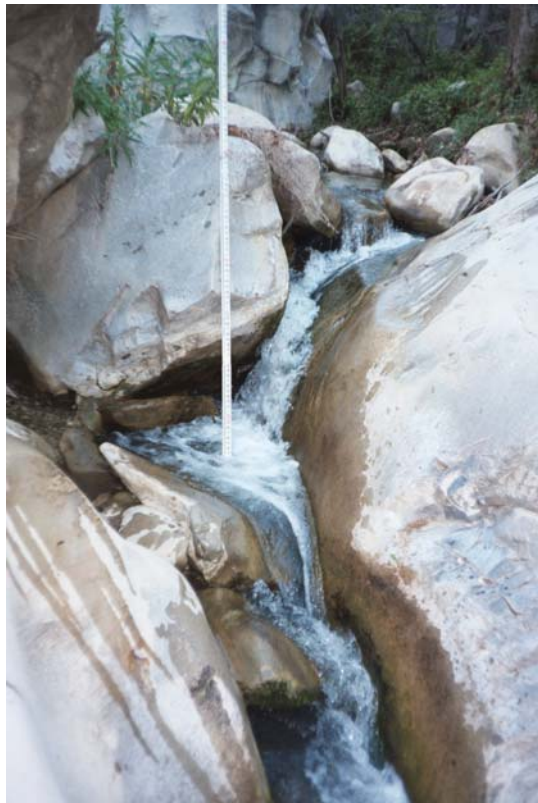
Barrier #63 in Upper North Fork Matilija Creek. Visible portion of stadia rod is approximately 13 ft long. See Figure 3 for location and Table 2 for barrier details.

Barrier #63 in Upper North Fork Matilija Creek. Visible portion of stadia rod is approximately 12 ft long. See Figure 3 for location and Table 2 for barrier details.

Barrier #63 in Upper North Fork Matilija Creek. See Figure 3 for location and Table 2 for barrier details.

Cascade immediately below barrier #63 in Upper North Fork Matilija Creek. Visible portion of stadia rod is approximately 9 ft long. See Figure 3 for location and Table 2 for barrier details.

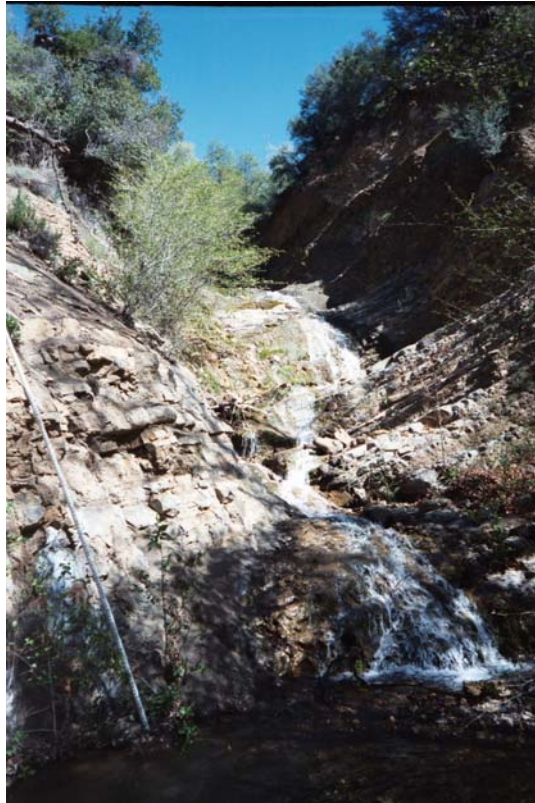
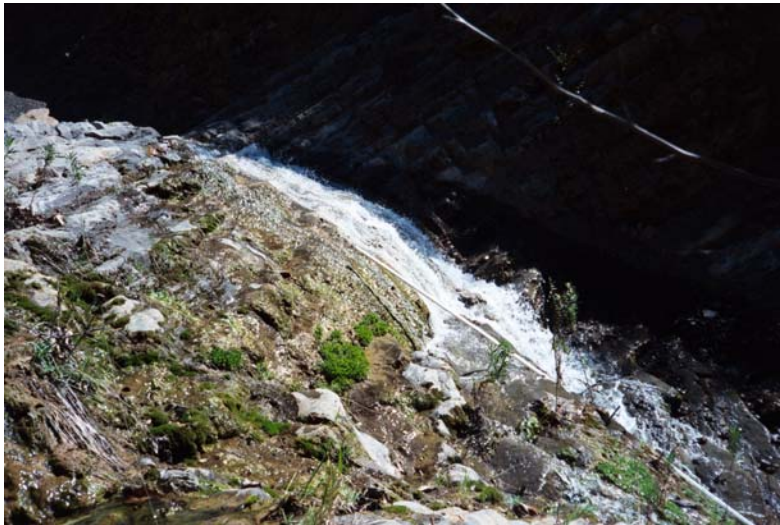
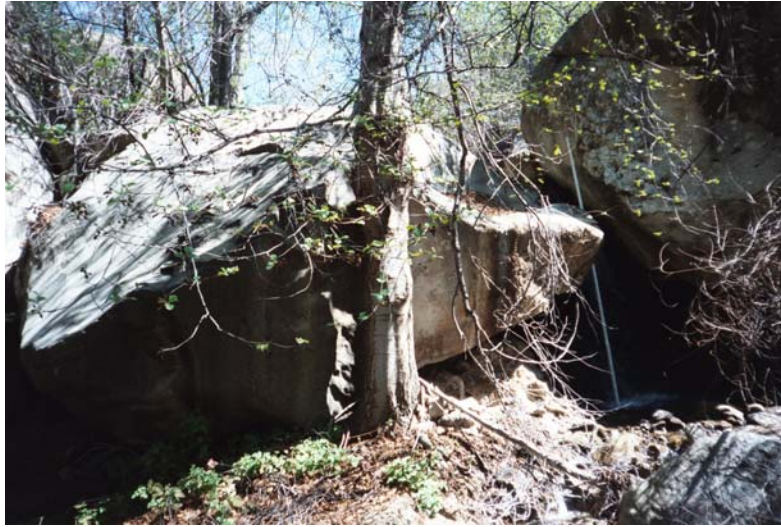
Barrier #100 on unnamed tributary to the Upper North Fork Matilija Creek. Visible portion of stadia rod is approximately 13 ft long. See Figure 3 for location and Table 2 for barrier details.

Barrier #100 on unnamed tributary to the Upper North Fork Matilija Creek. Visible portion of stadia rod is approximately 14 ft long. See Figure 3 for location and Table 2 for barrier details.

Top end of barrier #100 on unnamed tributary to the Upper North Fork Matilija Creek. Visible portion of stadia rod is approximately 14 ft long. See Figure 3 for location and Table 2 for barrier details.

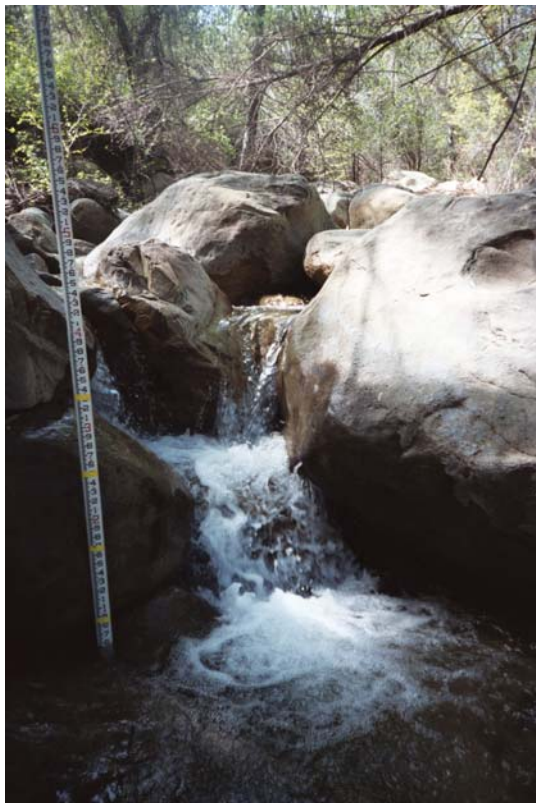
Steelhead access to this long reach could be difficult given the periodically dry channel downstream and the presence of several possible barriers (barriers #611, #612, #613, #617, Table 2, Appendix C). At approximately 5,900 ft upstream, an unnamed tributary adds significant flow. Gradient in this B channel varies between 2 to 4% with small to medium boulders (and occasional large boulders) dominating substrate (Table 1, Figure 4). Spawning gravels were numerous and showed none of the mineral cementing found in most other sub-basins. Riparian forest was dense throughout most of the reach and woody debris was plentiful. Although many excellent holding pools were present, only one rainbow trout was observed. Overall the spawning and rearing habitat in this reach was judged as good, although the access and stability of streamflows remains questionable.

Barrier #611 in Murietta Creek. Visible portion of stadia rod is approximately 6.5 ft long. See Figure 3 for location and Table 2 for barrier details.
