**ASSESSMENT OF STEELHEAD HABITAT  
IN UPPER MATILIJA CREEK BASIN**

*Stage One: Qualitative Stream Survey*

9 June 2003

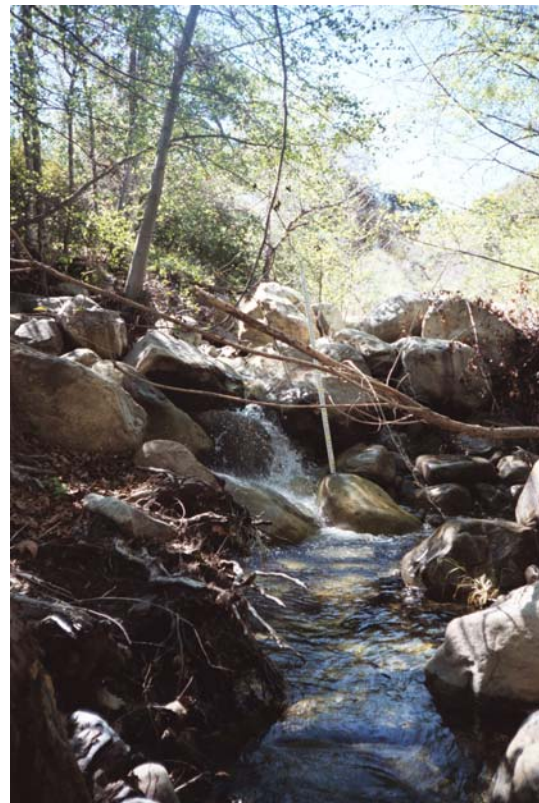
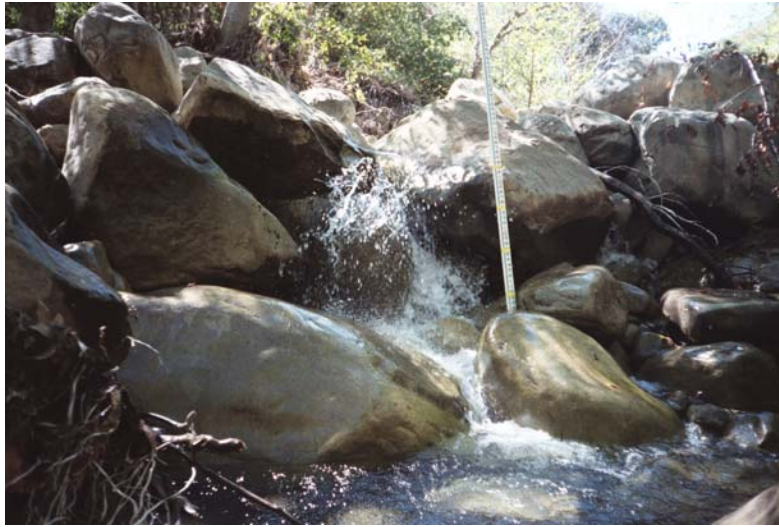
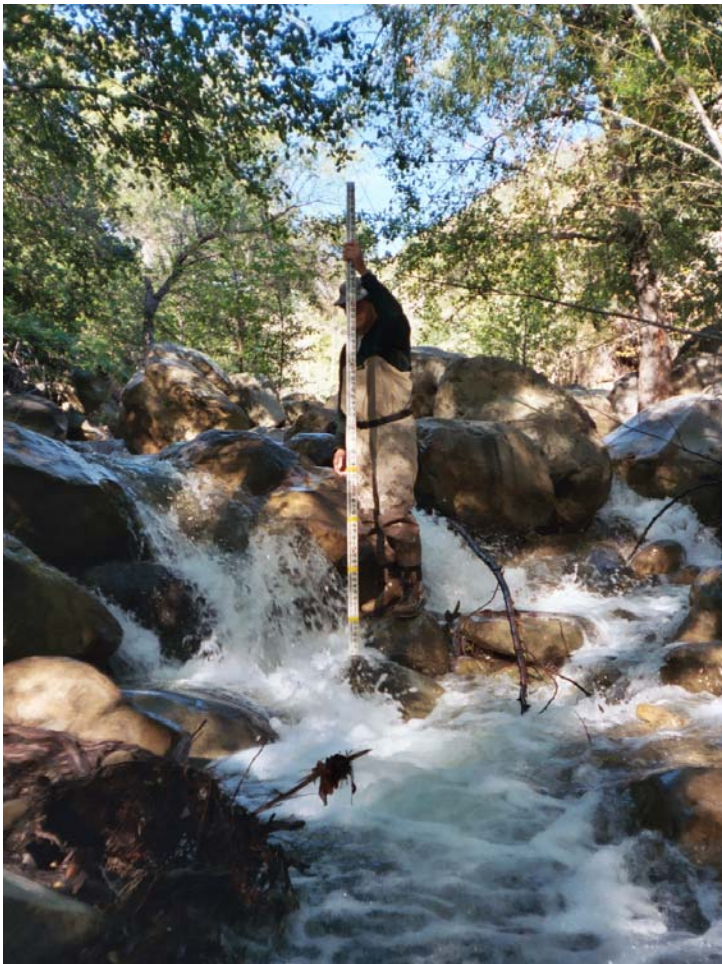
Barrier #612 in Murietta Creek. Visible portion of stadia rod is approximately 8 ft long. See Figure 3 for location and Table 2 for barrier details.

Barrier #612 in Murietta Creek. Visible portion of stadia rod is approximately 7 ft long. See Figure 3 for location and Table 2 for barrier details.

Barrier #612 in Murietta Creek, April survey. Visible portion of stadia rod is approximately 8 ft long. See Figure 3 for location and Table 2 for barrier details.

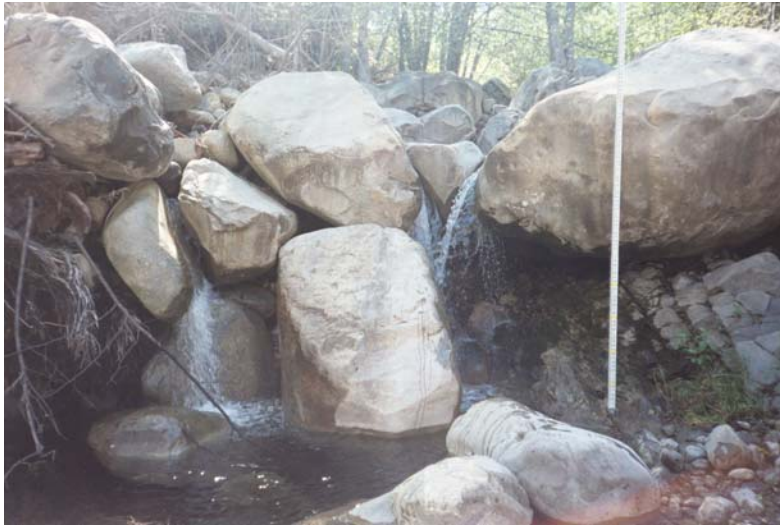
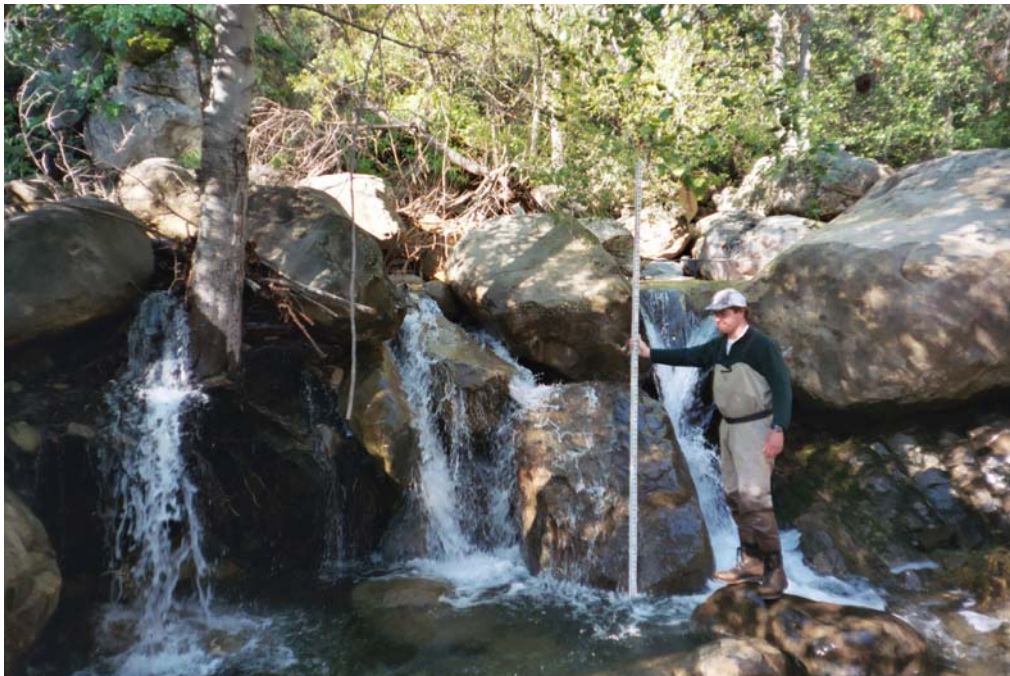
Barrier #613 in Murietta Creek. Visible portion of stadia rod is approximately 10 ft long. See Figure 3 for location and Table 2 for barrier details.

Barrier #613 in Murietta Creek, April survey. Visible portion of stadia rod is approximately 9 ft long. See Figure 3 for location and Table 2 for barrier details.

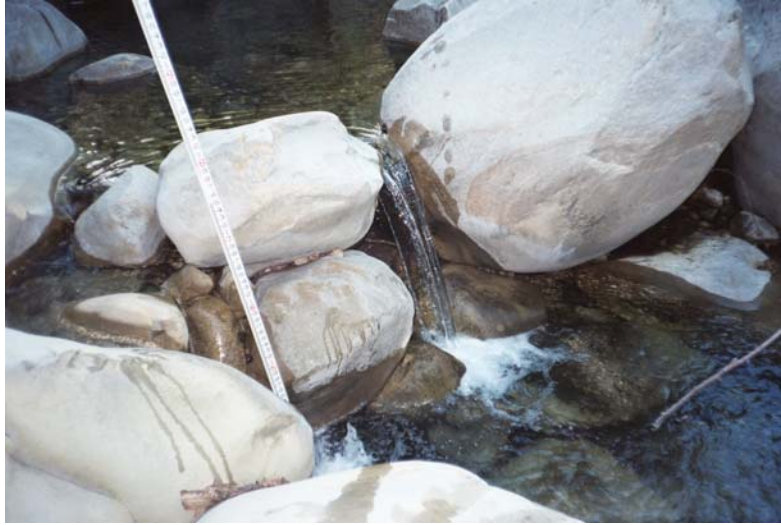
Barrier #617 in Murietta Creek. Visible portion of stadia rod is approximately 5 ft long. See Figure 3 for location and Table 2 for barrier details.

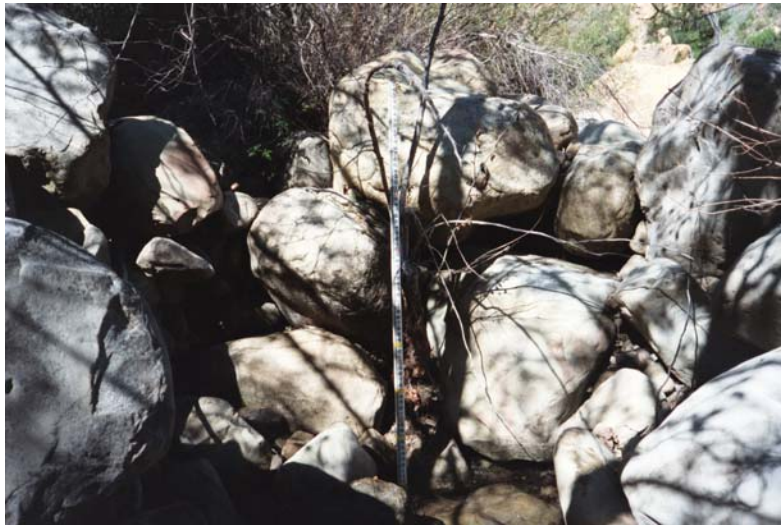
This upper reach had intermittent flow or was dry. Occasional holding pools were found to have water, but they were stagnant and choked with algae and surface flow was inconsistent. One possible barrier (barrier #622) exists halfway up this reach and a barrier initially classified as definite (barrier #625) was located near the top boundary (Figure 3, Table 2, Appendix C). The channel remained dry for approximately one-half mile above the last barrier. The dry or intermittent nature of flow in this reach suggests very poor habitat potential in most normal or dry water years. When originally evaluated barrier #625 occurred in a dry channel, however when re-visited under flowing conditions the barrier exhibited less severe passage characteristics (Table 2, Appendix C).

Barrier #622 in Murietta Creek. Visible portion of stadia rod is approximately 7 ft long. See Figure 3 for location and Table 2 for barrier details.

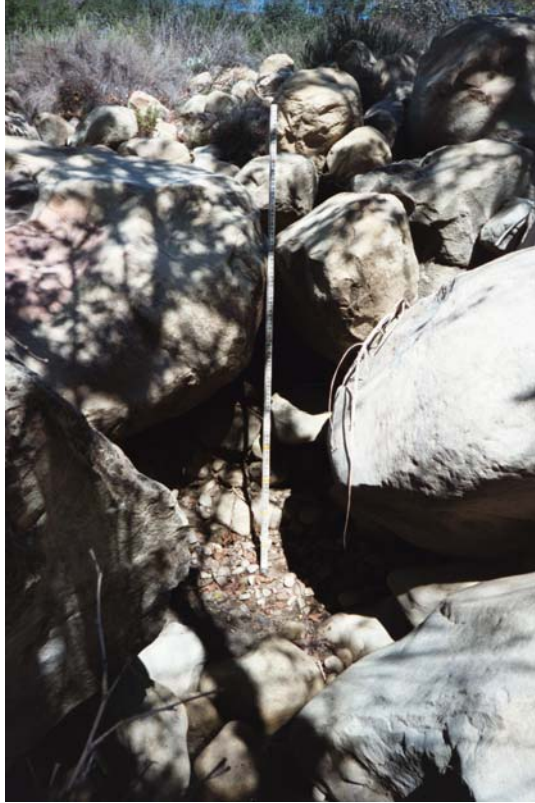
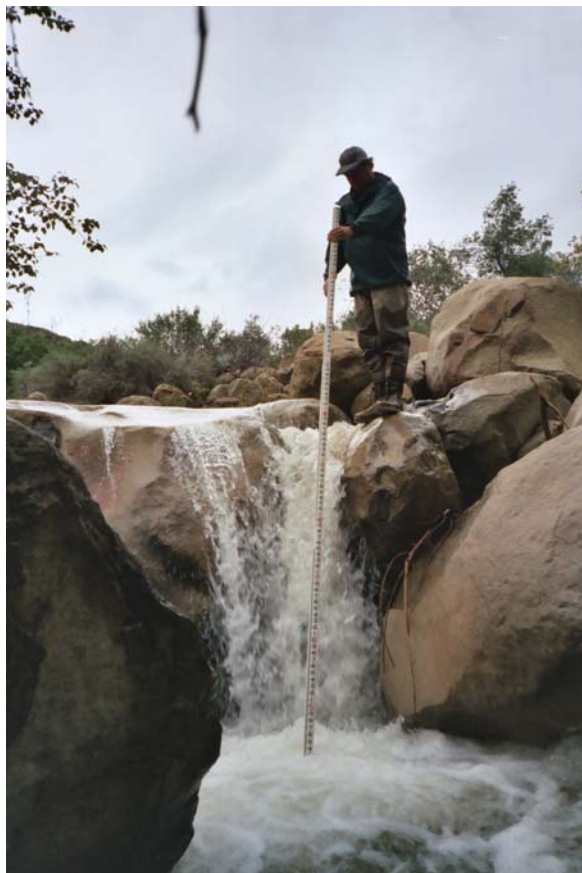
Barrier #625 in Murietta Creek.  
Visible portion of stadia rod is  
approximately 11 ft long. See  
Figure 3 for location and Table 2  
for barrier details.

Barrier #625 in Murietta Creek,  
April survey. Visible portion of  
stadia rod is approximately 10 ft  
long. See Figure 3 for location and  
Table 2 for barrier details.

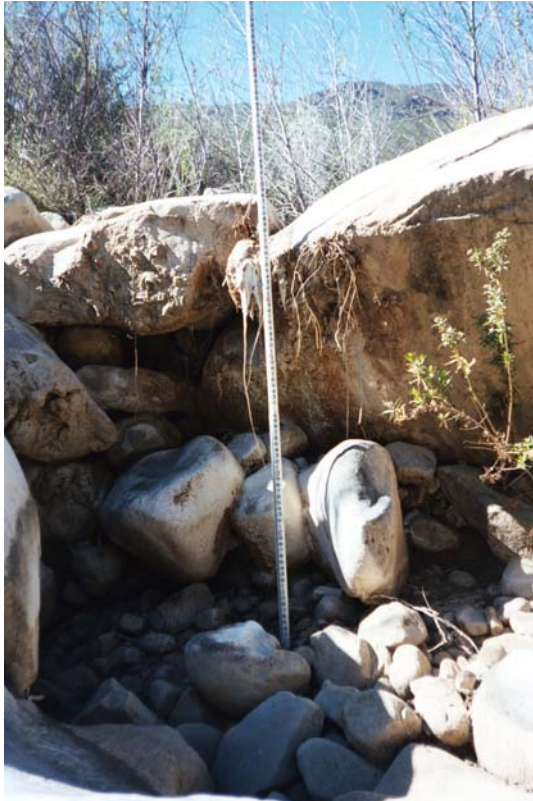
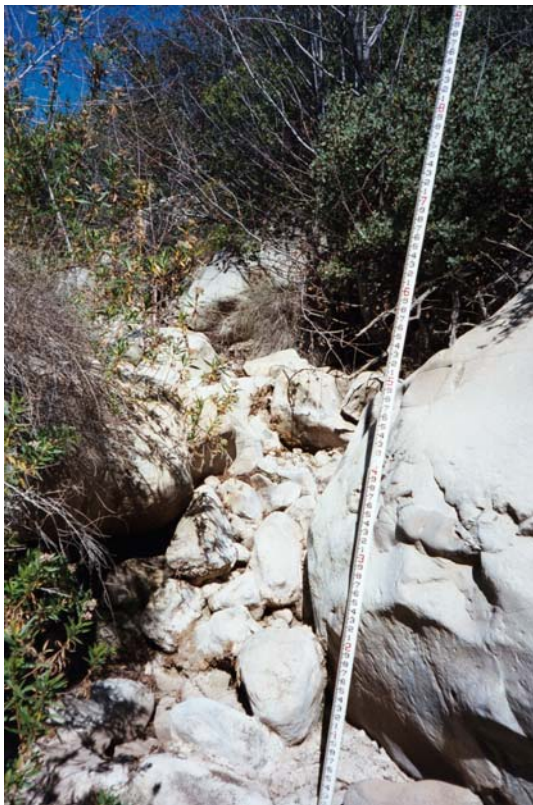
Most of this reach was completely dry making access to the rest of the stream impossible at the current flow (Table 1). Access at higher flows would probably be difficult, due to some steep cascades and falls (barrier #65, Table 2, Figure 3, Appendix C). Less than 300 ft of this reach contained intermittent flow (<0.5 cfs), and no fish observed in this portion of the stream. No spawning gravel was observed in this reach, and the overall habitat rating for this reach was poor.

Barrier #65 in Old Man Creek. Visible portion of stadia rod is approximately 11 ft long. See Figure 3 for location and Table 2 for barrier details.

Side channel around barrier #65 in Old Man Creek. Visible portion of stadia rod is approximately 9 ft long. See Figure 3 for location and Table 2 for barrier details.

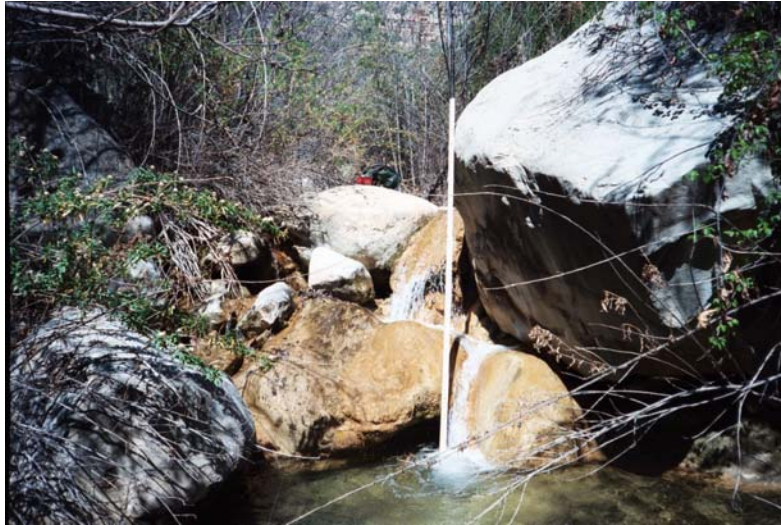
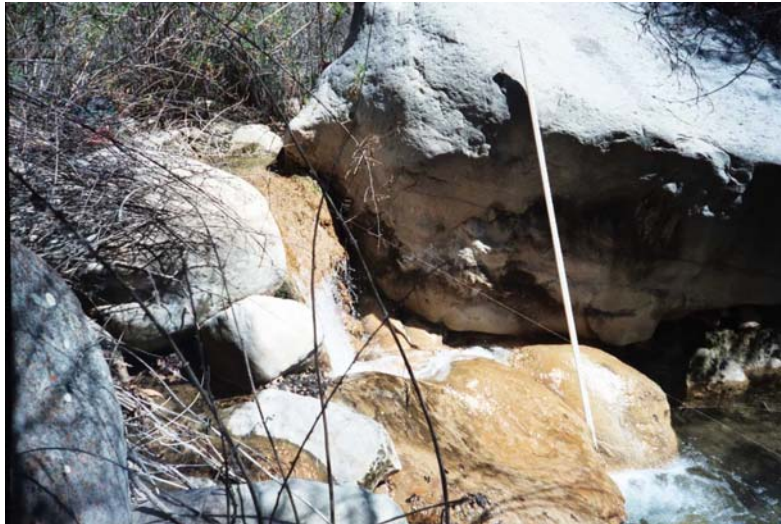
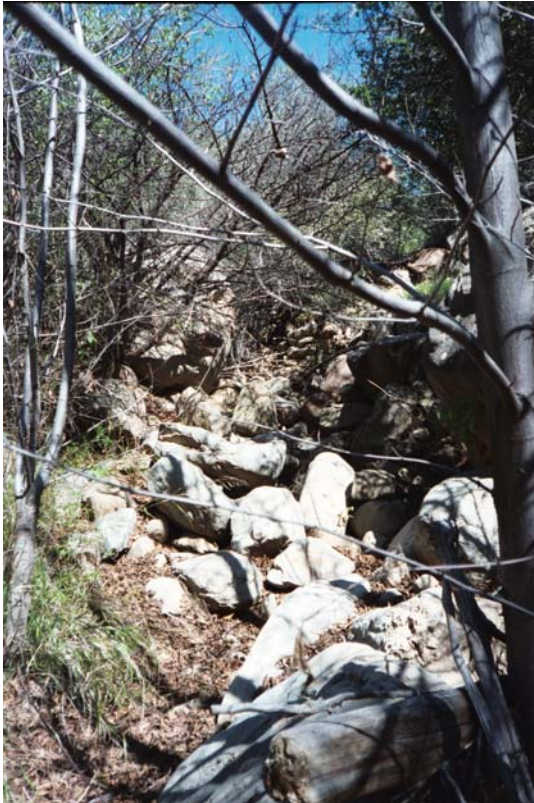
This relatively long B reach contained surface flow with good riparian forest cover and good patches of gravel (Table 1, Figures 3, 4, and 5), although some gravels were cemented. Two rainbow trout observed in this reach. Overall, the habitat rating for this reach was judged to be good, although the dry channel downstream and a possible barrier (barrier # 74, Table 2, Appendix C) could restrict access to this habitat.

Barrier #74 in Old Man Creek. Visible portion of stadia rod is approximately 9 ft long. See Figure 3 for location and Table 2 for barrier details.

Side channel around barrier #74 in Old Man Creek. See Figure 3 for location and Table 2 for barrier details.

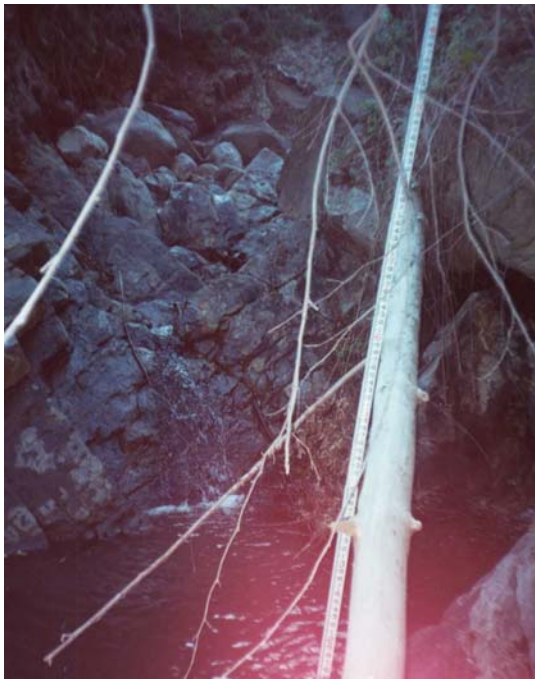
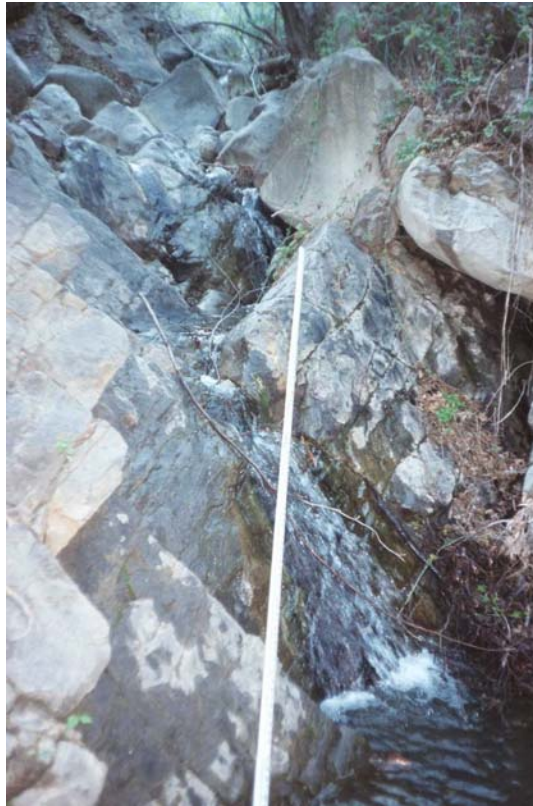
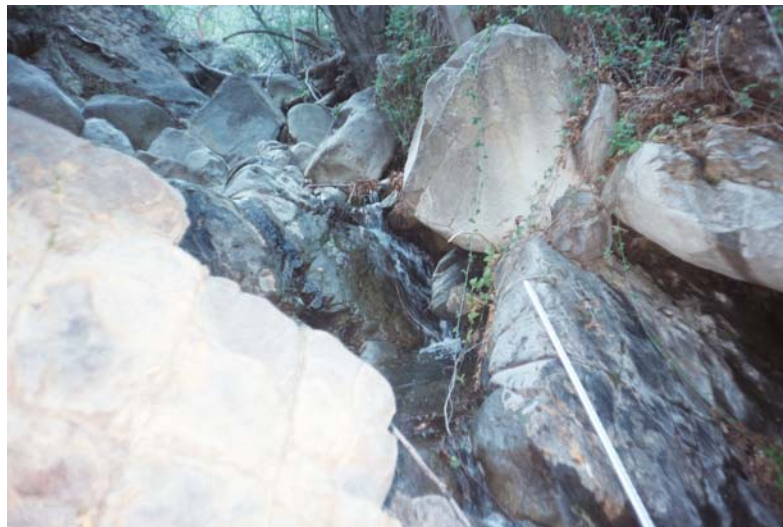
Barrier #91 in Old Man Creek. Visible portion of stadia rod is approximately 9 ft long. See Figure 3 for location and Table 2 for barrier details.

Barrier #91 in Old Man Creek. Visible portion of stadia rod is approximately 11 ft long. See Figure 3 for location and Table 2 for barrier details.

Barrier #91 in Old Man Creek. See Figure 3 for location and Table 2 for barrier details.

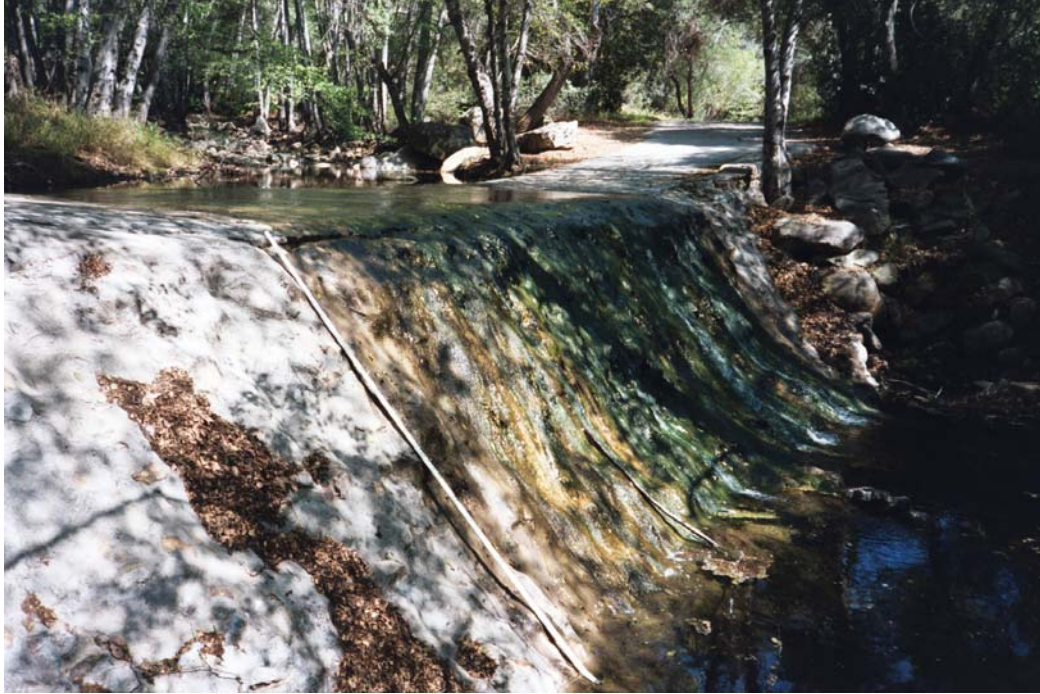
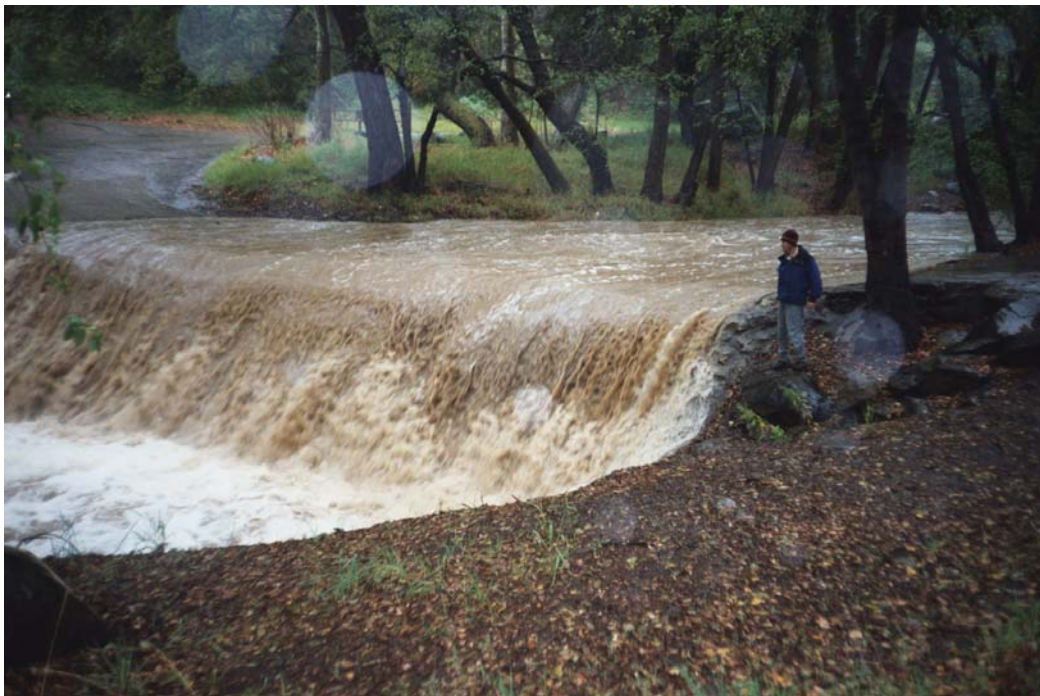
The Lower North Fork of the Matilija appeared to contain some of the best habitat for steelhead spawning and rearing within the upper basin. The majority of the channel was type B and was enclosed by riparian forest or, in Wheeler Gorge, by canyon walls (Table 1, Figure 6). Spawning gravels were very abundant and in good condition, although there was some mineral cementation in areas. Rainbow trout were frequently observed, and several redds and spawning adults were also seen during the March survey. Potential access for steelhead was good throughout most of this reach, despite some steep cascades and falls in the lower end that were expected to be passable at higher flows. There was, however, a definite man-made barrier at a road crossing in the Wheeler Gorge Campground (barrier #710, Table 2, Figure 6, Appendix C).

Barrier #710 in Lower North Fork. See Figure 6 for location and Table 2 for barrier details.

Barrier #710 in Lower North Fork during 15 March storm event. See Figure 6 for location and Table 2 for barrier details.

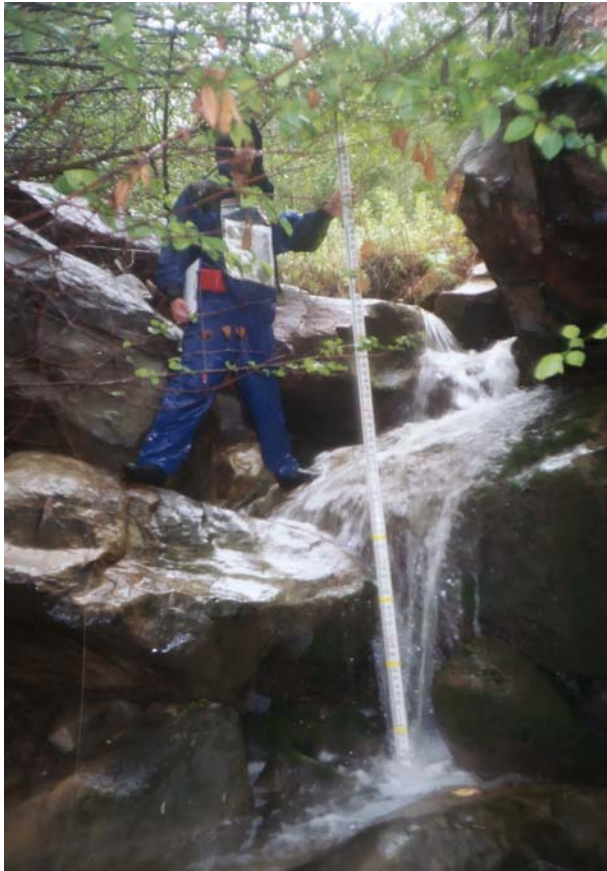
Barrier #721 on Lower North Fork, April survey. Visible portion of stadia rod is approximately 8 ft long. See Figure 6 for location and Table 2 for barrier details.

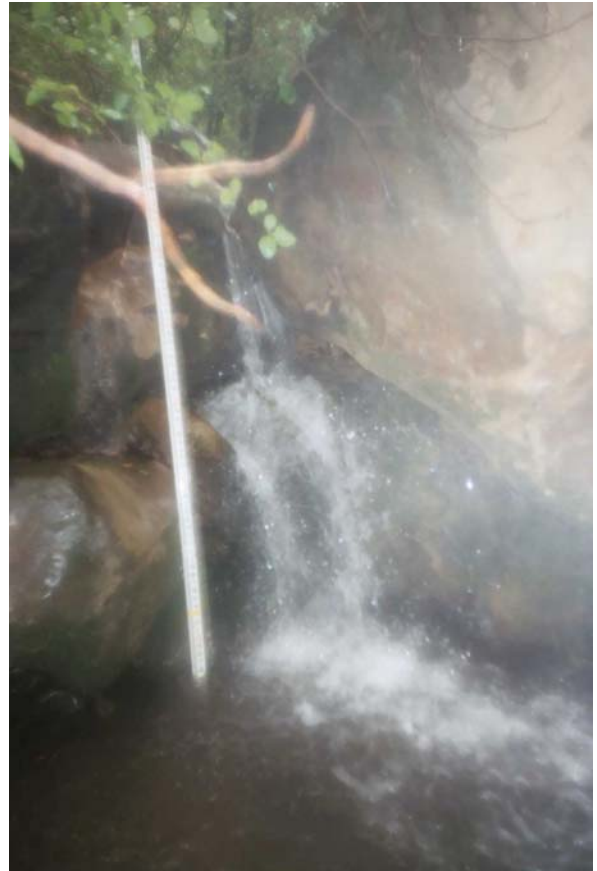
Barrier #722 on Lower North Fork, April survey. Visible portion of stadia rod is approximately 7 ft long. See Figure 6 for location and Table 2 for barrier details.
