# Appendix B

## Biological Resources Appendices

**B.1 Least Bell's Vireo Protocol Survey and Territory Mapping  
and Southwestern Willow Flycatcher Protocol Survey**

**Least Bell's Vireo (*Vireo bellii pusillus*)  
Protocol Survey and Territory Mapping  
on the Santa Clara River  
Oxnard, Ventura County, 2013**

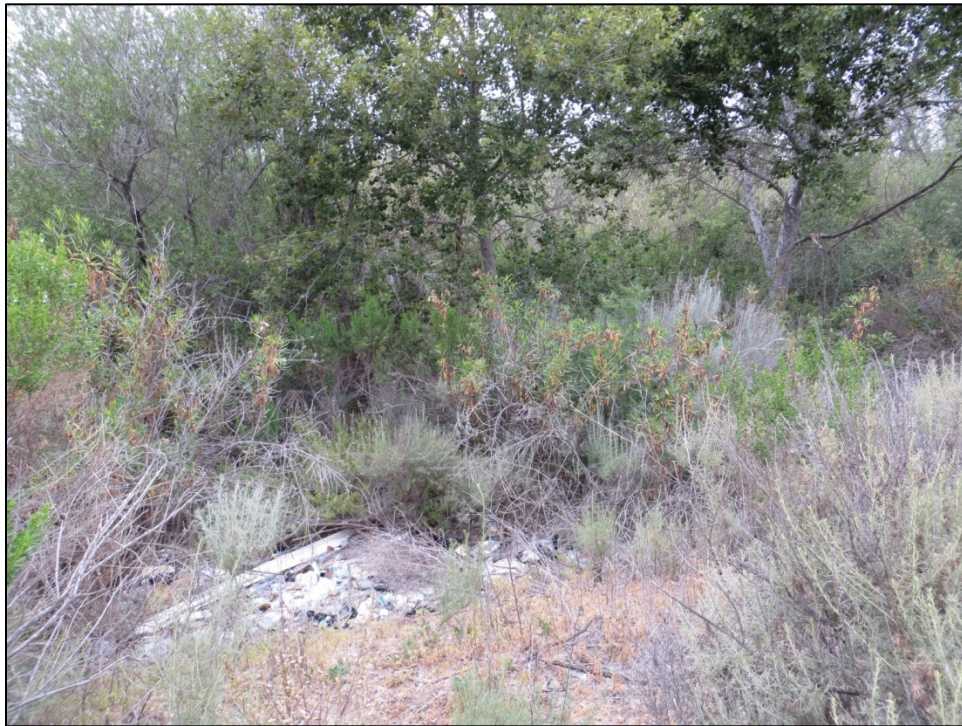
**Figure 12.** Photo of least Bell's vireo nest site in Territory 5 (April 24, 2013).  
The area in the foreground was later burned (see text).

eucalyptus (*Eucalyptus* spp.). A nest with an incubating female was located from a distance on April 25, 2013, along the terrace, 3.5 ft (1 m) above the ground in a clump of mule fat, California sagebrush (*Artemisia californica*), and Southern California black walnut (*Juglans californica*) (Figure 12). There was no apparent activity at the nest site during the following visit on May 4, and on May 16, the nest was confirmed to have failed, containing one broken egg. However, fledglings were later seen in the territory on June 18 and July 1.

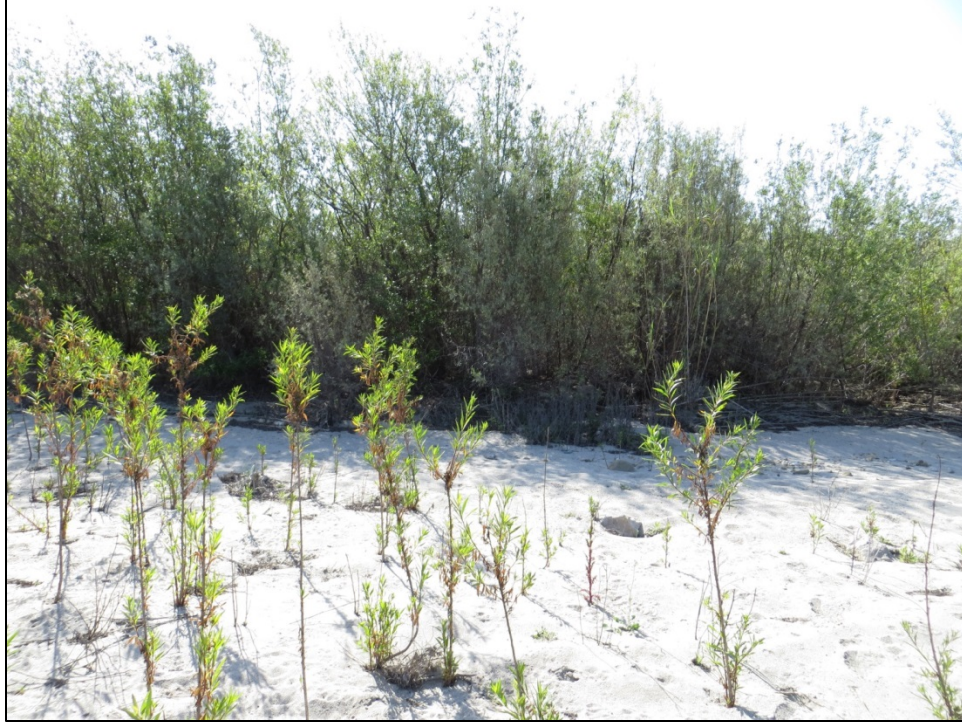
**Figure 13.** Photo of Territory 7 nest stand with young arroyo willow, red willow, sandbar willow, and mule fat (April 25, 2013).

Vireos were detected in Territory 7 during all surveys. A singing male's location was followed on April 25, 2013, and the bird was found to be singing while incubating unknown nest contents on April 25. The nest was 5 ft (1.5 m) above the ground in a dense stand of young arroyo willows. Non-intrusive observation was possible because the nest was 15 ft (5 m) from the open sandy river bottom (Figures 13 through 15). The nest was quickly checked for activity while passing by on subsequent visits, and 1 or more large nestlings were observed on May 16, followed by a fledgling located nearby on May 28. Vegetation in the territory consisted of an early seral stage arroyo willow thicket with red willow, sandbar willow (*Salix exigua*), and mule fat at river-level.

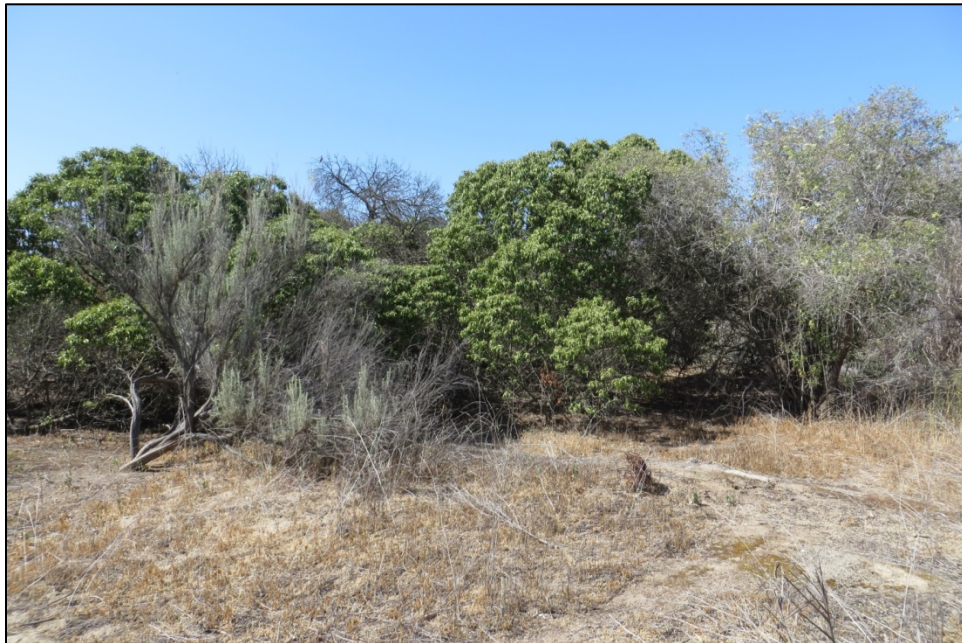
**Figure 18.** Photo of Territory 9 nest site for both nests found there (May 28, 2013).

A male was observed singing in Territory 9 on April 12 and April 26, 2013. On May 5 he was accompanied by a female that was building a nest 4 ft (1.2 m) above the ground in a thicket of blue elderberry and arundo. By the following visit on May 18, the pair had abandoned the original nest and had built a new nest 50 ft (15 m) away, 4 ft (1.2 m) above the ground in a myoporum (*Myoporum laetum*), on which the incubating female now sat. On May 28, the adults were delivering food to nestlings. On June 10 the nest was empty, and the parents were observed feeding at least 2 fledglings on June 20 and July 1. Territory 9 was located on a slight terrace 6 ft (2 m) above the adjacent river channel,

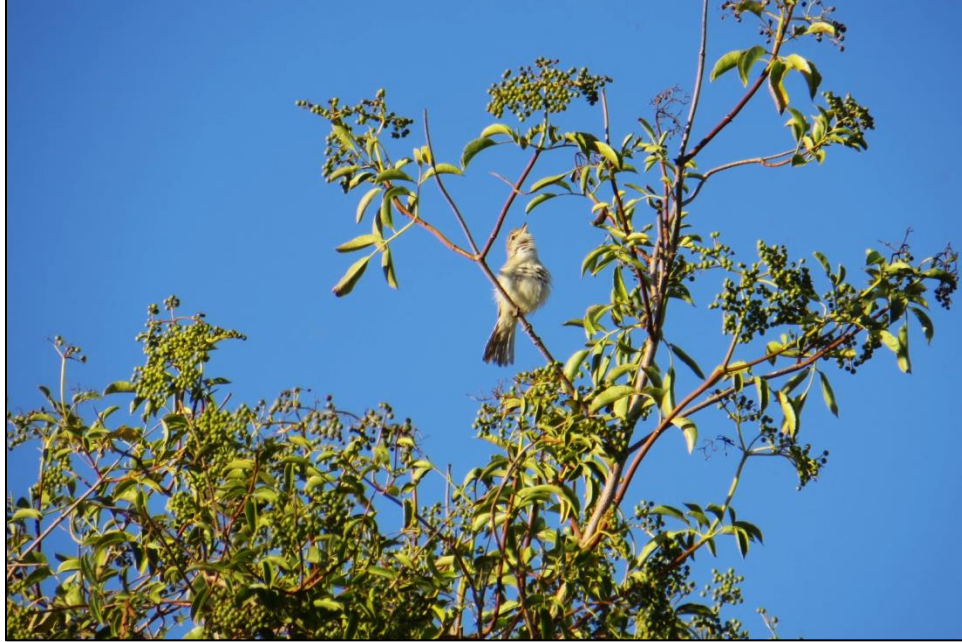
**Figure 19.** Photo of singing male least Bell's vireo in a blue elderberry in Territory 10 (May 29, 2013).

These two territories are described together because of their proximity and the shifting boundaries through the season. Only one resident vireo was observed consistently (within Territory 10), during most surveys (Figure 19). Vegetation in Territories 10 and 11 was similar to that of Territory 9: willows along the river edge with patchy blue elderberries codominant with Southern California black walnuts and interspersed with the upland scrub species described for Territory 9. On April 26, 2013, a singing vireo was observed in the general area covering Territories 10 and 11. During the following visit on May 5, three singing males were behaving territorially within distinct areas, while one of these birds started to build a nest in the area described as Territory 10 within a poison oak thicket under a blue elderberry. No female was observed with this male. During the following visit on May 18, two singing males were observed, each within the approximate polygons illustrated in Figure 9 as Territories 10 and 11. The approximate dividing line between the territories was the access road running north to south. The nest observed during the previous visit had fallen and was not much more than a loosely woven outline. This nest was determined to be a false nest (Kus et al. 2010) because only one bird was observed building it and extensive observation indicated that this vireo was unmated. The vireo in Territory 11 was observed for a final time on May 29 and not detected thereafter. The vireo in Territory 10 continued to sing regularly throughout the territory during all subsequent visits except on June 21 when it was not detected. It was never observed to be paired with any other female or young vireos that would indicate a mated status or breeding attempt. This bird had a brief notable encounter on July 15 with another vireo moving through the territory. It encountered the second bird at the south edge of Territory 10 and performed a courtship display similar to the pre-copulatory display described by Kus et al. (2010) for about 20 seconds. The second bird appeared unresponsive and continued on its way, exiting the territory and flying downriver.

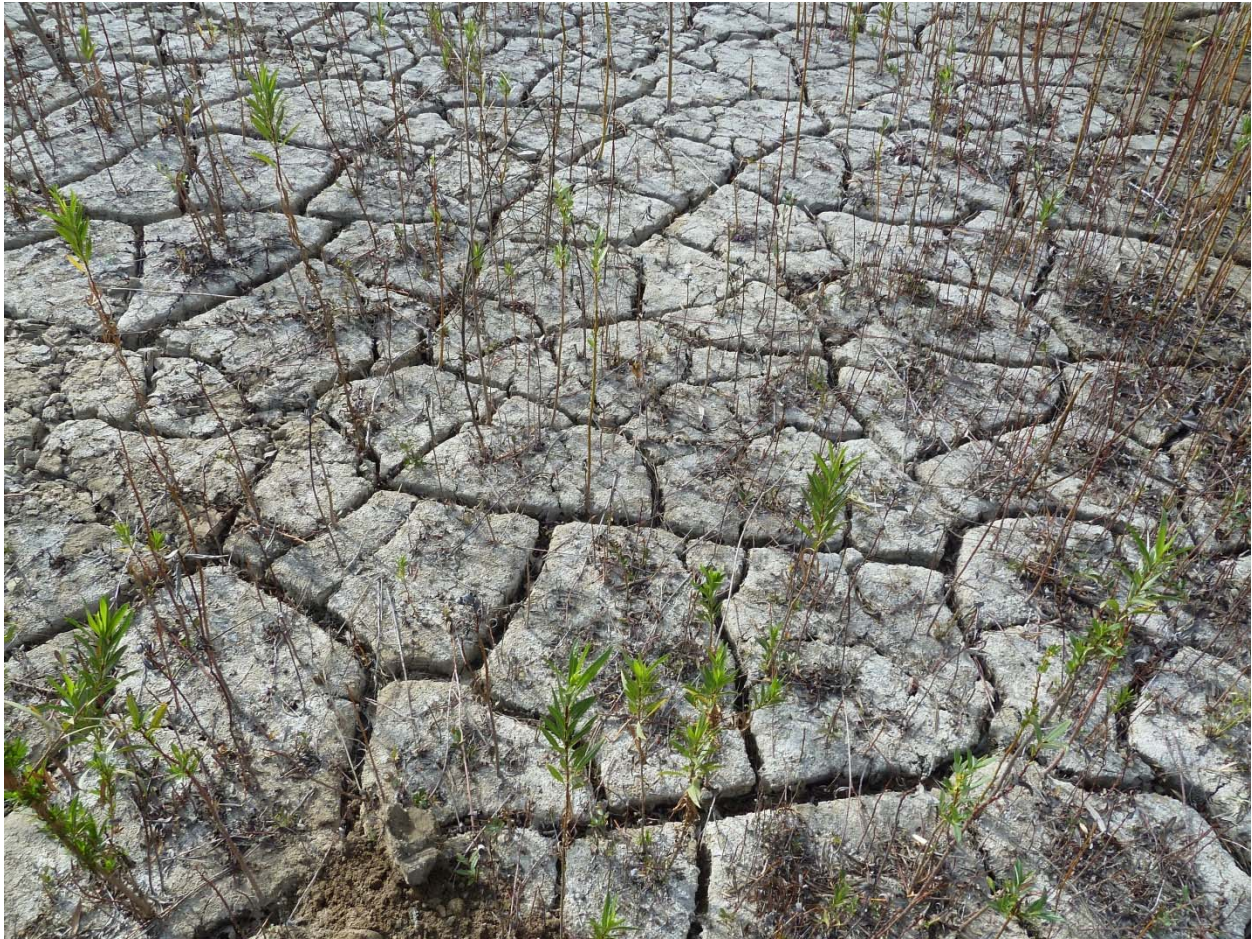
**Photo 1 - View of cracked soils near T4 P3S. This soil pit is adjacent to the downstream-most bendway weir constructed by the District in 2012. The bendway weirs are designed to slow river flows, encourage deposition between pairs of weirs, and promote scouring and pond formation at their tips. The weirs are encased in sheetpile driven approximately 35 feet deep, and thus also encourage groundwater to rise toward the ground surface along their upstream edge.**

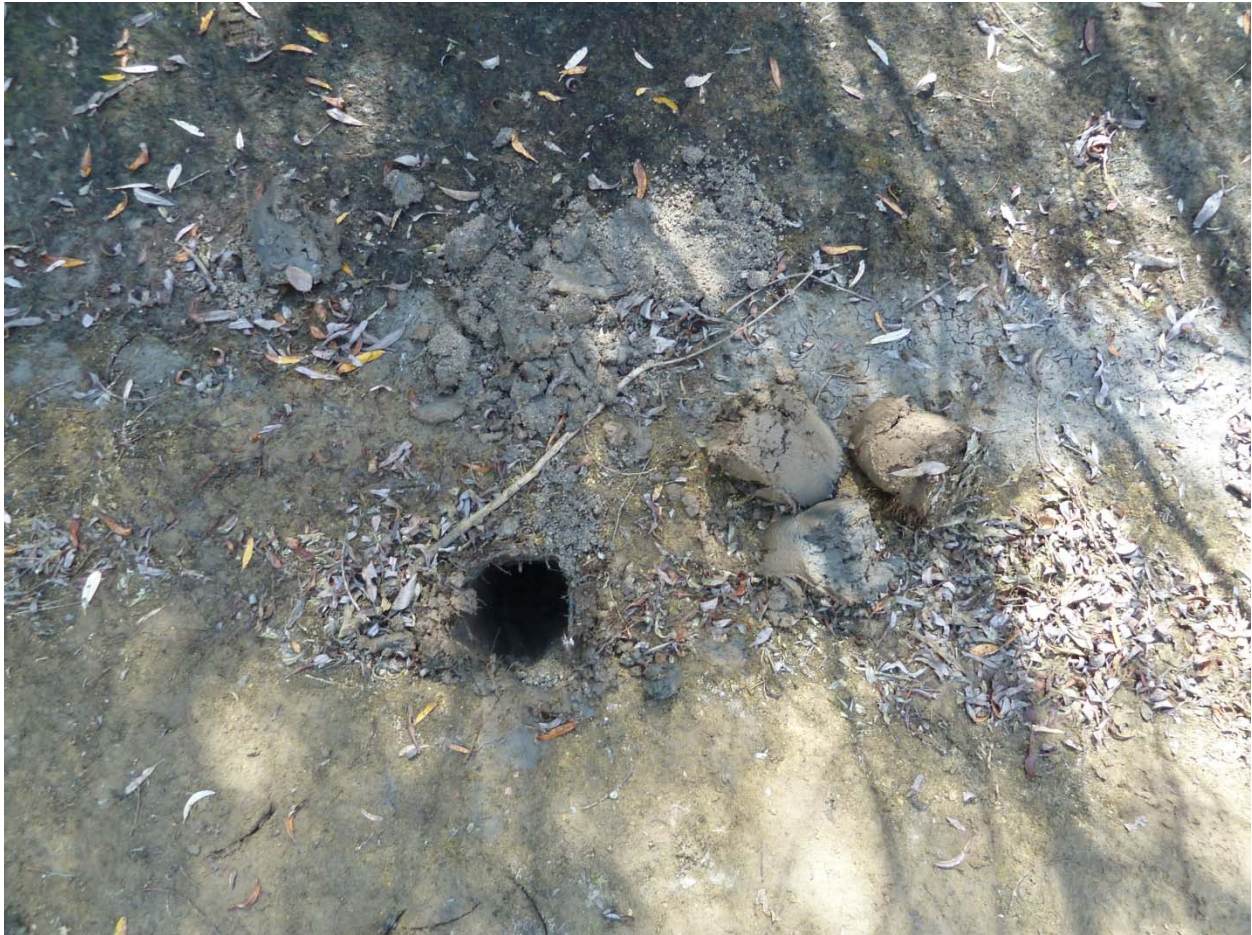
**Photo 2 - View of T6 P3S; it was determined that this soil pit occurred in a wetland. For additional information refer to the data sheets in Attachment 4.**
