**FEMA Levee Certification
Ventura County, California**

**Santa Clara River Levee (SCR-1)
Highway 101 to Saticoy**

**Evaluation Report
February 13, 2009**

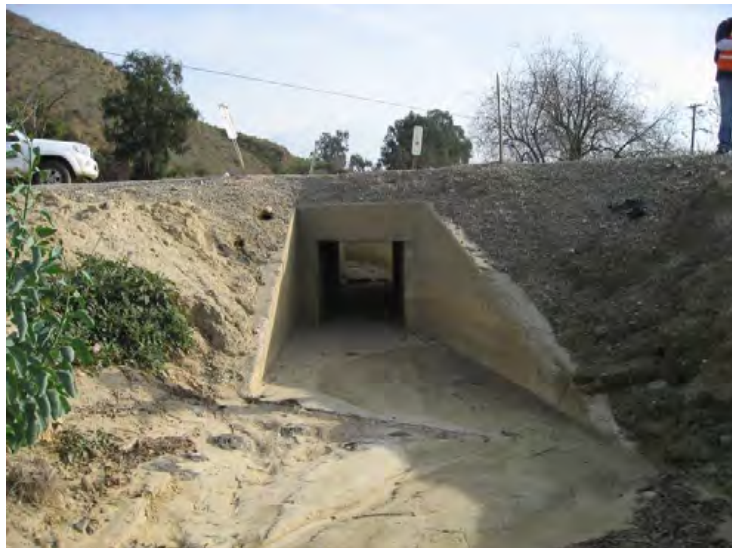
Santa Clara River Levee, From Hwy 101 to Saticoy. (Photo No. P1 – Side drain 1-A, 4' x 4' R.C.B located at upstream end of levee (riverward side)

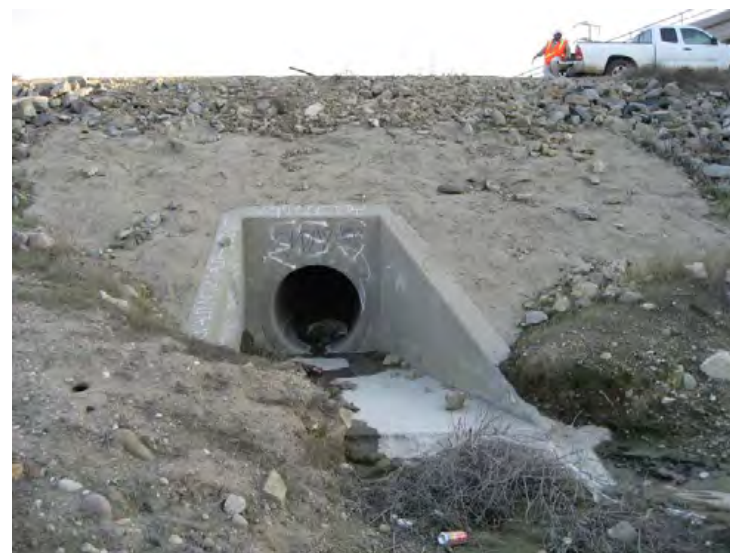
Santa Clara River Levee, From Hwy 101 to Saticoy. (Photo No. P3) – Side Drain No. 2, 48\"/>

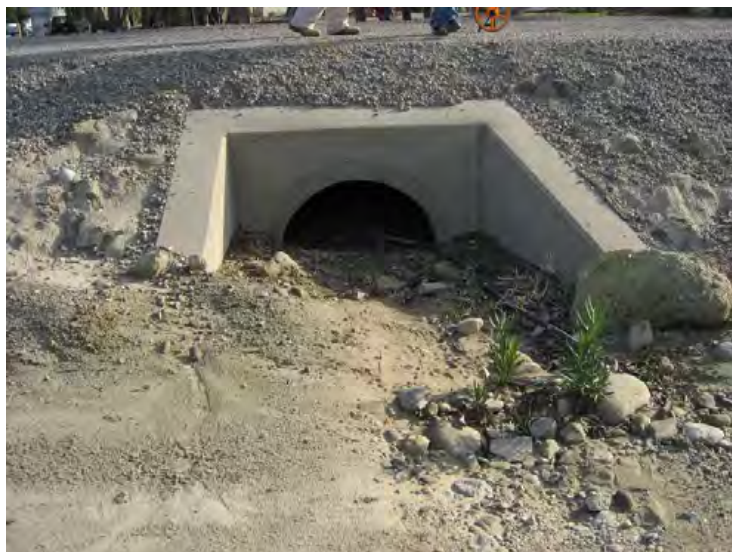
Santa Clara River Levee, From Hwy 101 to Saticoy. (Photo No. P2) – Side Drain No. 1, 42\"/>

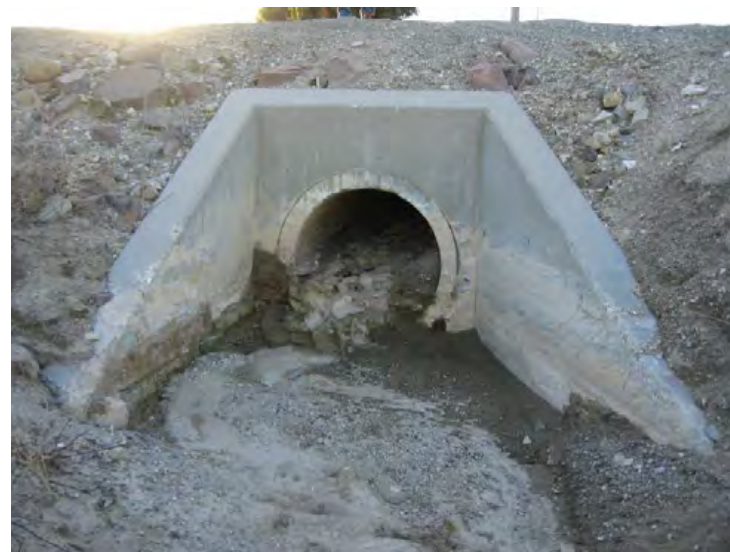
Santa Clara River Levee, From Hwy 101 to Saticoy. (Photo No. P4) – Side Drain No. 3, 48\"/>

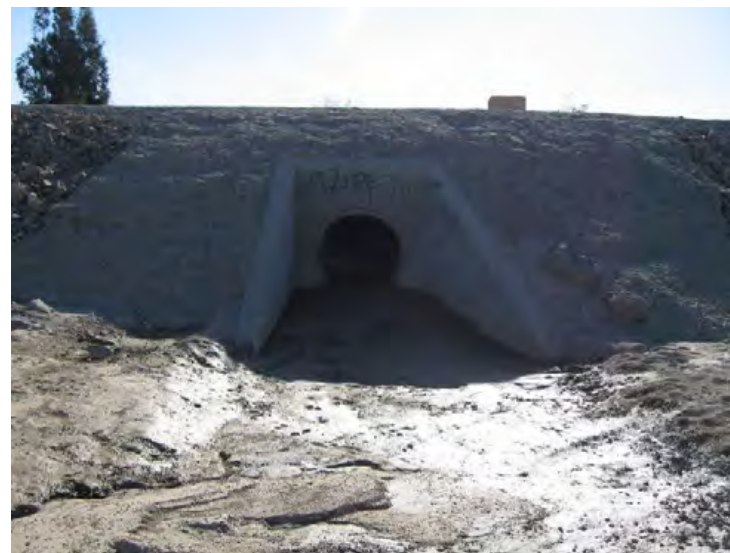
Santa Clara River Levee, From Hwy 101 to Saticoy. (Photo No. P7) – Side Drain No. 4, 48” RCP (riverward side)

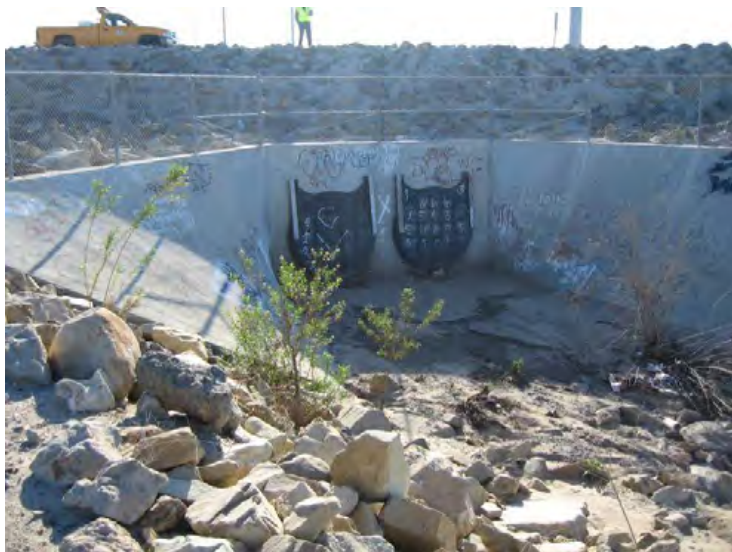
Santa Clara River Levee, From Hwy 101 to Saticoy. (Photo No. P6) – Central Avenue Drain, 2-72” RCP with flap gates (riverward side)

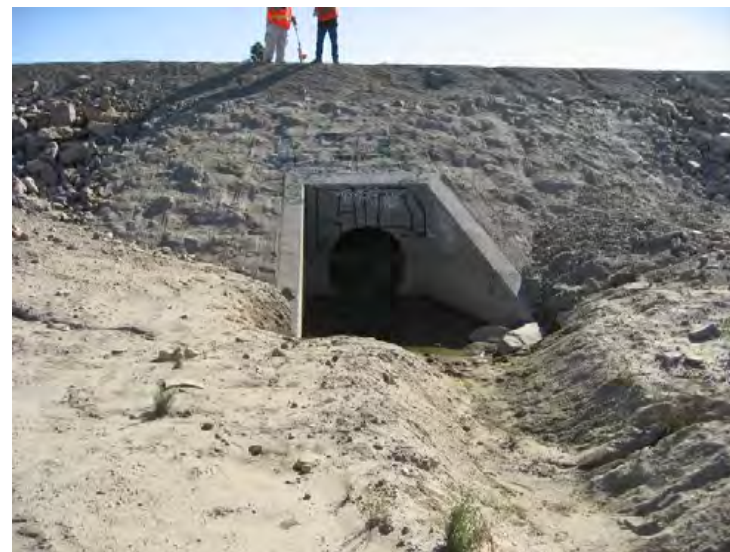
Santa Clara River Levee, From Hwy 101 to Saticoy. (Photo No. P8) – Side Drain No. 6, 48” RCP

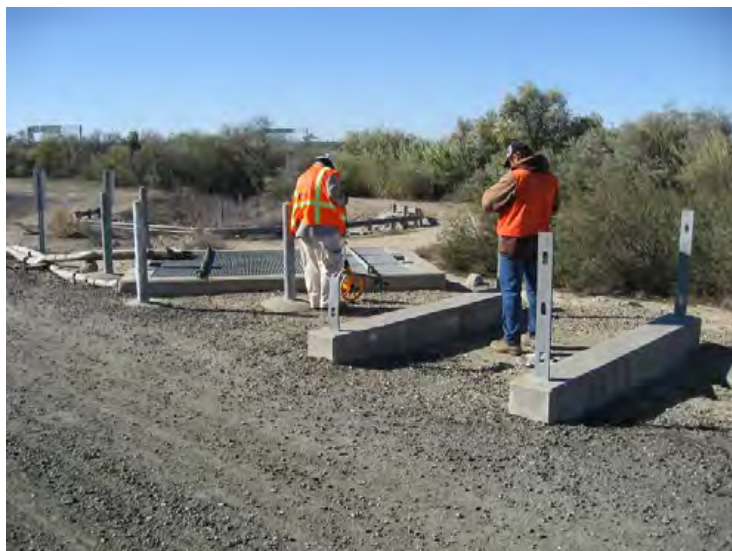
Santa Clara River Levee, From Hwy 101 to Saticoy. (Photo No. P9) –
Stroube Drain – Unit I, Stop Log Structure looking downstream

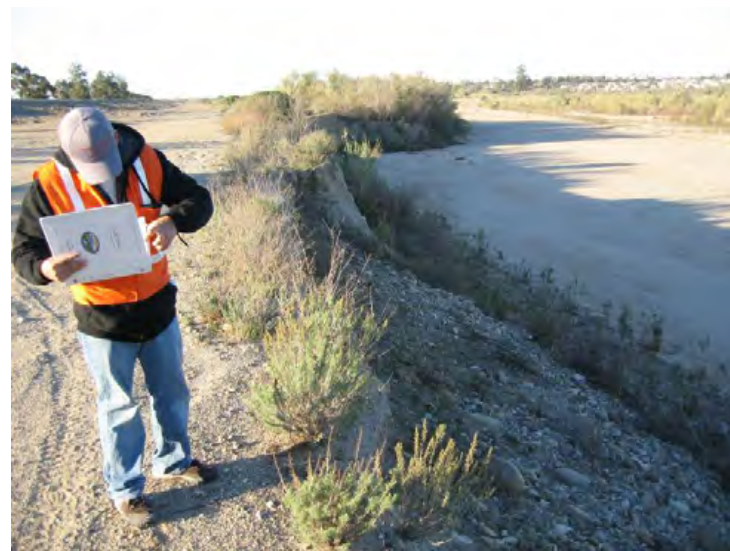
Santa Clara River Levee, From Hwy 101 to Saticoy. (Photo No. F1) –
20' -25' high erosion cut eroding towards levee, looking d/s (riverward)

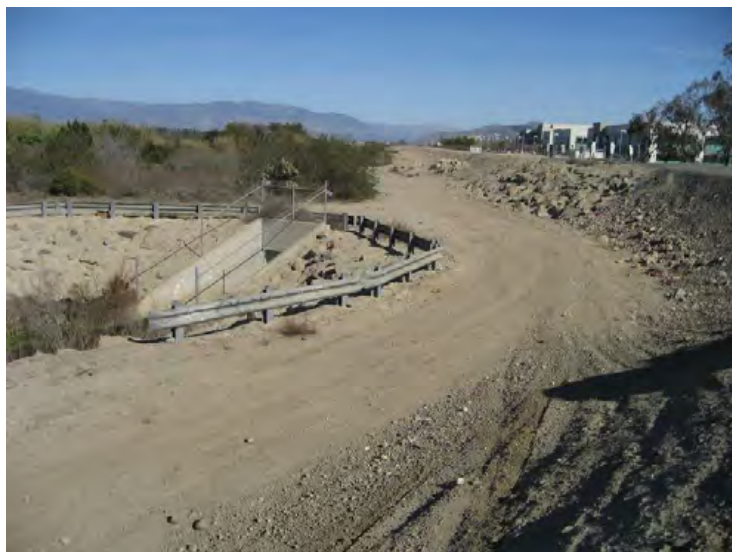
Santa Clara River Levee, From Hwy 101 to Saticoy. (Photo No. P10) –
Stroube Drain – Unit I, 10'Wx8'H RCB looking upstream

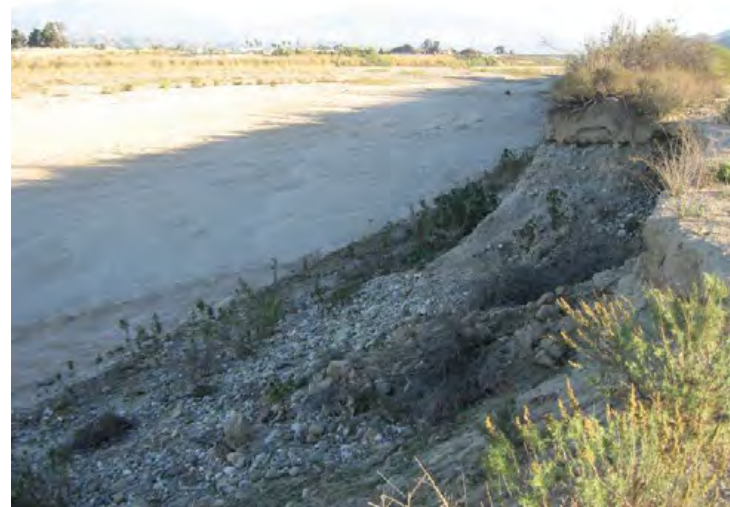
Santa Clara River Levee, From Hwy 101 to Saticoy. (Photo No. F2) –
20' -25' high erosion cut eroding towards levee, looking u/s (riverward)

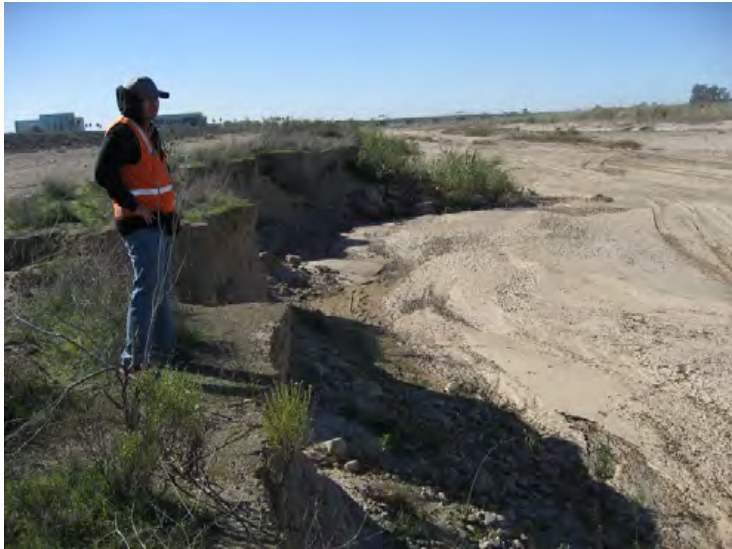
Santa Clara River Levee, From Hwy 101 to Saticoy. (Photo No. F3) – Erosion cut eroding towards levee exposing groins, looking d/s (riverward)

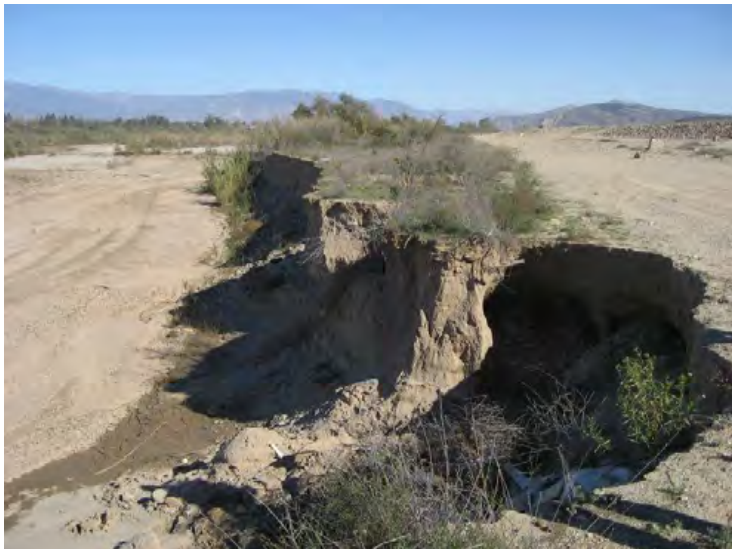
Santa Clara River Levee, From Hwy 101 to Saticoy. (Photo No. F4) – Erosion cut eroding towards levee exposing groins, looking u/s (riverward)

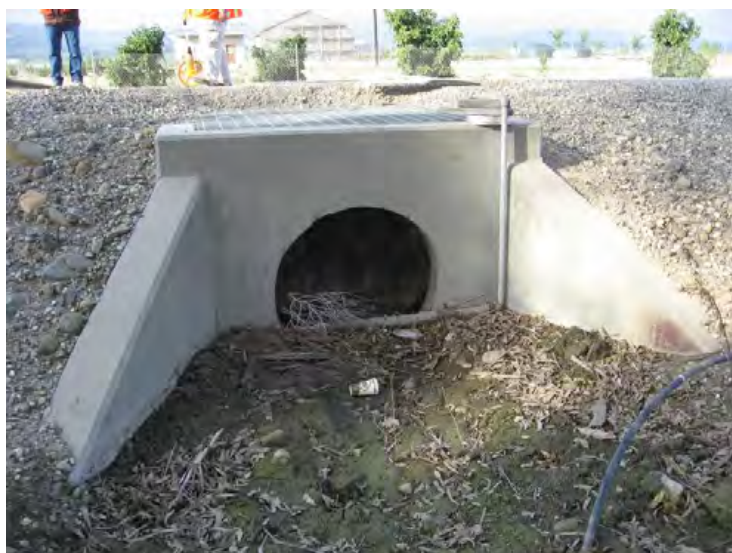
Santa Clara River Levee, From Hwy 101 to Saticoy. (Photo No. M5) – Sediment deposition in Side Drain No. 1, 42” RCP inlet (landward side)

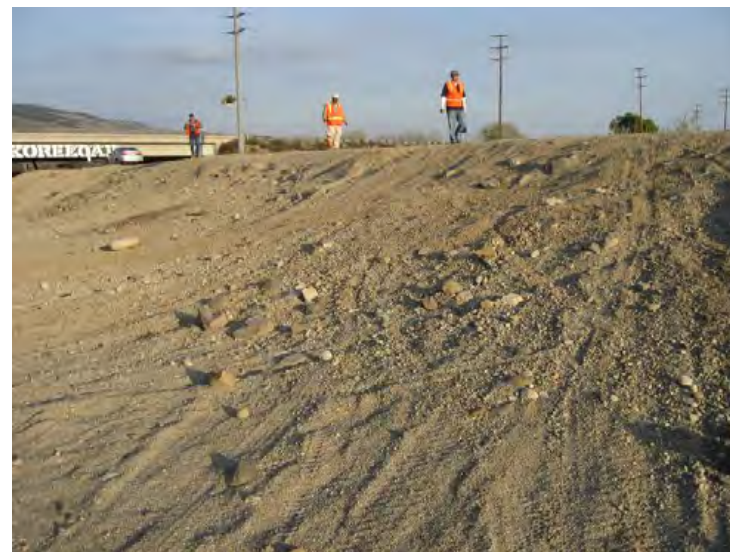
Santa Clara River Levee, From Hwy 101 to Saticoy. (Photo No. M12) –
Erosion of levee embankment just downstream of L.A. Ave.(riverward side)

M11, M12	Levee embankment erosion (riverward side)	Reestablish levee embankment and fill voids with impervious material and firmly compact	C1/C4, or C5 - fencing needed, redesign needed?, How do we stop the vehicle issue?	E2	Excavate & recompact existing levee, in kind		Definition of impervious material	Erosion should be repaired as indicated with in-kind material and documented. Documentation of the removal and replacement/re-compaction of the impacted material shall be conducted by a certified testing and materials lab that the District is familiar with. The documentation shall include a report provided by the testing and materials lab. AMEC will periodically observe these locations and will require a copy of the report for documentation and review. In-kind backfill would be materials free of organic or deleterious debris that has similar or lower permeability than the levee material. These materials could consist of excavated soil, imported soil, concrete, or slurry, and shall be evaluated by the testing and materials lab. compaction requirements are detailed on the attached Figure 1. Major repair examples include any erosion feature that is deeper than 1 foot or that is greater than 2 feet wide. Additionally, revetment protection evaluation including rock sizing analysis should be incorporated in repair of revetment material. Additionally, revetment protection evaluation including rock sizing analysis should be incorporated in repair of revetment material.

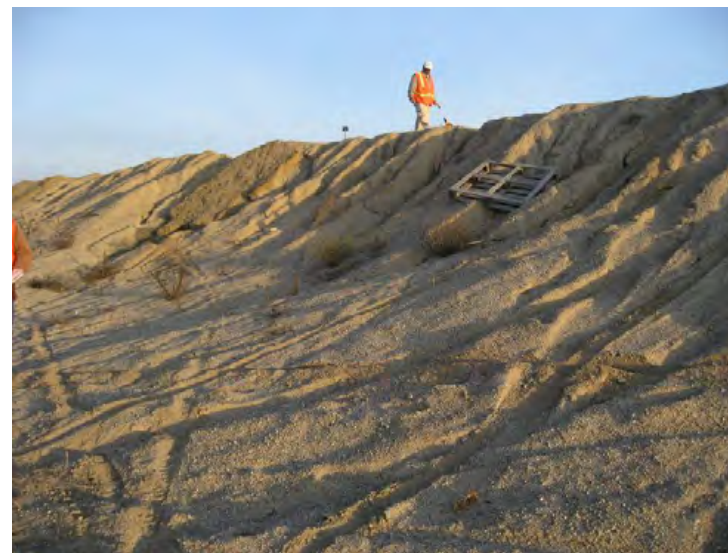
Santa Clara River Levee, From Hwy 101 to Saticoy. (Photo No. M15) –
Erosion of levee embankment, looking upstream (riverward side)

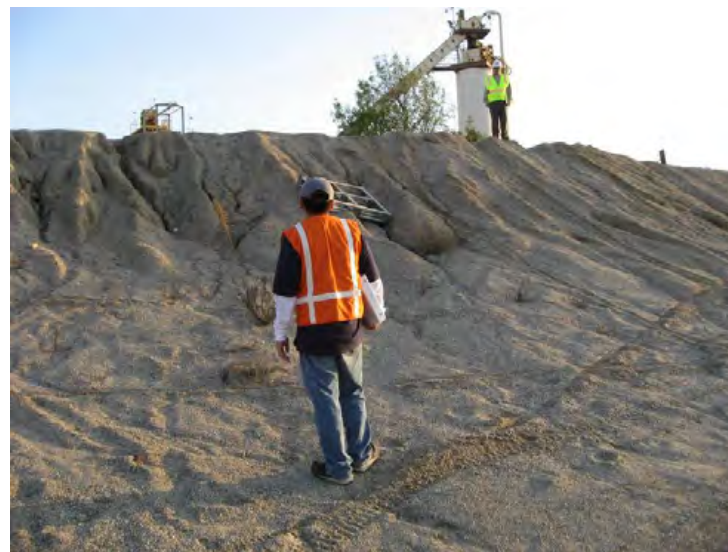
Santa Clara River Levee, From Hwy 101 to Saticoy. (Photo No. M16) –
Erosion of levee embankment, adjacent to asphalt plant (riverward side)

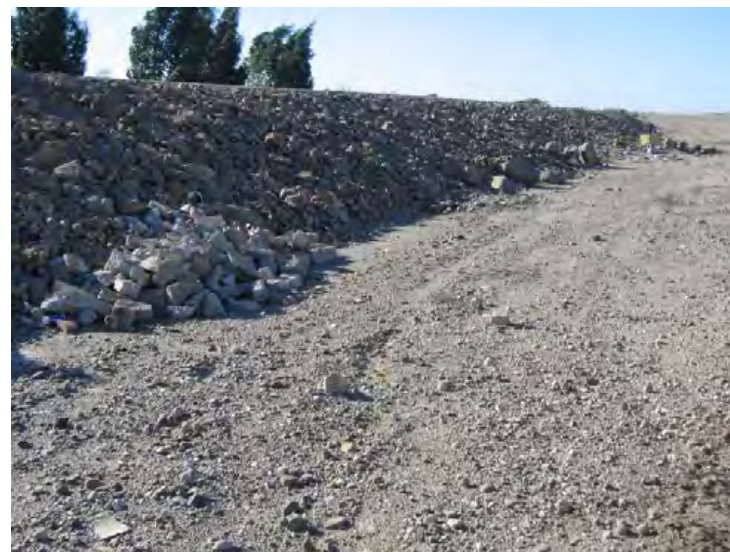
Santa Clara River Levee, From Hwy 101 to Saticoy. (Photo No. M28) –
Debris along levee toe, looking downstream (riverward side)

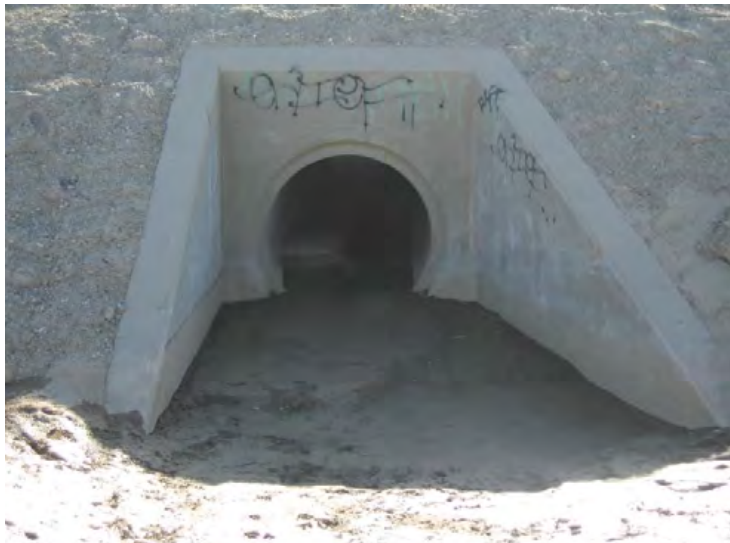
Santa Clara River Levee, From Hwy 101 to Saticoy. (Photo No. M29) –
Sediment deposition in Side Drain No. 6, 48" RCP outlet (riverward side)

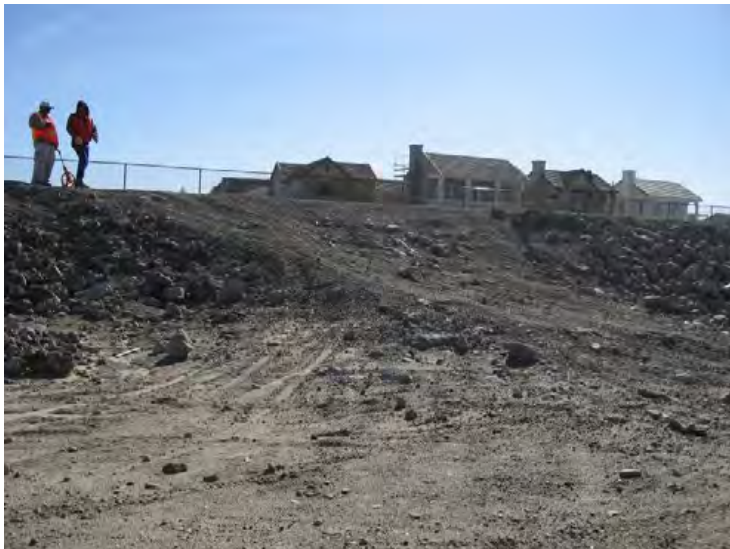
Santa Clara River Levee, From Hwy 101 to Saticoy. (Photo No. M30) –
Unauthorized ramp on levee (riverward side)

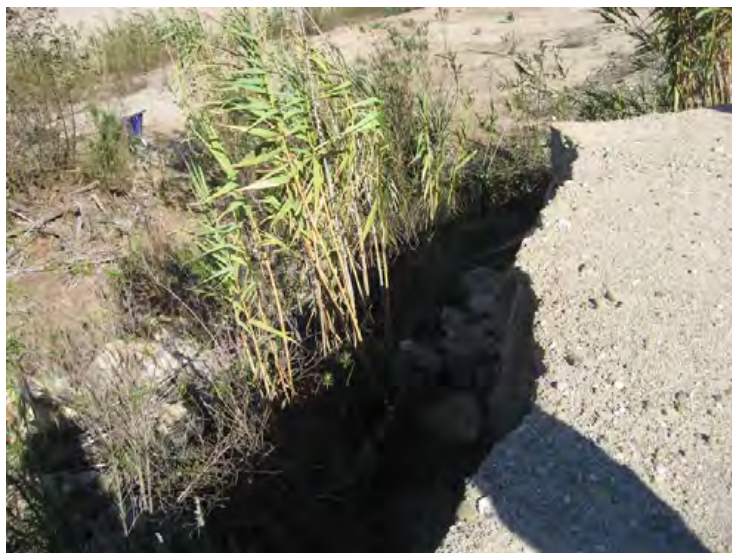
Santa Clara River Levee, From Hwy 101 to Saticoy. (Photo No. M33) – Exposure of tip of buried groin looking downstream (riverward side)

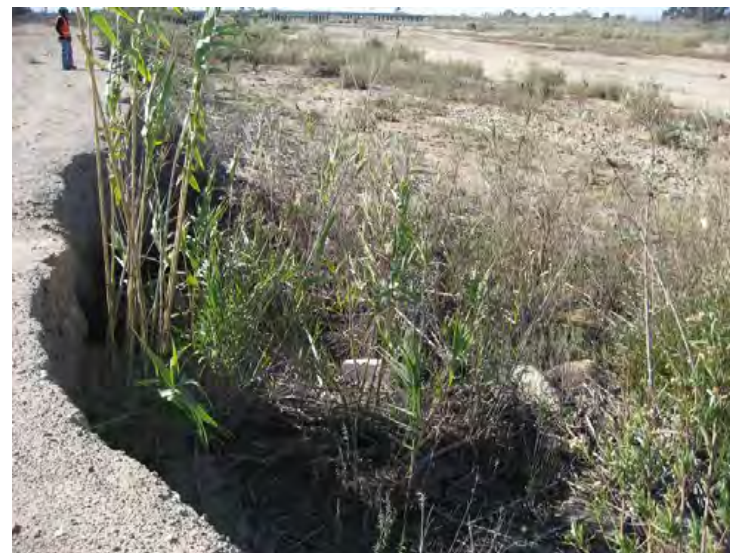
Santa Clara River Levee, From Hwy 101 to Saticoy. (Photo No. M35) – Exposure of tip of buried groin looking downstream (riverward side)

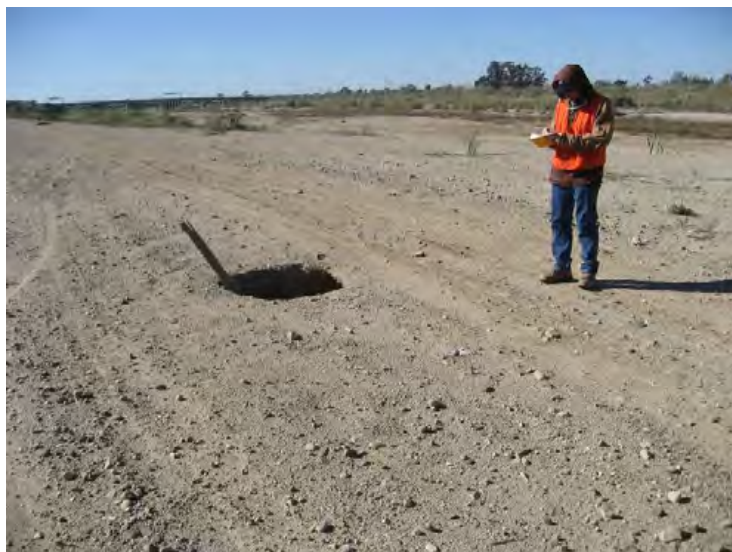
Santa Clara River Levee, From Hwy 101 to Saticoy. (Photo No. M34) – Sink hole in soil covering buried groins looking down/s (riverward side)

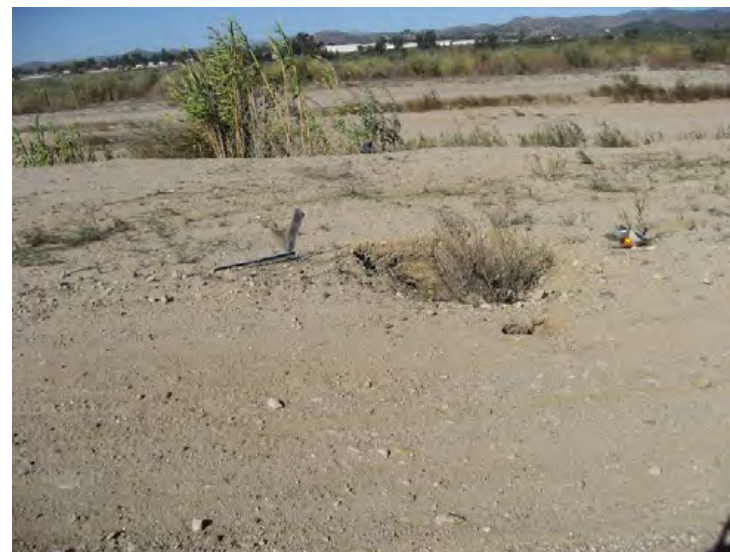
Santa Clara River Levee, From Hwy 101 to Saticoy. (Photo No. M36) – Sink hole in soil covering buried groins (riverward side)

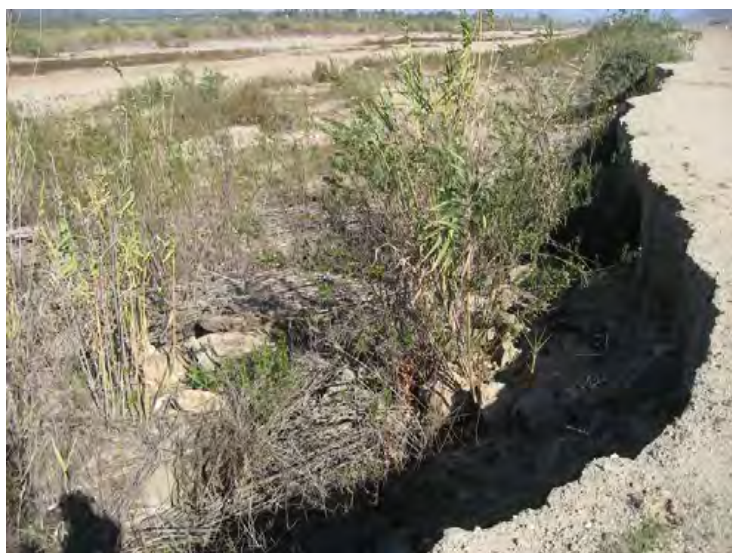
Santa Clara River Levee, From Hwy 101 to Saticoy. (Photo No. M37) – Exposure of tip of buried groin, looking upstream (riverward side)

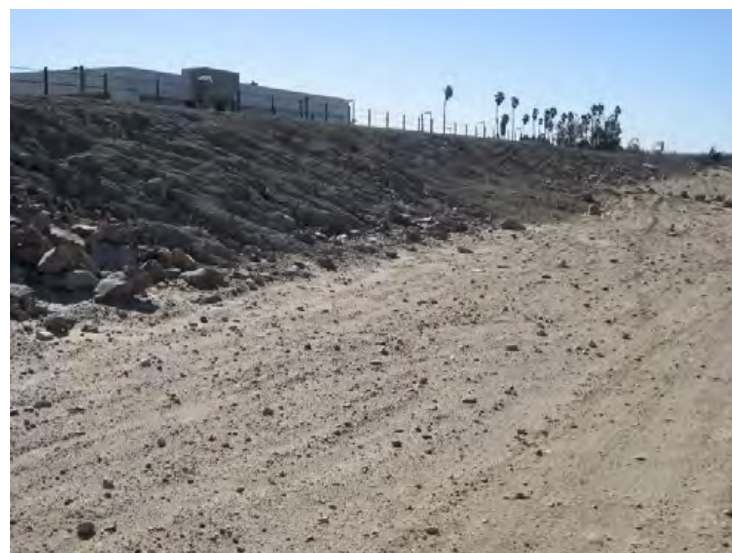
Santa Clara River Levee, From Hwy 101 to Saticoy. (Photo No. M39) – Concrete washout poured over rock protection, looking d/s (riverward side)

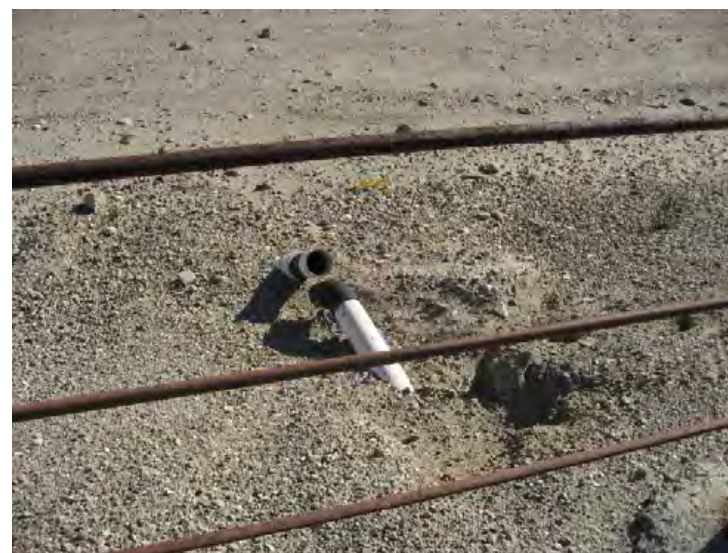
Santa Clara River Levee, From Hwy 101 to Saticoy, (Photo No. M43) –
PVC pipe protruding from levee (landward side)

M43	PVC pipe protruding from top of levee (landward side)	Remove unauthorized PVC pipe and fill voids with impervious material and firmly compact	C1/C4	E1	Excavate & repair in kind			
M44	Erosion on top of levee exposing fence posts (landward side)	Reestablish top of levee and fill voids with impervious material and firmly compact	C1/C4	E1	Repair, redress in kind			
M45	Stone debris approximately 500-feet along levee toe (landward side)	Remove unauthorized stone debris from levee toe	C1/C4	E1	Remove debris			
M46	Erosion on top of levee (landward side)	Reestablish top of levee and fill voids with impervious material and firmly compact	C1/C4	E1	Regrade levee top & bank, in kind repair			
M47, M48	Dumped stone and debris approximately 100-feet along the levee (landward side)	Remove unauthorized stone debris from levee toe	C1/C4	E1	Remove debris			
M49, M50	Sediment deposition in Side Drain No. 4, 48" RCP inlet structure (landward side)	Remove sediment and debris and establish a clear passage from pipe to channel (riverward & landward sides)	C1/C4	E1	Remove sediment & debris

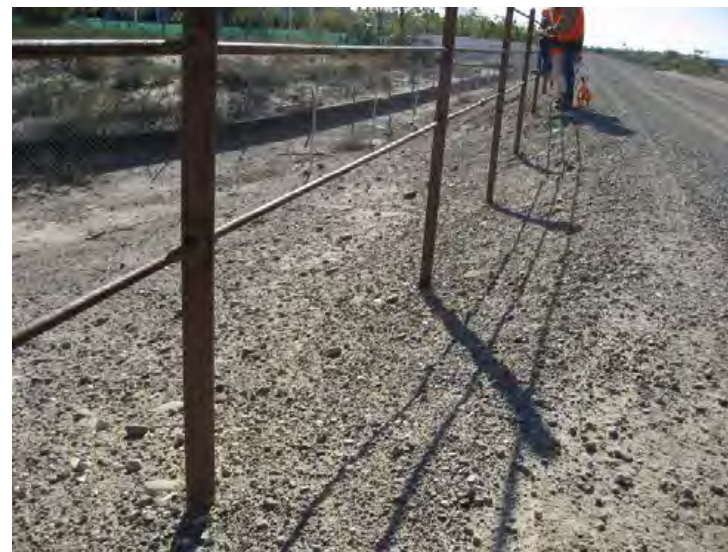
Santa Clara River Levee, From Hwy 101 to Saticoy, (Photo No. M44) –
Erosion on top of levee exposing fence posts, looking d/s (landward side)

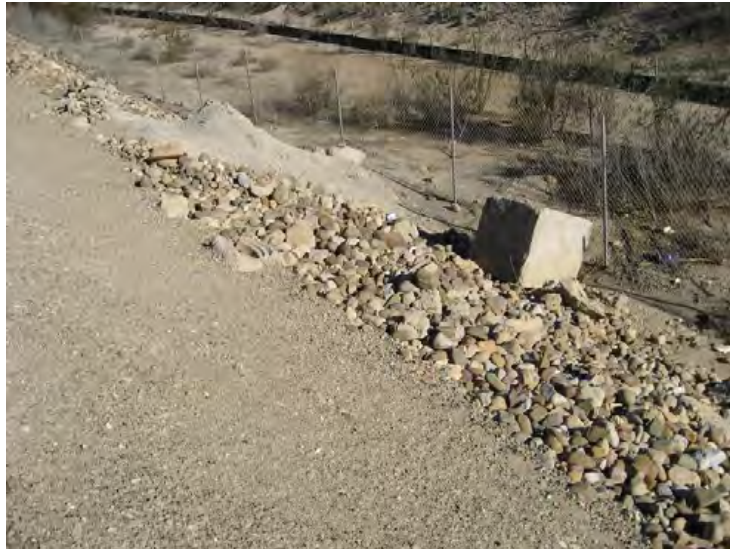
Santa Clara River Levee, From Hwy 101 to Saticoy, (Photo No. M45) –
Stone debris approx. 500' along levee toe, looking u/s (landward side)

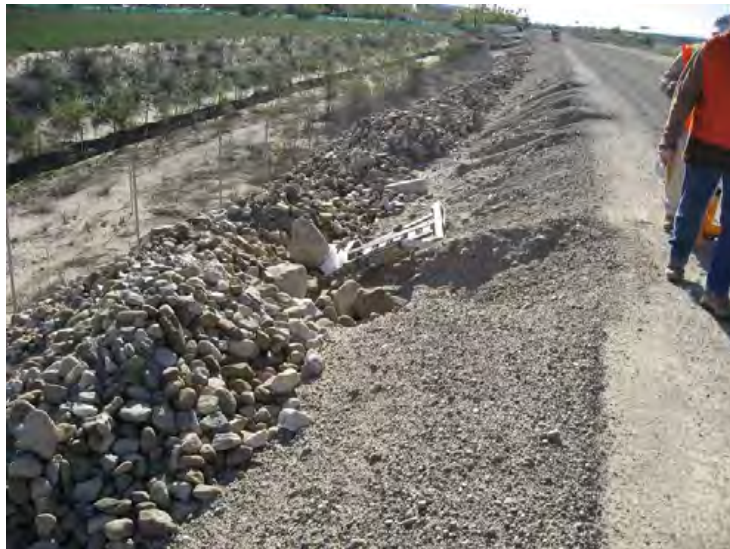
Santa Clara River Levee, From Hwy 101 to Saticoy, (Photo No. M46) –
Erosion on top of levee, looking downstream (riverward side)

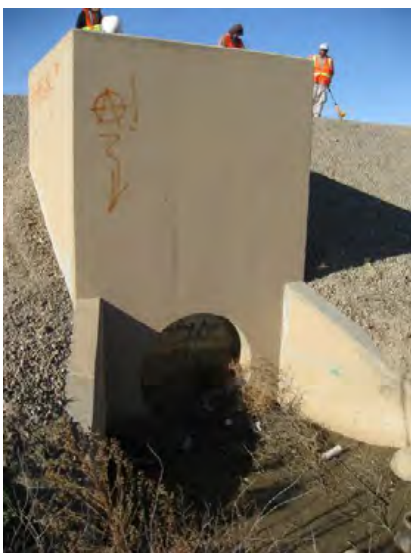
Santa Clara River Levee, From Hwy 101 to Saticoy, (Photo No. M49) –
Sediment deposition in Side Drain No. 4, 48" RCP invert (landward side)

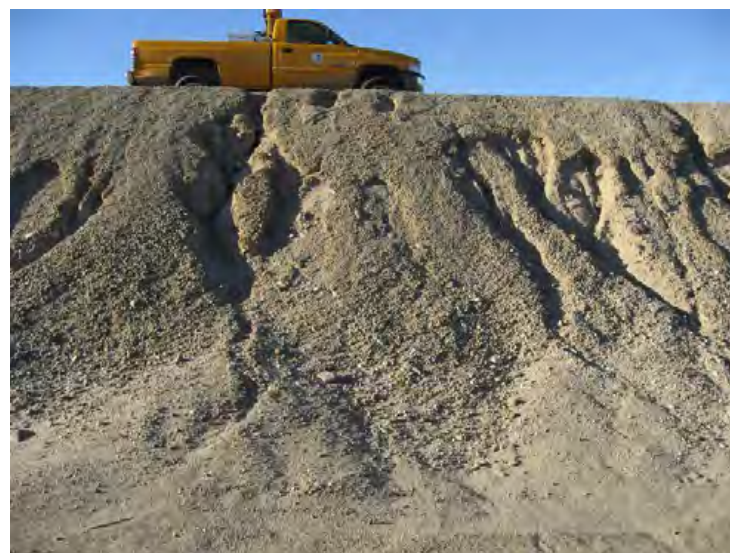
Santa Clara River Levee, From Hwy 101 to Saticoy, (Photo No. M51) –
Erosion on levee embankment, looking upstream (landward side)

M51, M52	Erosion on levee embankment (landward side)	Reestablish levee embankment and fill voids with impervious material and firmly compact	C1/C4	E1	Redress levee slope in kind repair			
M53	Animal burrows near top of levee (landward side)	Remove animal burrows, fill voids with impervious material and firmly compact	C1	E1	Excavate & recompact existing levee, add IPM			
M54	Tree within 15' of levee toe (landward side)	Remove tree and root ball, fill voids with impervious material and firmly compact.	C1/C4	E1	Landward veg removal not regulated	X	Where does the toe start?	The fifteen (15) foot vegetation line is measured from the visual toe of slope to the center line of the trunk (tree), the closest trunk to the toe (multiple trunk trees/plants) or the stock/stem protruding through the soil (large plant connected to a root system)
M55, M56	Trees within 15' along levee toe (landward side)	Remove trees and root ball, fill voids with impervious material and firmly compact.	C1/C4	E1	Landward veg removal not regulated	X	Where does the toe start?	The fifteen (15) foot vegetation line is measured from the visual toe of slope to the center line of the trunk (tree), the closest trunk to the toe (multiple trunk trees/plants) or the stock/stem protruding through the soil (large plant connected to a root system)

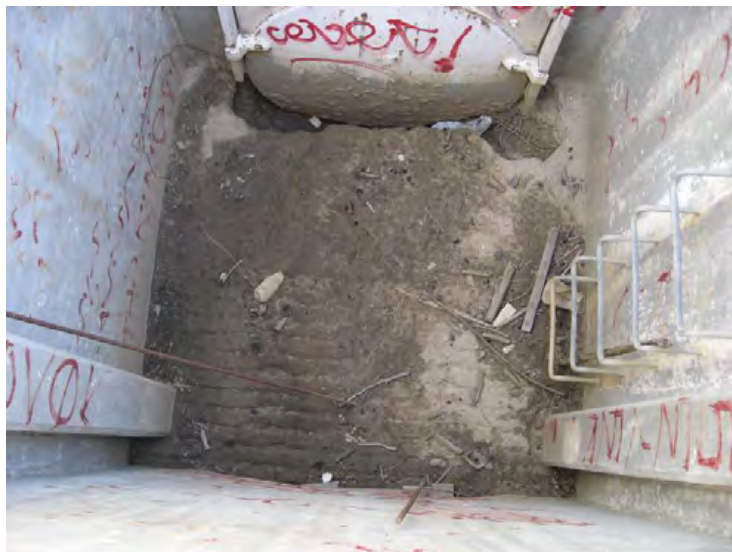
Santa Clara River Levee, From Hwy 101 to Saticoy, (Photo No. M50) –
Looking down at sediment in SD No. 4, inlet structure (landward side)

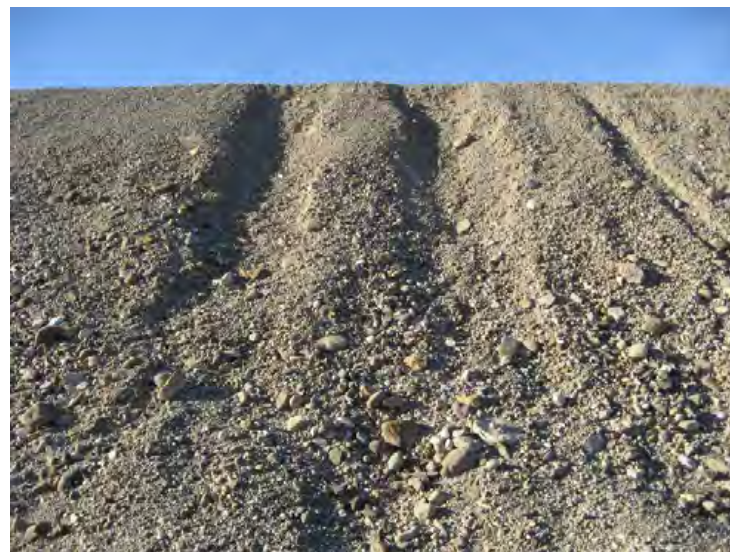
Santa Clara River Levee, From Hwy 101 to Saticoy, (Photo No. M52) –
Erosion on levee embankment, looking downstream (landward side)

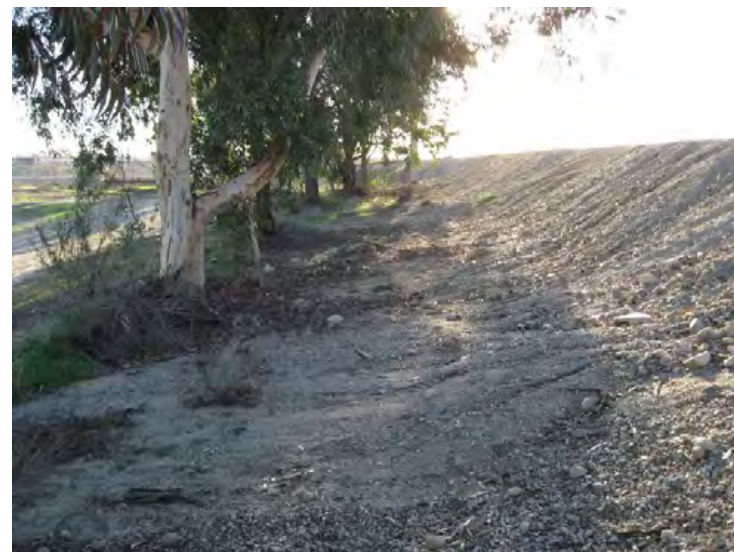
Santa Clara River Levee, From Hwy 101 to Saticoy, (Photo No. M56) –
Trees within 15' of levee toe, looking upstream (landward side)

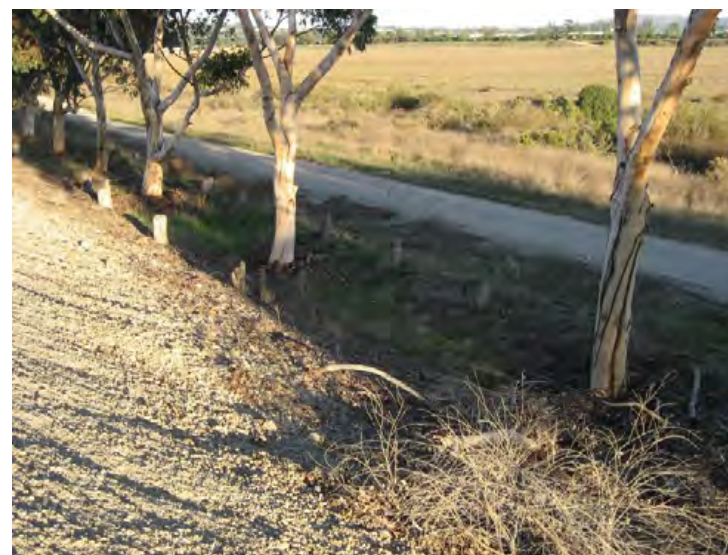
Santa Clara River Levee, From Hwy 101 to Saticoy, (Photo No. M59) –
Trees within 15' of levee toe, looking u/s (landward side)

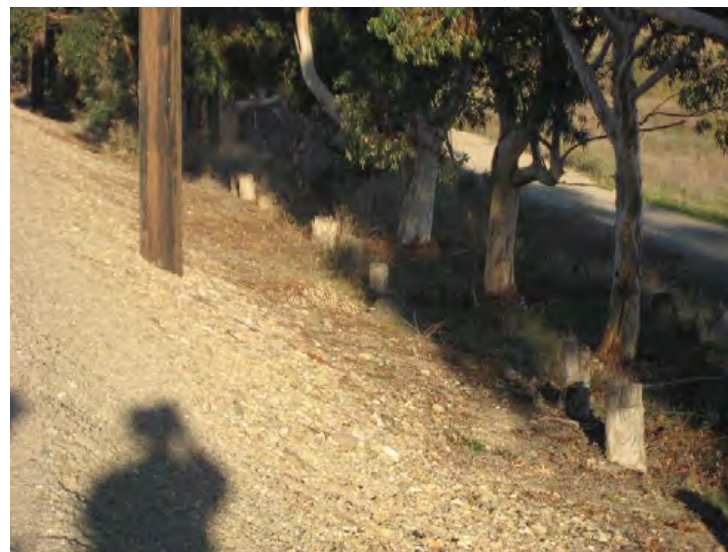
Santa Clara River Levee, From Hwy 101 to Saticoy, (Photo No. M60) –
Trees, power poles & stumps within 15' of toe, looking u/s (landward side)

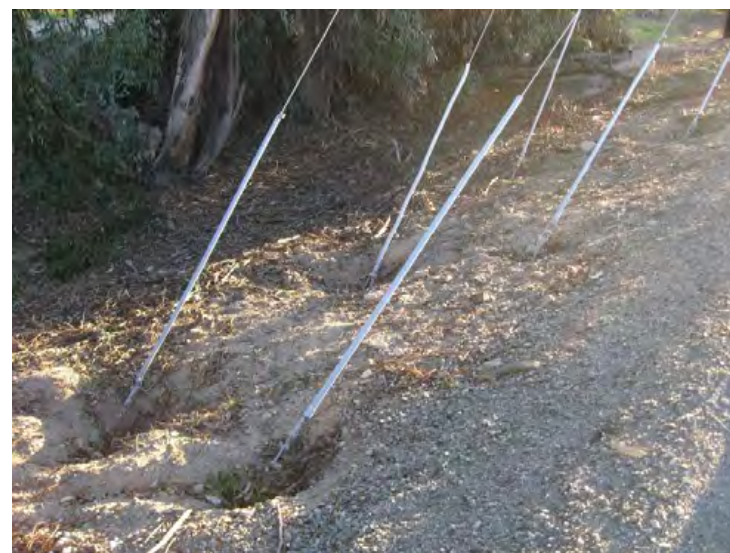
Santa Clara River Levee, From Hwy 101 to Saticoy, (Photo No. M63) –
Power poles guy wires anchored in levee bank, looking d/s (landward side)

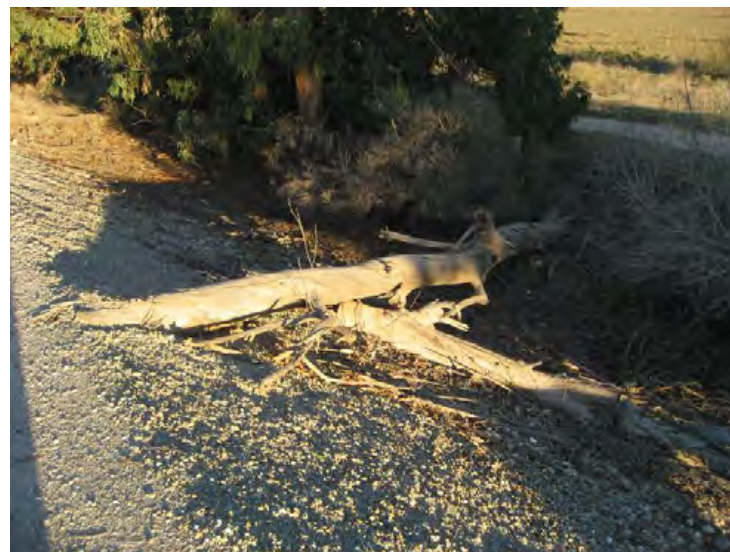
Santa Clara River Levee, From Hwy 101 to Saticoy, (Photo No. M64) –
Fallen trees and vegetation on levee bank, looking u/s (landward side)

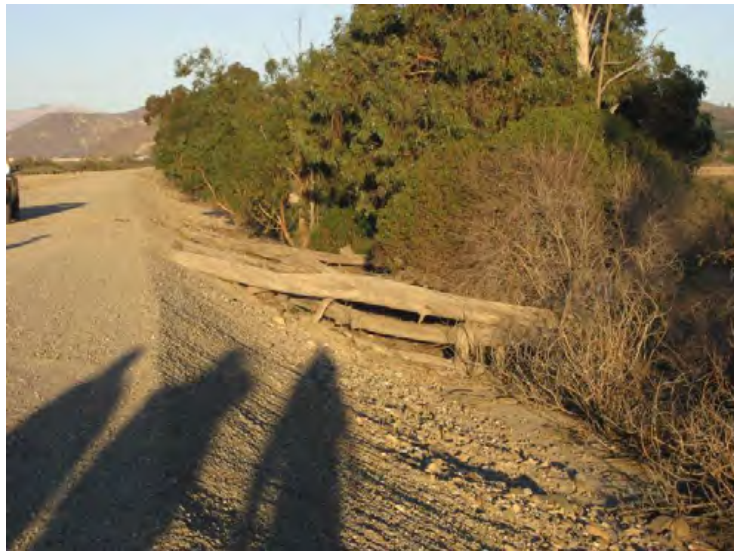
Santa Clara River Levee, From Hwy 101 to Saticoy, (Photo No. M65) –
Trees and fallen trees within 15' of levee toe, looking u/s (landward side)

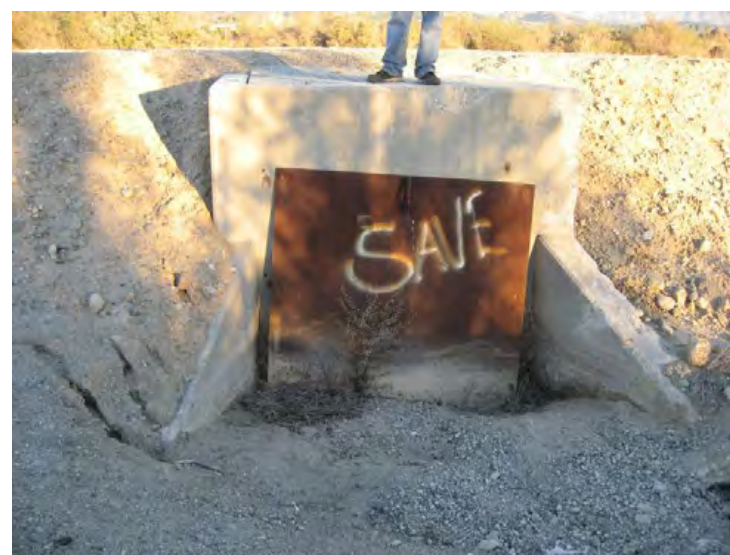
Santa Clara River Levee, From Hwy 101 to Saticoy, (Photo No. M71) –
Sediment & metal debris in Side Drain No. 3 inlet (landward side)

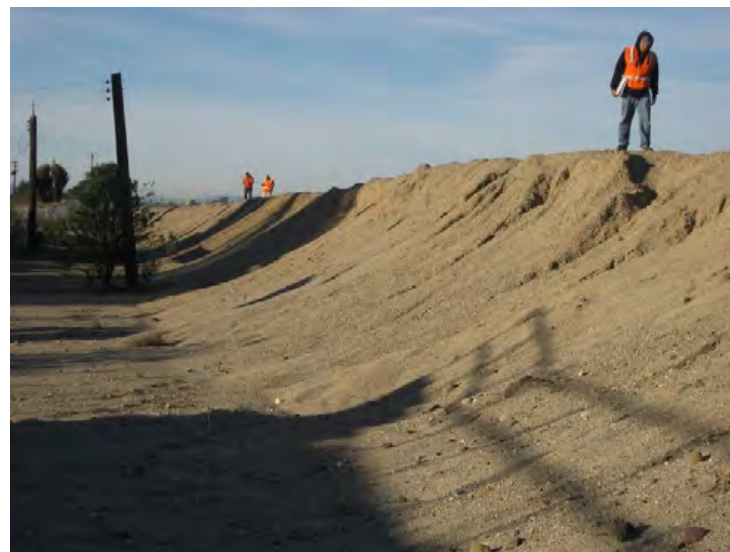
Santa Clara River Levee, From Hwy 101 to Saticoy, (Photo No. M72) –
Erosion on levee embankment, looking downstream (landward side)

M72	Erosion on levee embankment (landward side)	Reestablish levee embankment and fill voids with impervious material and firmly compact	C1/C4	E1	Redress levee slope in kind repair			
M73	Erosion on levee embankment (landward side)	Reestablish levee embankment and fill voids with impervious material and firmly compact	C1/C4	E1	Redress levee slope in kind repair			
M74	Erosion caused by vehicles under Los Angeles bridge crossing (landward side)	Reestablish levee embankment and fill voids with impervious material and firmly compact	C5, Cal-Trans issue	E1	Remove sediment, repair slopes, in kind repair	X	This could be a Cal-Trans issue?	Repair is required
M75, M76	Vegetation within 15-feet of levee toe (landward side)	Remove vegetation and root ball, fill voids with impervious material and firmly compact.	C1/C4	E1	Landward veg removal not regulated			
M77	Erosion at top of levee with miscellaneous debris at toe (landward side)	Repair erosion and remove miscellaneous debris	C1/C4	E1	Redress levee slope in kind repair

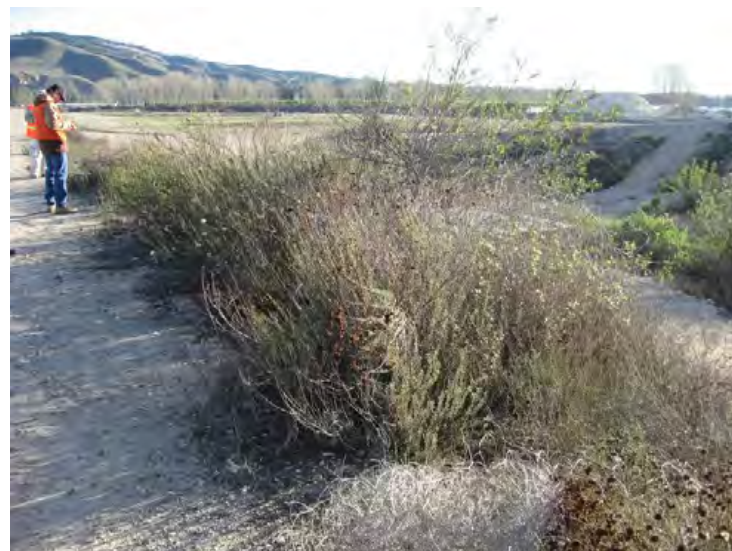
Santa Clara River Levee, From Hwy 101 to Saticoy, (Photo No. M75) –
Vegetation within 15-feet of levee toe, looking downstream (landward side)

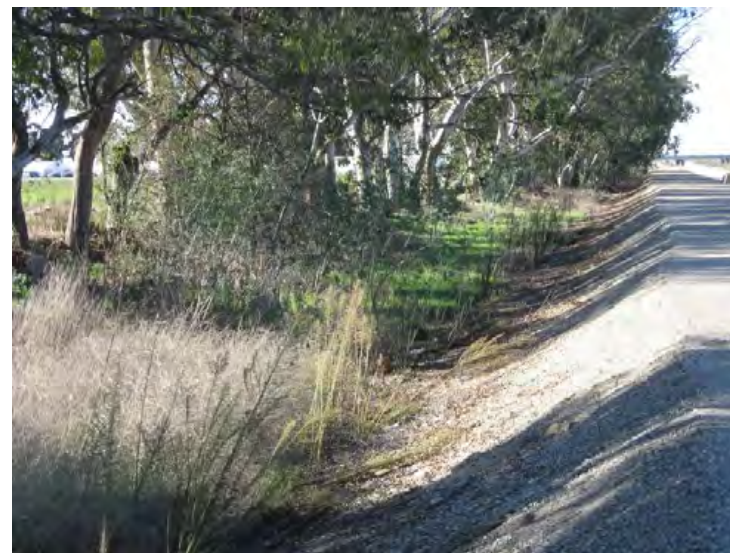
Santa Clara River Levee, From Hwy 101 to Saticoy, (Photo No. M79) –
Trees within 15-feet of levee toe, looking downstream (landward side)

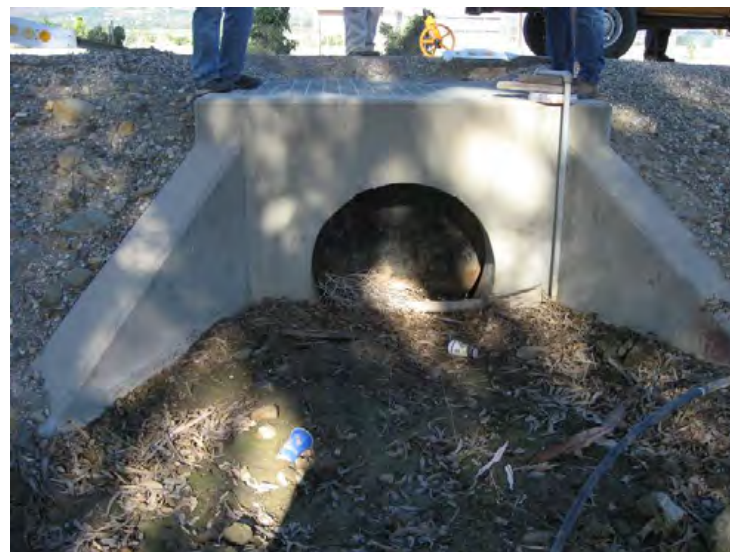
Santa Clara River Levee, From Hwy 101 to Saticoy, (Photo No. M80) –
Sediment and debris in Side Drain No.1, 42" RCP inlet (landward side)

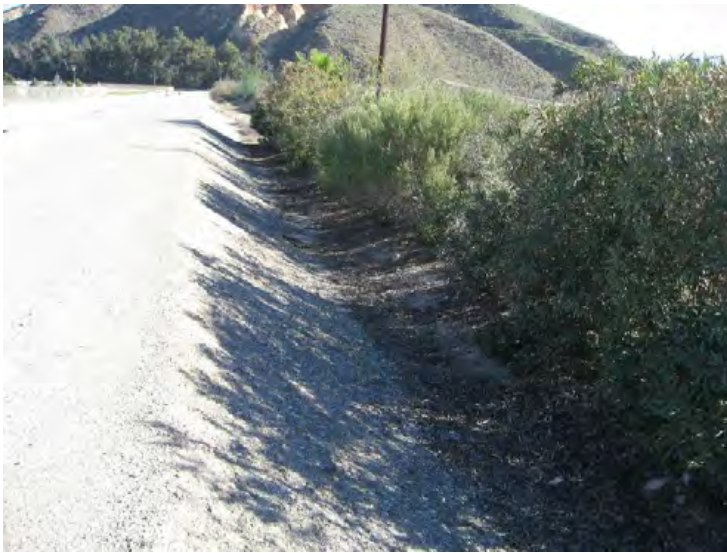
Santa Clara River Levee, From Hwy 101 to Saticoy, (Photo No. M81) –
Vegetation within 15-feet of levee toe, looking upstream (landward side)

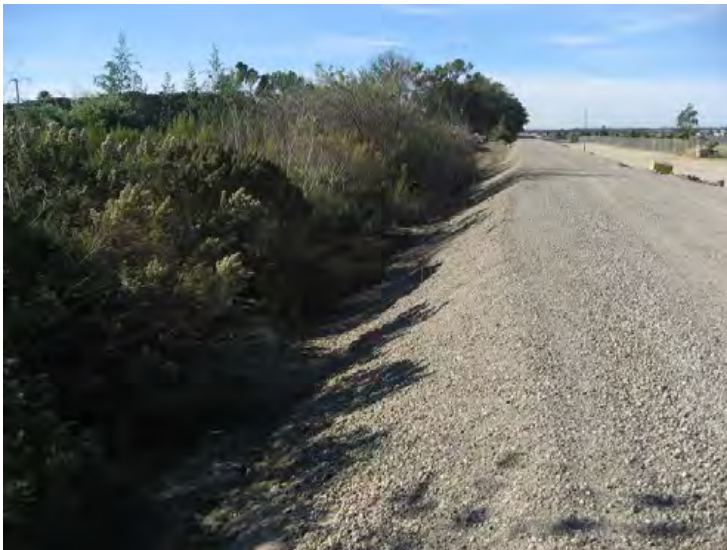
Santa Clara River Levee, From Hwy 101 to Saticoy, (Photo No. M82) –
Vegetation within 15-feet of levee toe, looking downstream (landward side)
